2025 Annual Performance Report  
Stormwater Management System

**ECA Number: 170-S701**

Town of Arnprior  
July 2026

| <b>System Name:</b> Town of Arnprior Stormwater Management System | |

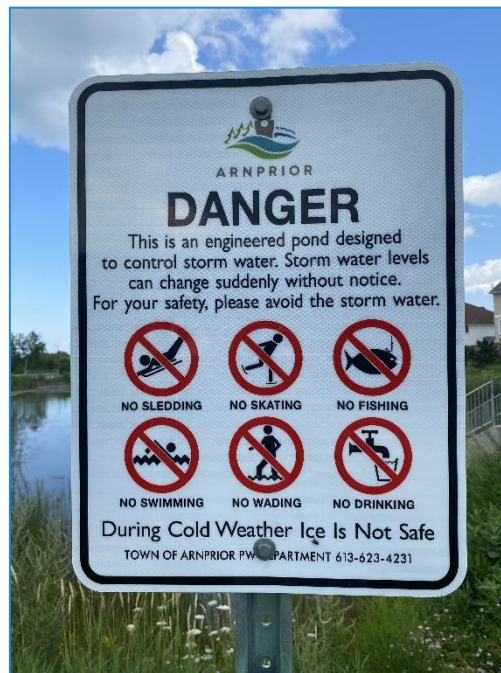
Figure 1: SWM Signage

In 2023, Public Works staff installed signage at each storm water management facility throughout the Town to communicate to residents the purpose of these facilities and associated risks, as these facilities are not intended to be used for recreational purposes. A sample of the sign installed is noted in Figure 1 below.

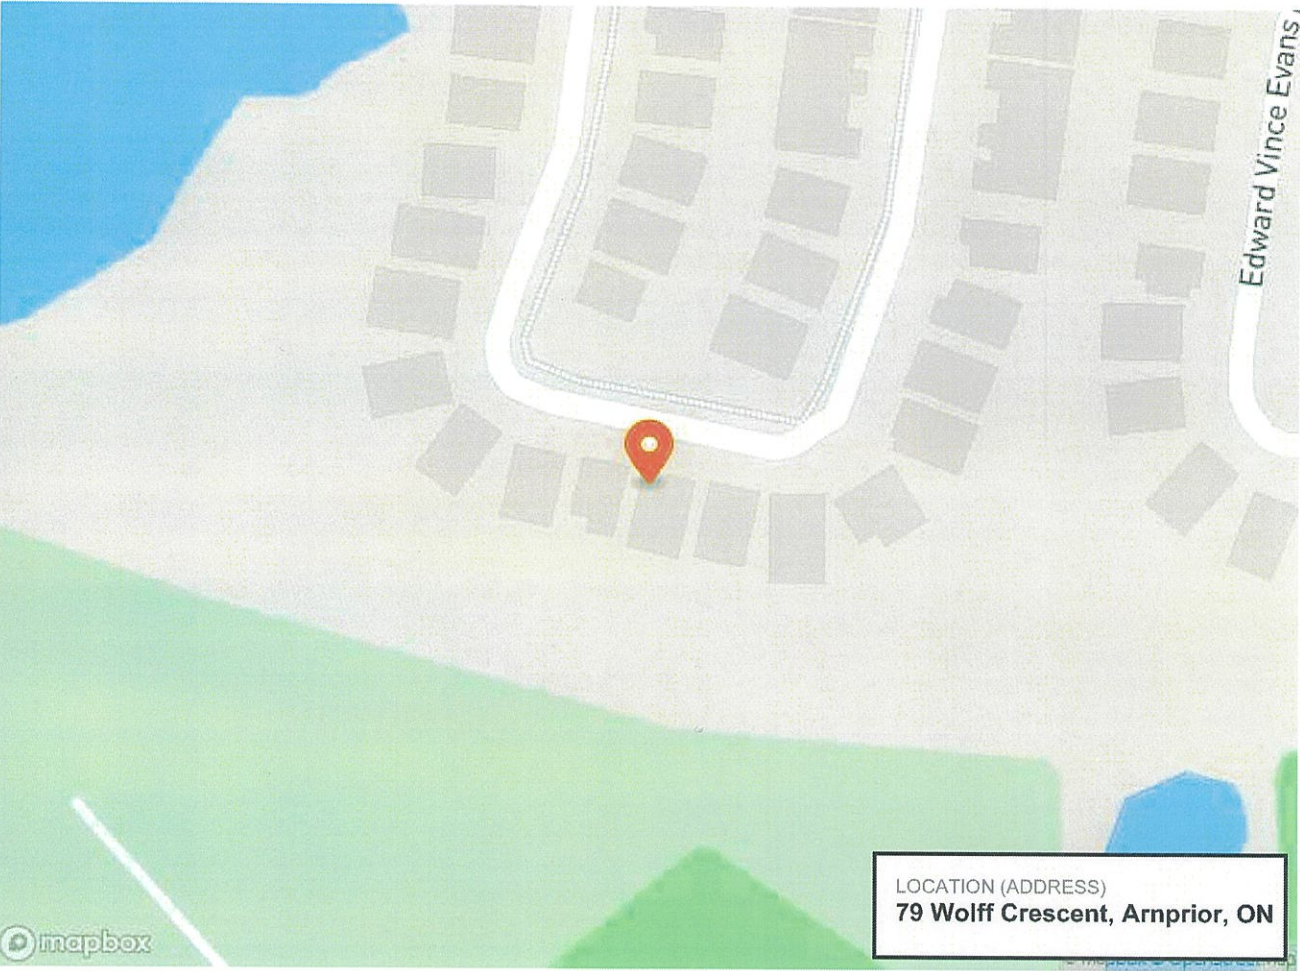
LOCATION DESCRIPTION

Clean out the ditch

The owner of 79 Wolfe Cres called as the ditch behind 71 and 75 Wolfe Cres has not been cleaned out yet this year. He would like to ensure this is done as the water is backing up and he is worried it will backup in the spring and cause flooding. He is asking that the annual maintenance the town is responsible for be completed.

complete

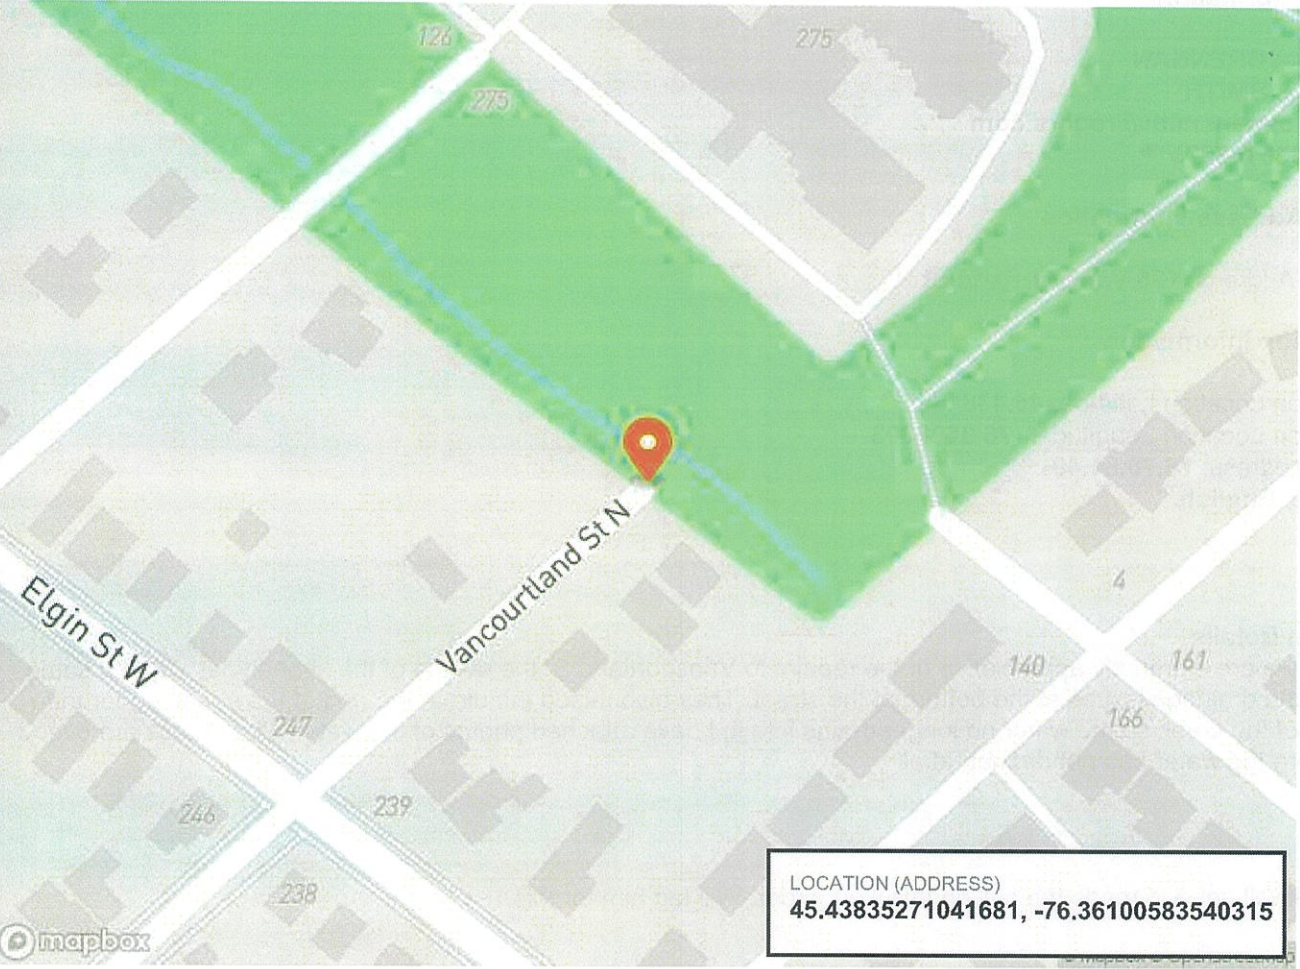
LOCATION DESCRIPTION

**WebForm Details**  
Although we are extremely appreciative of the repairs to Vancourtland St the raising of the asphalt has caused some flooding and drainage issues at the bottom of the street. They also raised the dirt at the end of the street higher then the edge of the creek so the water no longer drains into it. I have attached photos of the water. The photos are over 3 days where the water has not drained at all

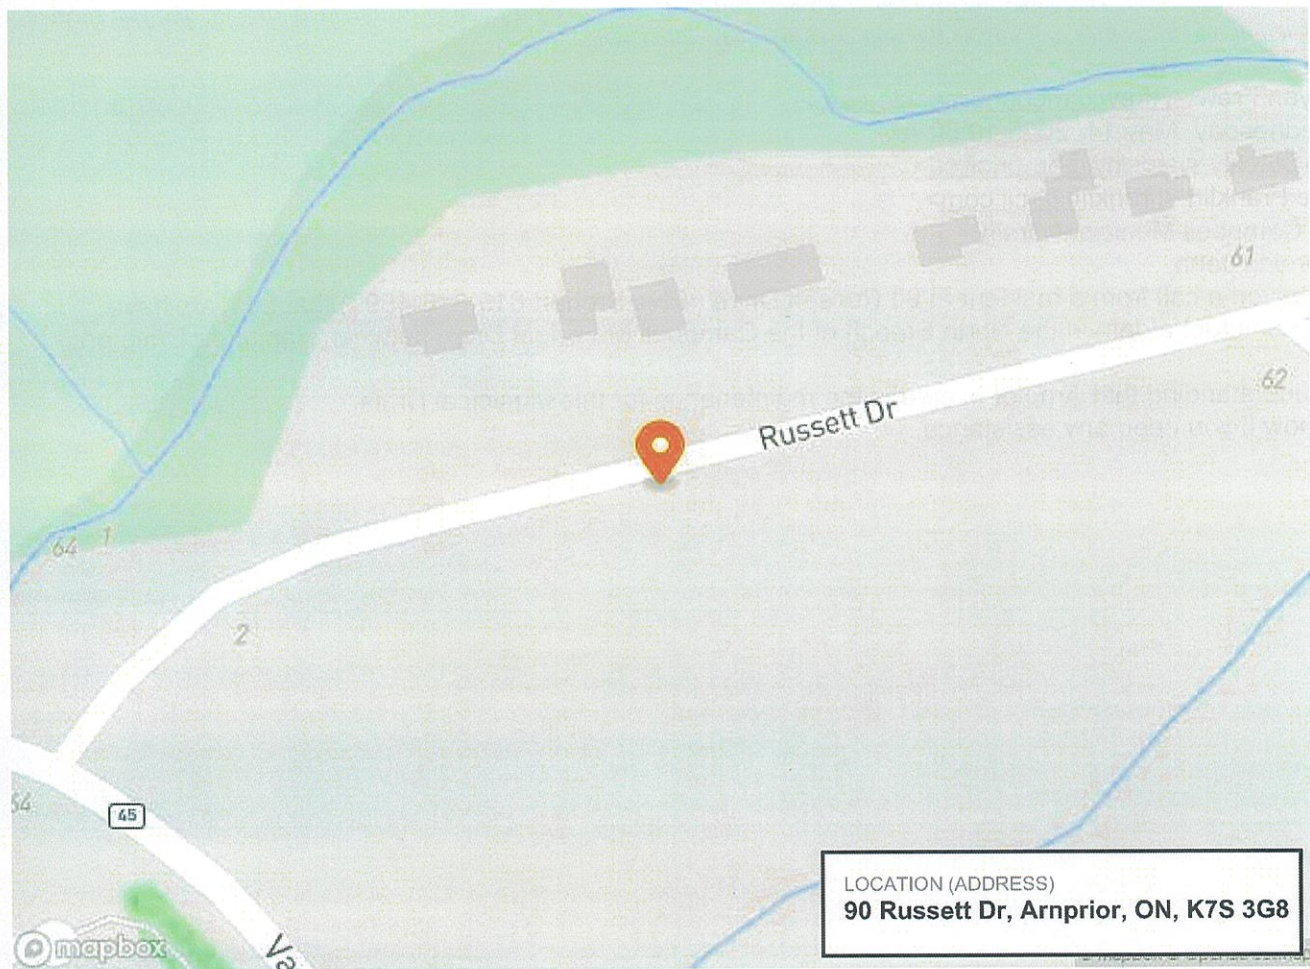
## LOCATION DESCRIPTION

| TASK | STATUS | DUE DATE | EFFORT | ASSIGNEE(S) | DEPENDENCY(S) |
|---|---|---|---|---|---|
| Remove beaver dam from drain | Closed automatically | | | | |

Dam was removed May 28th 2025 by PL,SM. Checked the rest of the ditch all the way to the highway. Found some grass in one yard in the ditch but water was still getting through it. Water seems to be flowing well now but we will check again in a couple days to ensure the dam is not rebuilt.

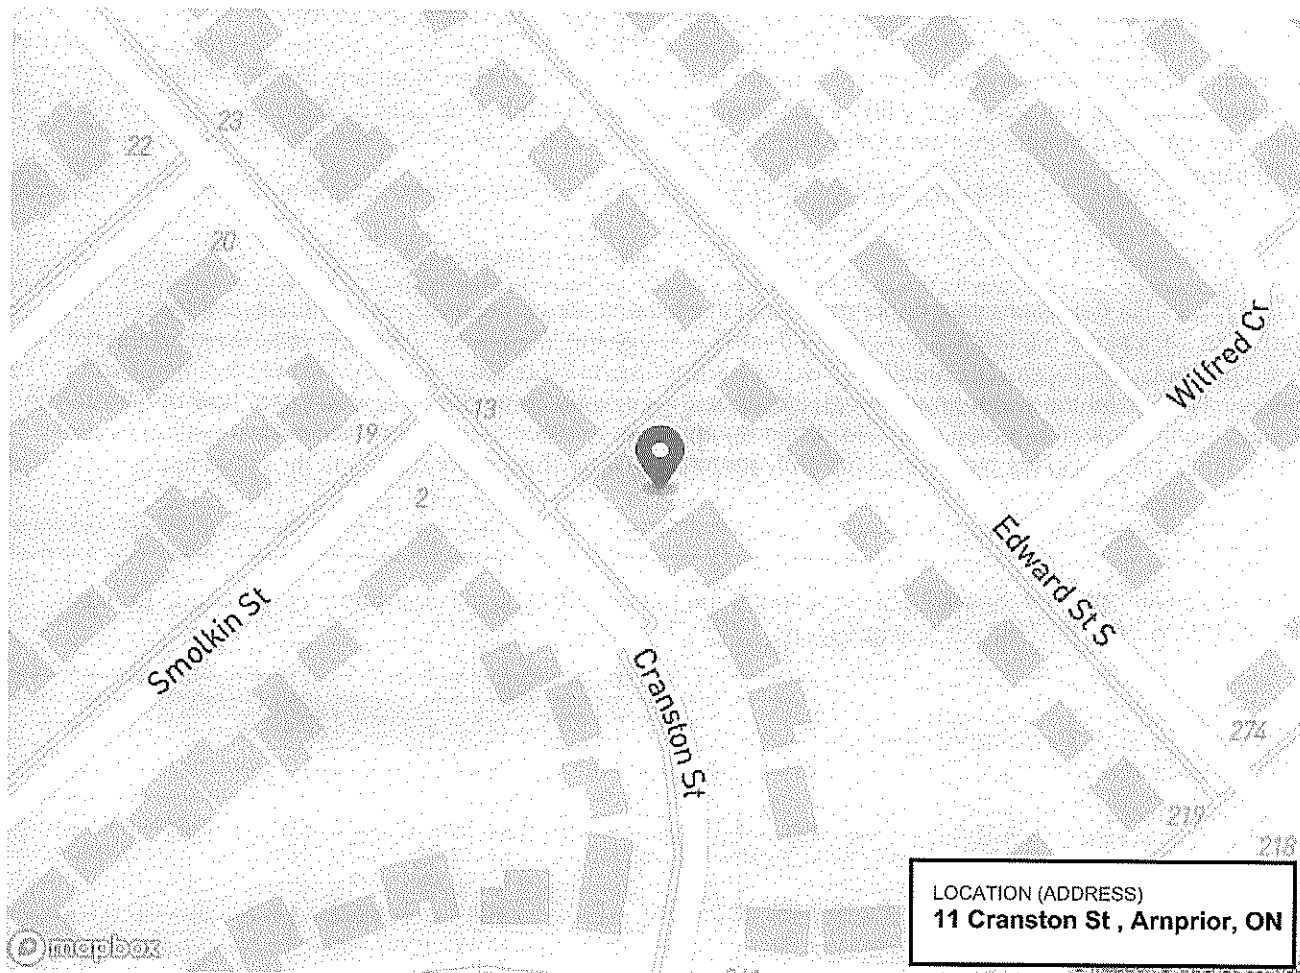
### LOCATION DESCRIPTION

\_\_\_\_\_ called with concerns about a drainage issue occurring in his backyard at 11 Cranston St due to the paved walking pathway between Edward and Cranston St. He claims that since this path was paved, the water has no where to go because it can no longer absorb into the ground. He claims the pavement isn't level with the ground which creates a tripping hazard and causes the water to run into his backyard. He claims it was 4 ft away from his backyard fence, and was pooling about 10 inches deep of water. It has dried up now and the issue only occurs during lots of rain or snow. He claims that the drain is at the other end of the path which doesn't support drainage. He also claims the drain is a tripping hazard as it is a dip in the ground. He explained 3 guys looked at it before from PW but nothing was done. He worries during an excessive rain that it could cause issues for water into his basement.

Public works has reviewed the area of concern. It appears that there are no current drainage issues at this time. There was record snow falls this year, and with the weather warming suddenly it caused an excessive volume of snow to melt. This caused a puddle that cleared within a day. Everything is working as intended. There are no concerns at this time.

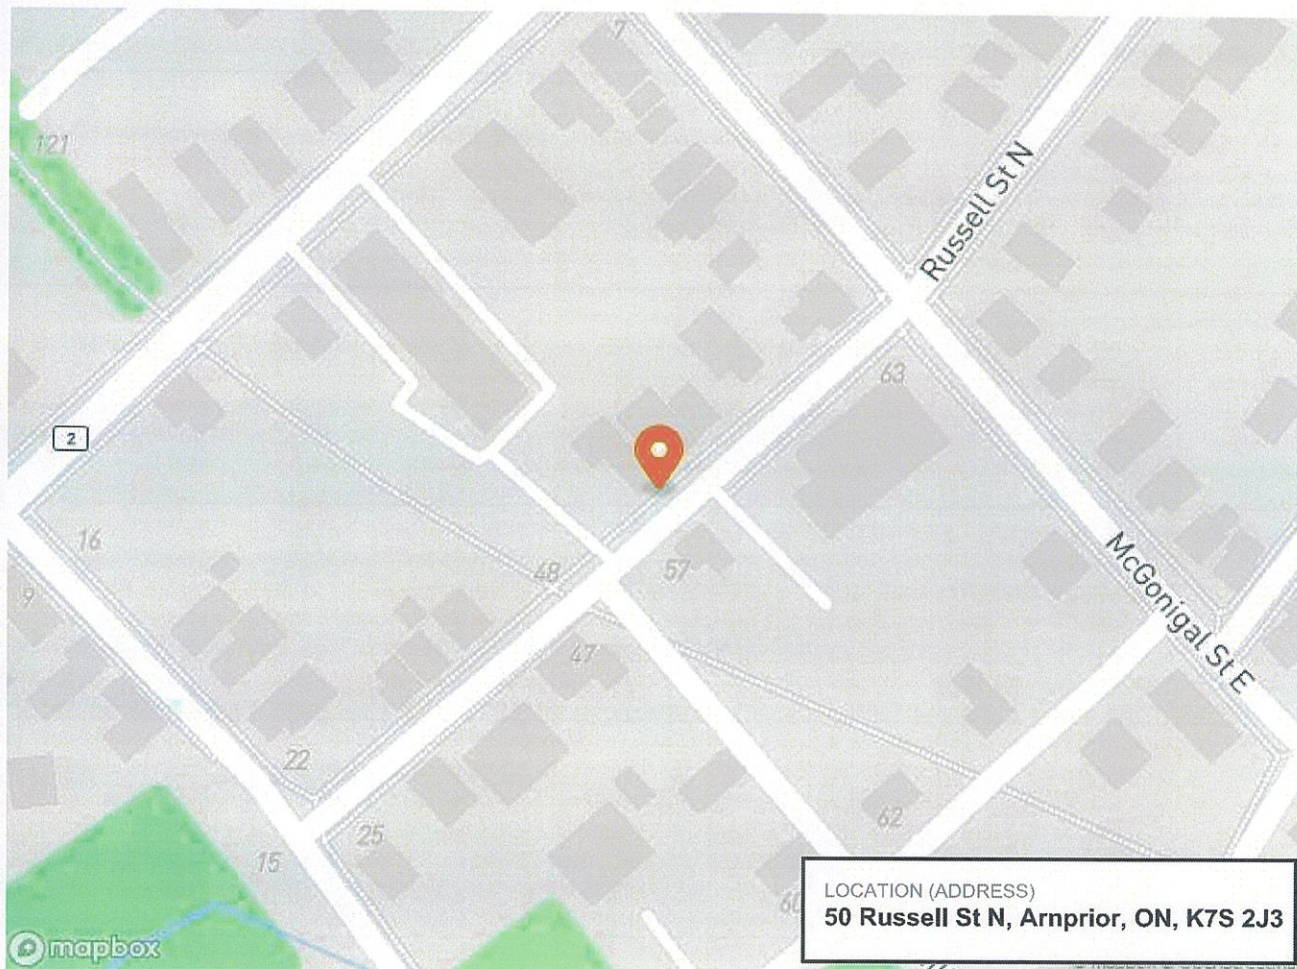
### LOCATION DESCRIPTION

| TASK | STATUS | DUE DATE | EFFORT | ASSIGNEE(S) | DEPENDENCY(S) |
|---|---|---|---|---|---|
| WATER IN BASEMENT - 50 RUSSELL ST N | Closed automatically | 2025-01-06 | | | |
