## Geotechnical Slope Assessment

*Proposed Reflection Shores Development, Municipality of Lambton Shores,  
Ontario*

CA-GLD-1898967-1000-R02-Rev9

December 9, 2025

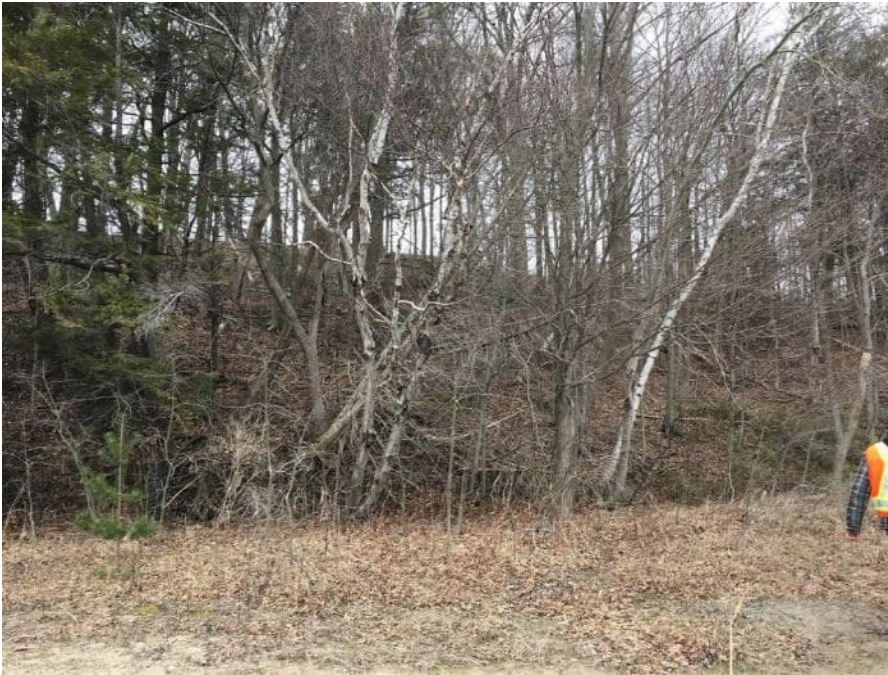
Photograph 1a: Lakeshore slope south of Section A-A'. No toe erosion on April 18, 2018.

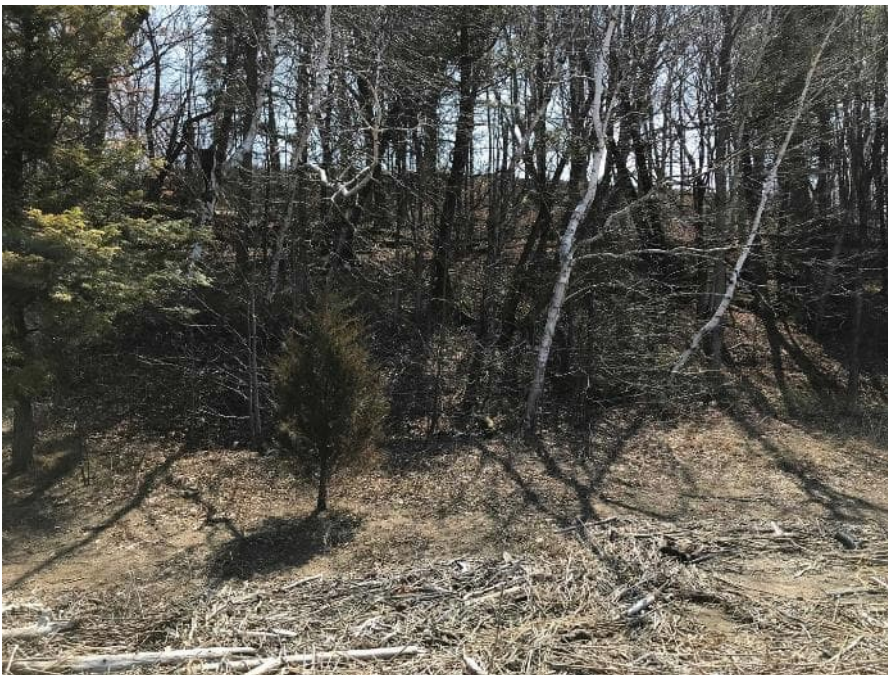
Photograph 1b: Lakeshore slope south of Section A-A'. No toe erosion. April 8, 2020.

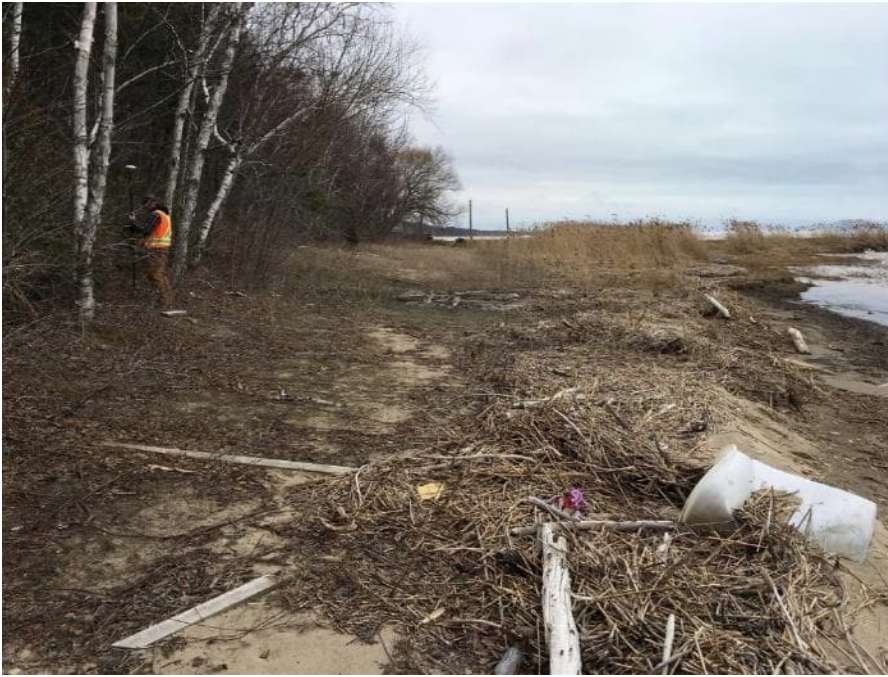
Photograph 2a: Section A-A' at beach looking south. No toe erosion on April 18, 2018.

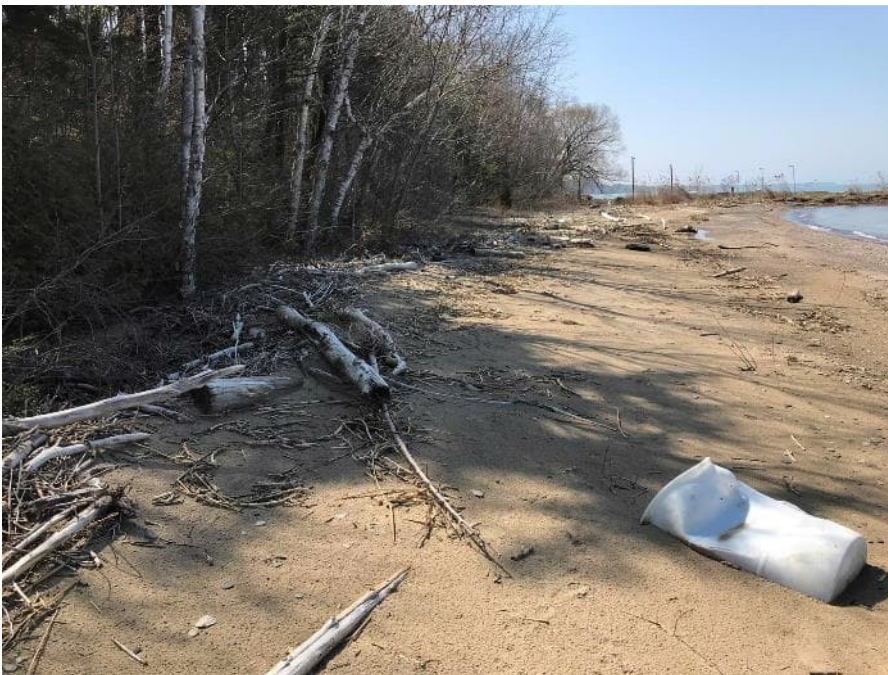
Photograph 2: Section A-A' at beach looking south. No toe erosion on April 8, 2020; however, recent higher water levels have moved driftwood and debris landward compared to April 18, 2018 condition above.

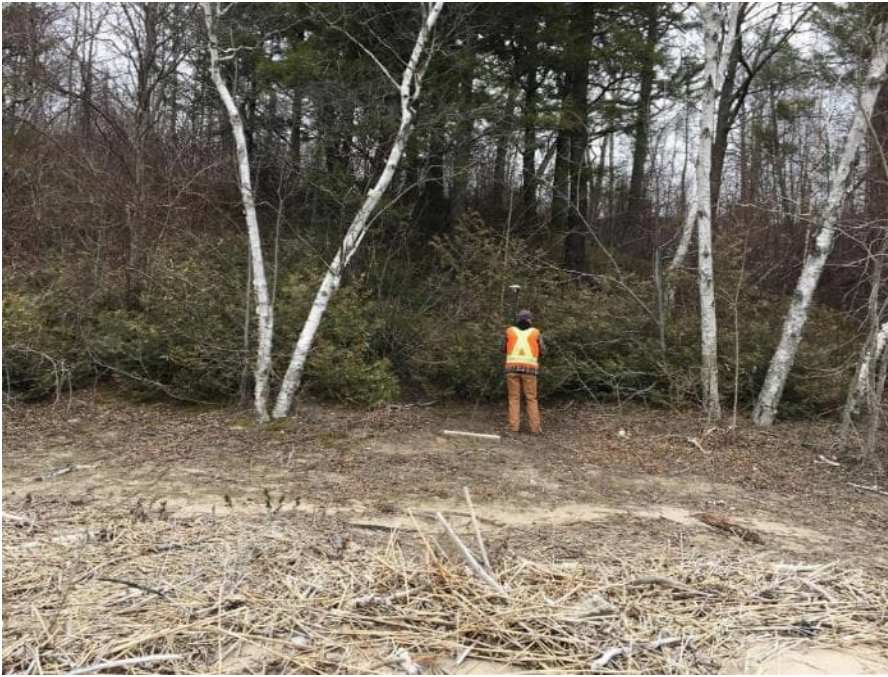
Photograph 3a: Section A-A' at beach looking upslope. No toe erosion on April 18, 2018.

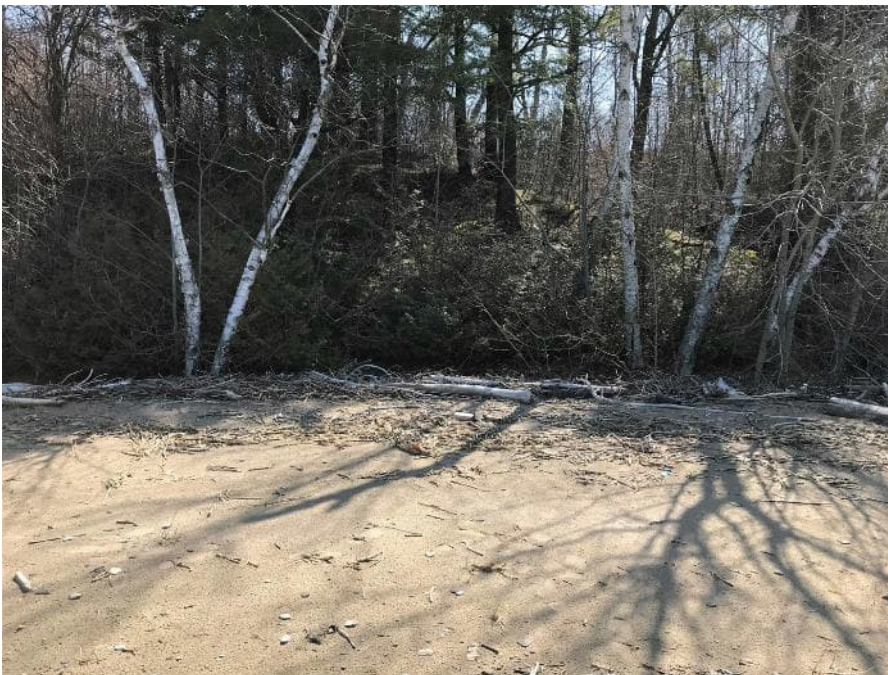
Photograph 3b: Section A-A' at beach looking upslope. No toe erosion on April 8, 2020; however, recent higher water levels have moved driftwood and debris landward compared to April 18, 2018 condition above.

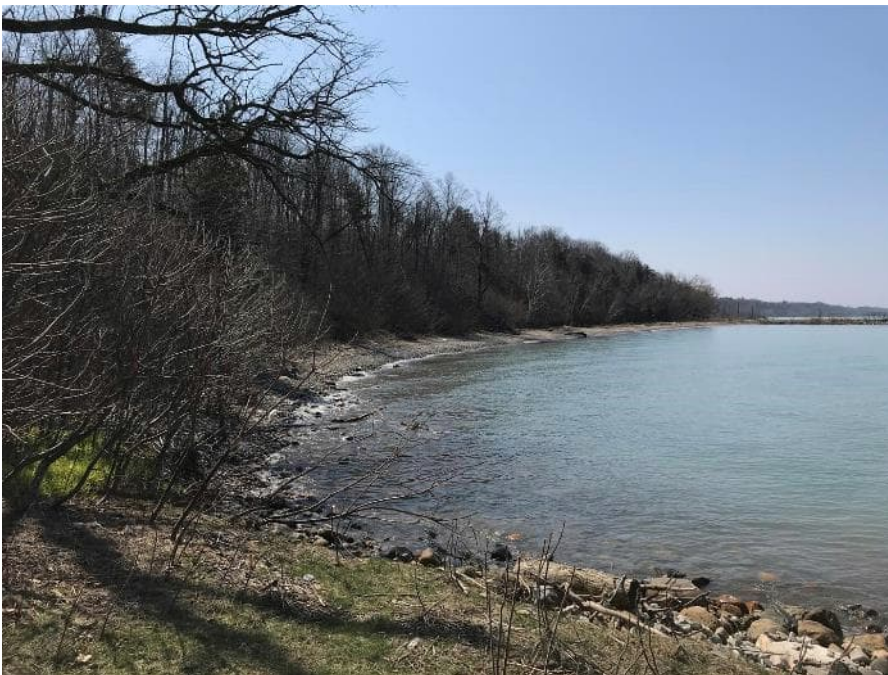
Photograph 8b: Section B-B' at toe looking south on April 8, 2020. Note higher Lake Huron water level on April 8, 2020, compared to April 18, 2020, however, no erosion at the slope toe was observed.

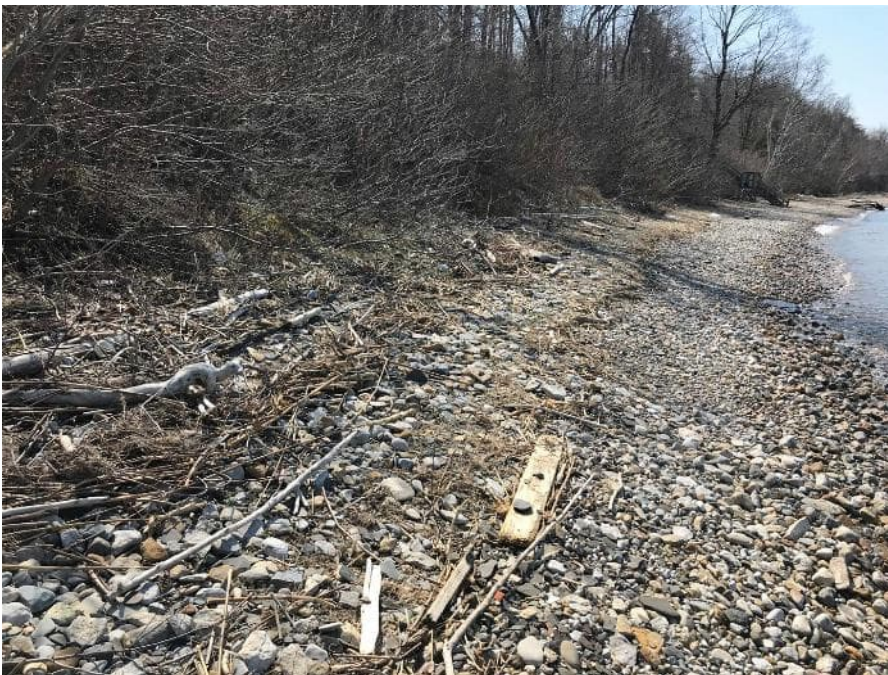
Photograph 14: Section B-B' at beach looking south on April 8, 2020. No erosion at toe of slope; however, evidence of higher Lake Huron water levels close to the toe of slope.

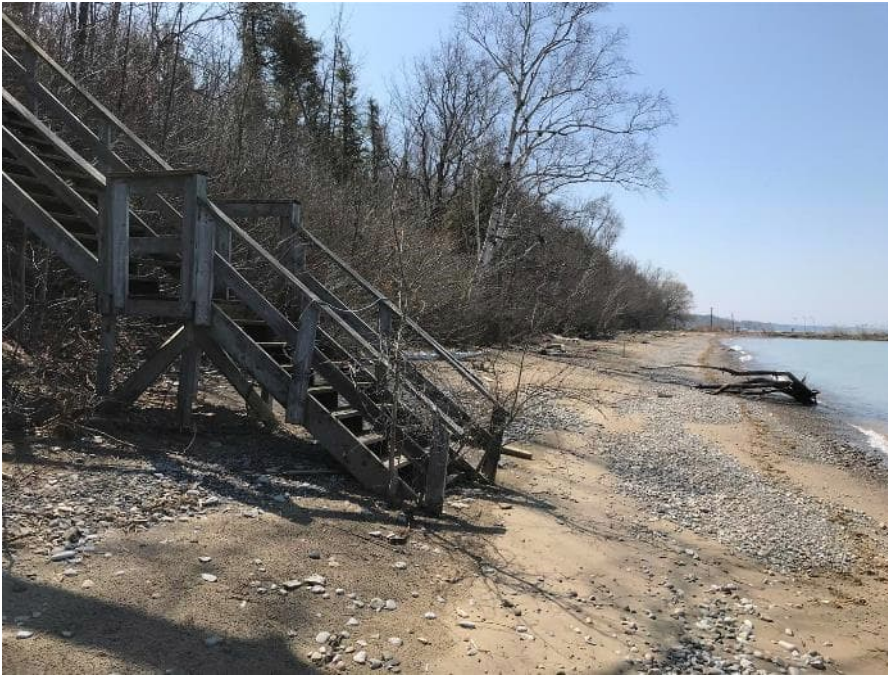
Photograph 15: Wooden staircase between Section A-A' and Section B-B' looking south. No erosion noted on April 8, 2020.

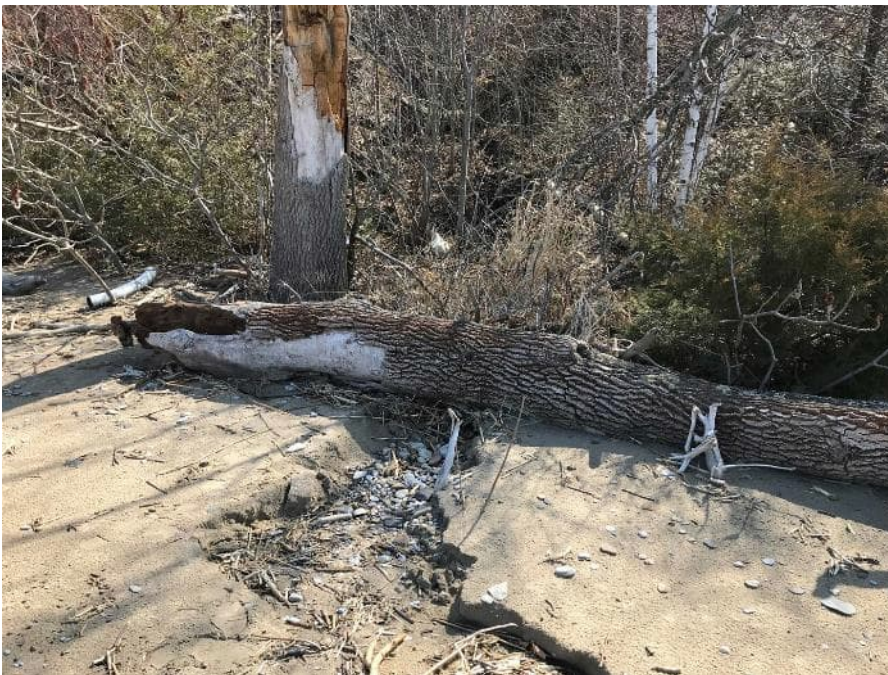
Photograph 16: Small gully south of the wooden staircase looking east on April 8, 2020.

It is considered that the proposed development works at the site may disrupt the existing drainage systems within the farm fields and thus reduce flow directed into the gullies. Rehabilitation of the existing gullies by controlling the erosion could be addressed by removing the loosened and saturated materials from within the gulley and placing sufficient well-graded rip rap in the gullies with a robust non-woven geotextile between the rip rap and native soil to protect the channels. The existing drainage pipes could be extended sufficiently down the slope and within the gullies to the toe. The pipes must be fully encapsulated in 19-millimetre crushed stone within a robust non-woven geotextile surround.

Alternatively, if the drains are removed, approved native cohesive backfill should be used to fill the gullies. Erosion control blankets would need to be installed along the slope face and vegetal growth established. Prior to backfilling the gullies, the subgrades soils must be cleared of organic, wet, loose, or any deleterious materials and inspected by the geotechnical engineer. The backfill material must be placed in loose lifts not exceeding 300 millimetres in thickness and uniformly compacted to at least 95 per cent of standard Proctor maximum dry density (SPMDD).

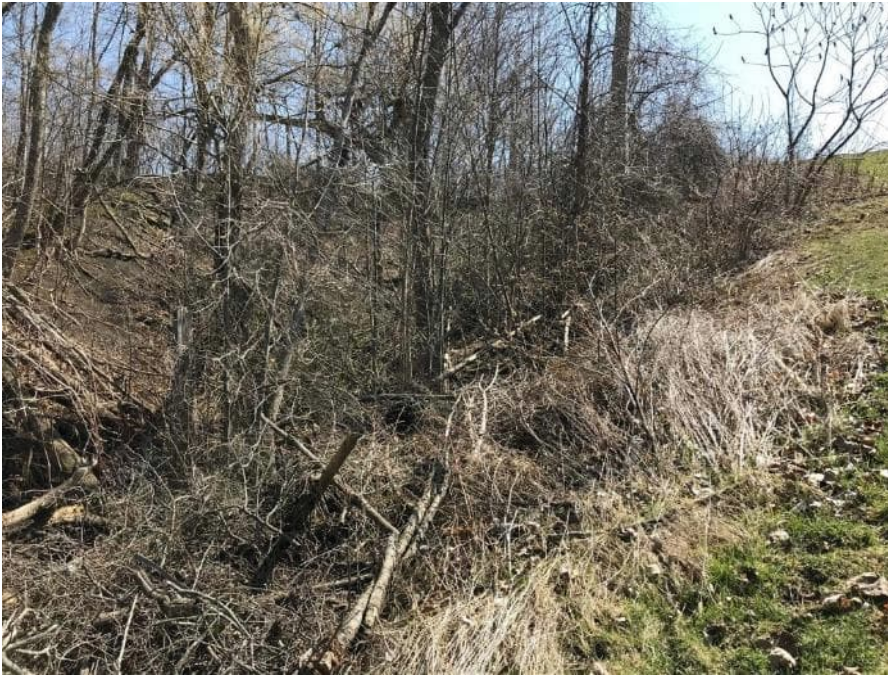
Photograph 17: Large erosion gully at south property line looking upslope on April 8, 2020. Gully caused by surface flows from north ditch along Cedar Point Line.

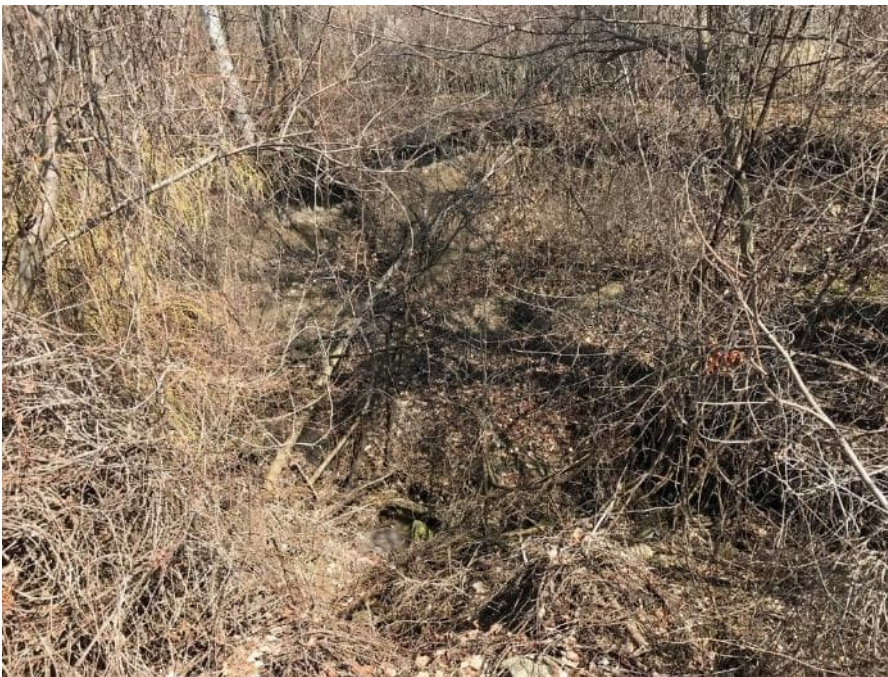
Photograph 18: Large erosion gully at south property line looking north on April 8, 2020. Gully caused by surface flows from north ditch along Cedar Point Line.

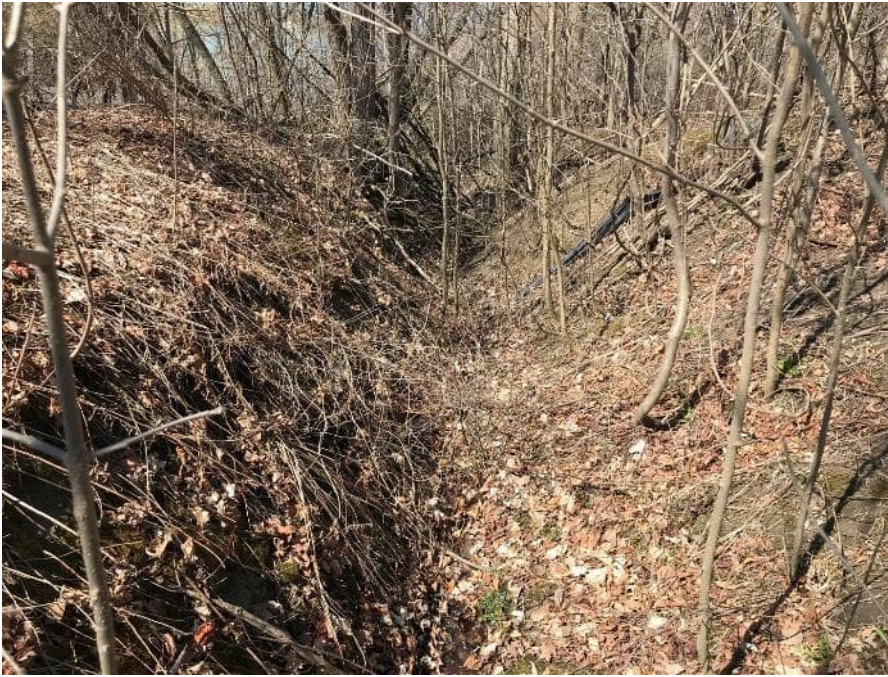
Photograph 19: Gully at south end of property looking west on April 8, 2020. Gully caused by drainage at the southwest corner of farm field.

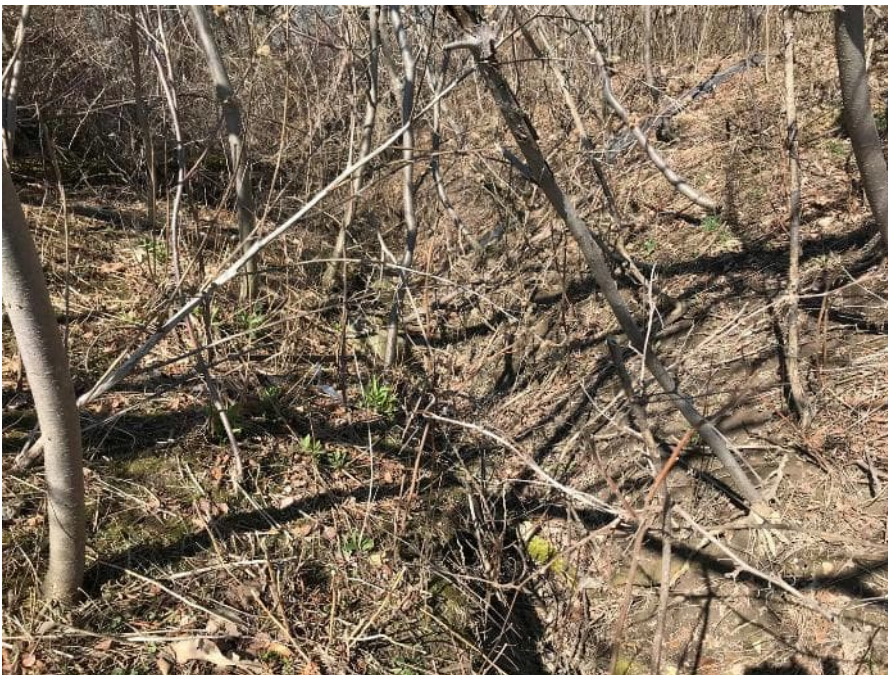
Photograph 20: Gully south of the wooden staircase looking west on April 8, 2020. Gully caused by drain from farm field.

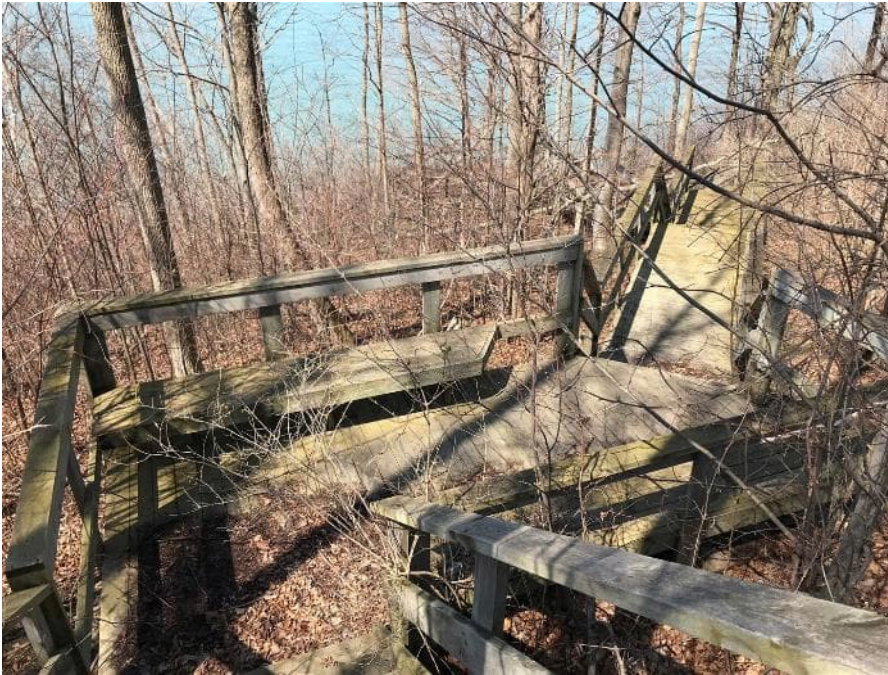
Photograph 21: Wooden staircase from top of slope looking west on April 8, 2020. Staircase in good condition.

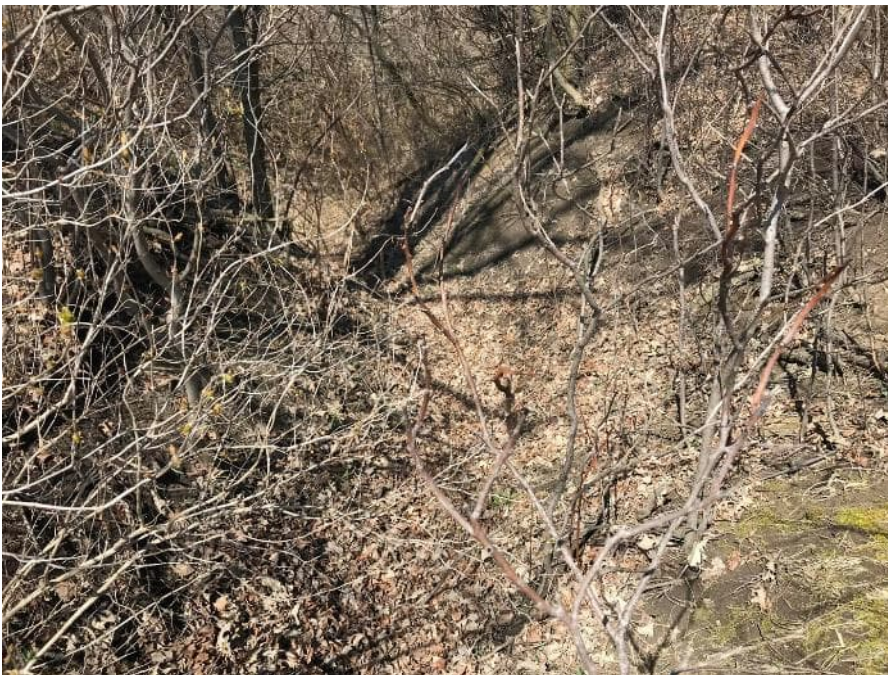
Photograph 22: Erosion gully at north end of site looking west on April 8, 2020. Gully caused by drain from adjacent farm field.

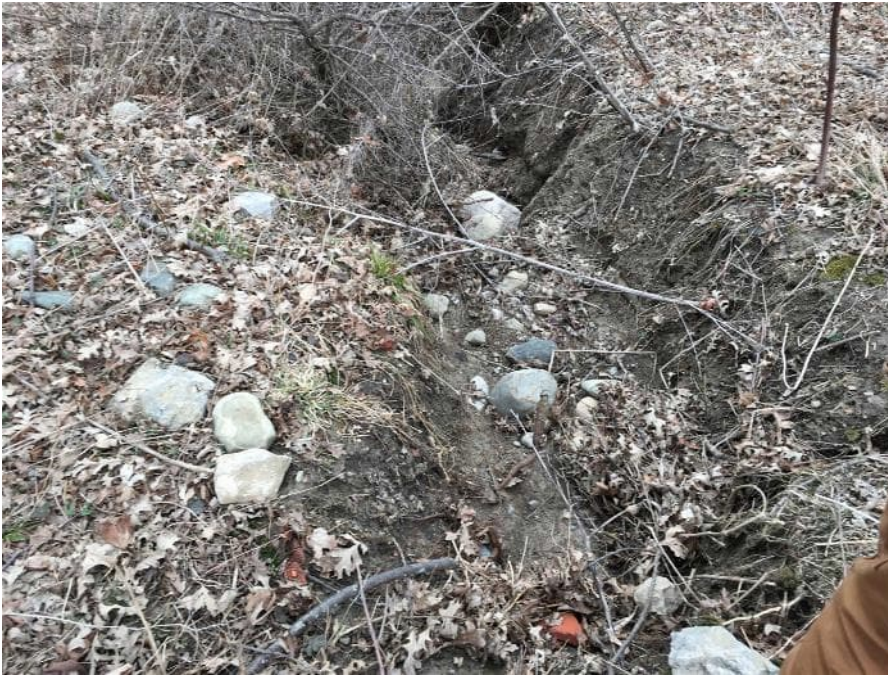
Photograph 23a: Gully at north end of site looking west. Gully caused by seepage from farm field drain pipe at top of slope on April 18, 2018.

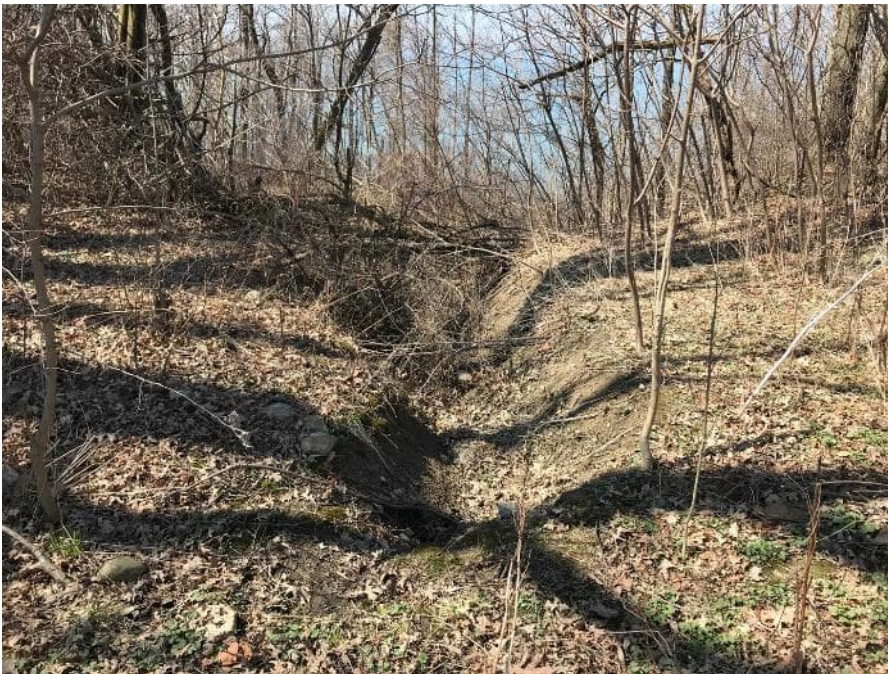
Photograph 23b: Gully at north end of site looking west. Gully caused by seepage from farm field drain pipe at top of slope on April 8, 2020.

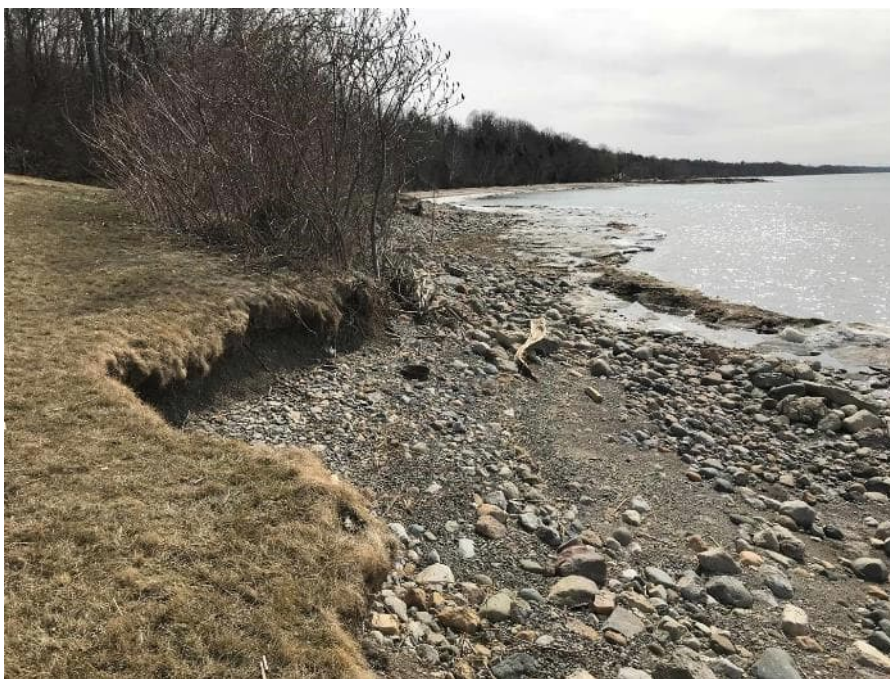
Photograph 24: Active erosion within grassy area west of the toe of slope near north end of property looking south on March 23, 2021.
