**HIGH LEVEL BANK STABILITY REVIEW  
PEMBINA RIVER VALLEY  
ENTWISTLE, ALBERTA  
REVISION 1**

**Report  
to  
Parkland County**

Date: November 29, 2017  
File: 18683

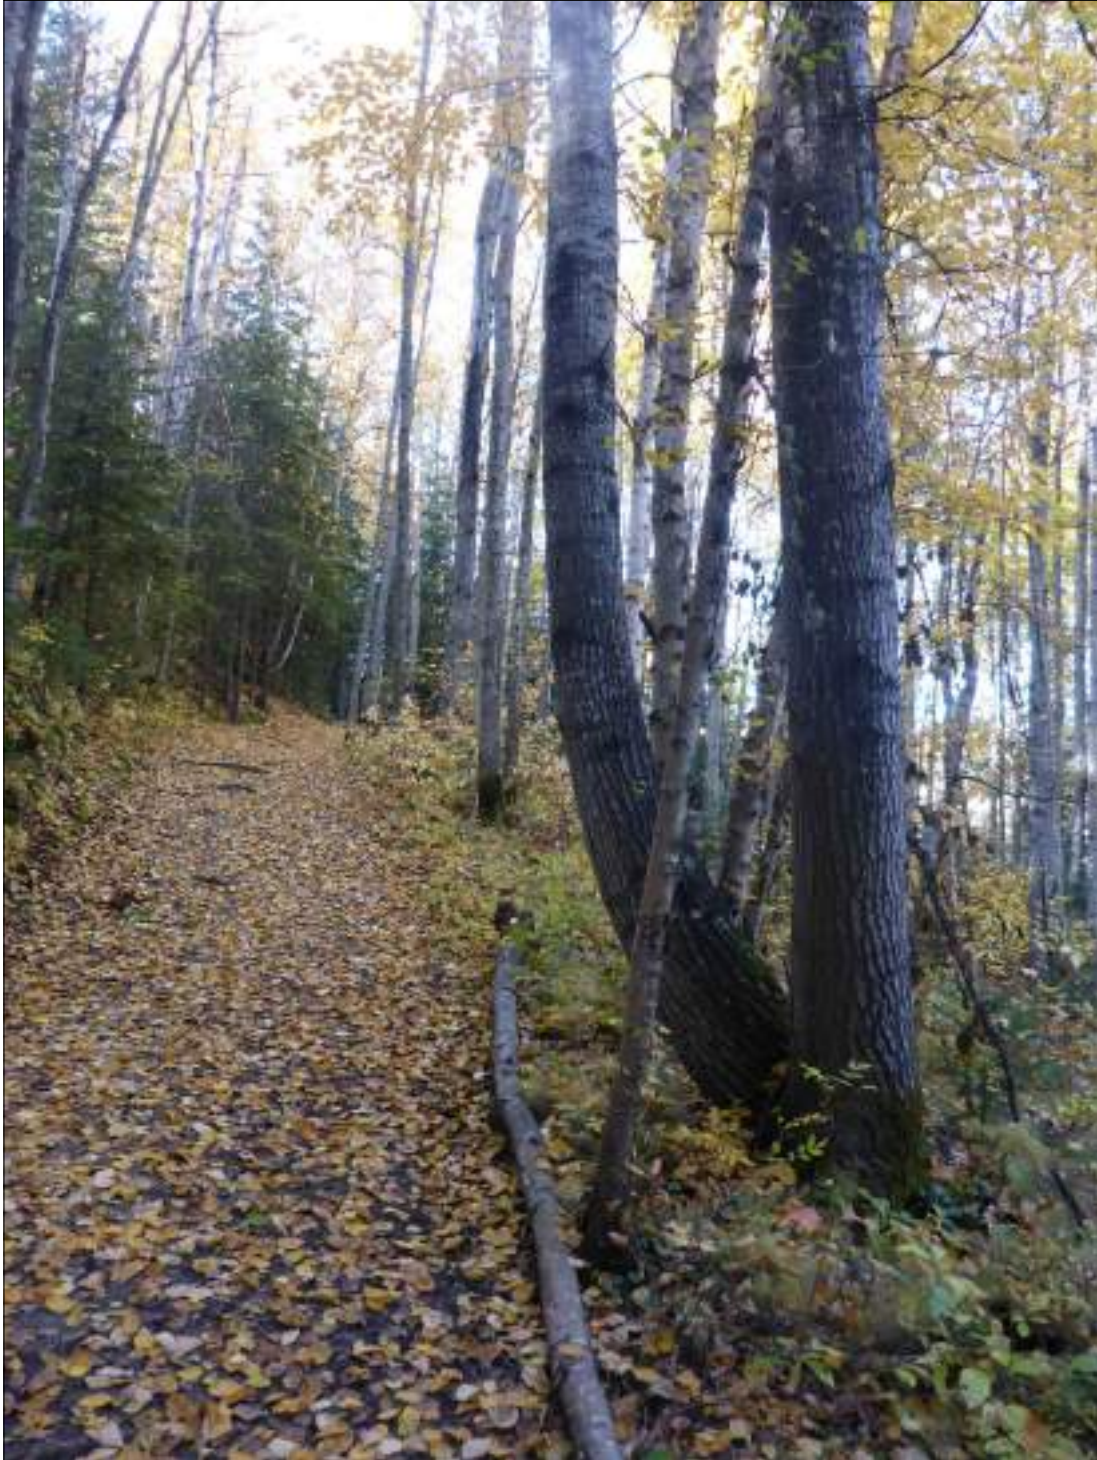
The site could be accessed via a foot trail from the Pembina River Tubing parking area that leads down the valley to the river shore. Along this path the slope was vegetated with mature trees. Some of the trees were observed to have bent trunks at their bases and mature straight trunks for the rest of their height (Photos 1 and 2, Appendix C). This type of growth is typical of trees that experienced some downslope movement when they were young but have not significantly moved in the years since, which is most likely on the order of decades.

PHOTO 1 SITE 1 - RIVER ACCESS PATH WITH CURVED TREES

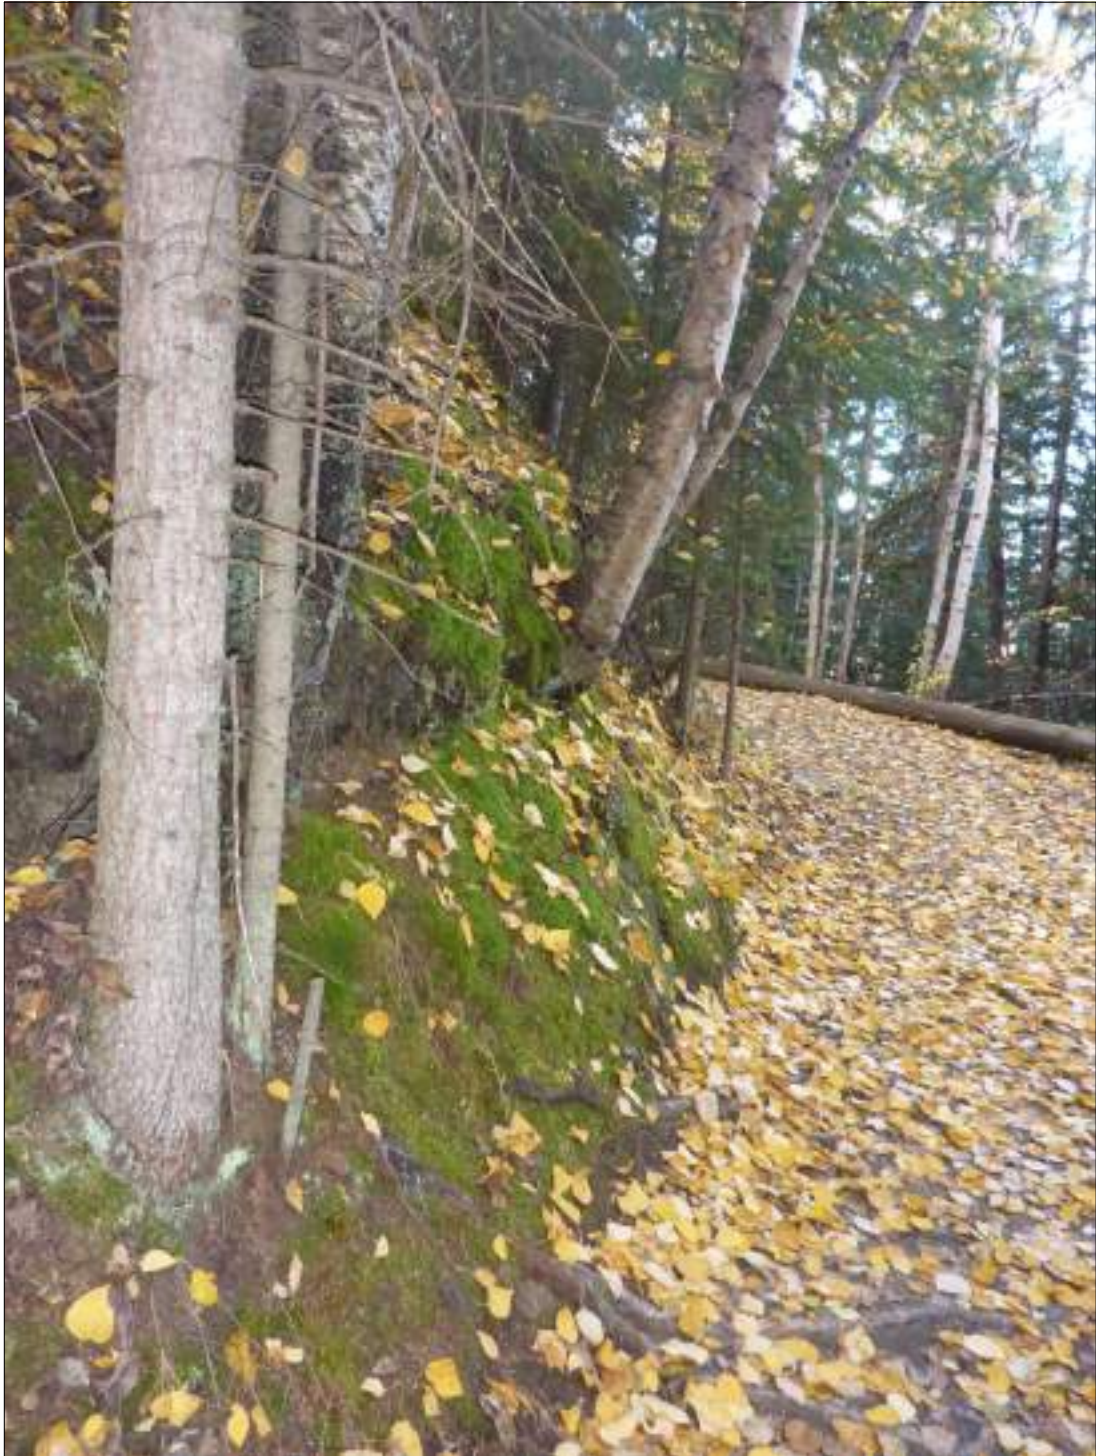
PHOTO 2 SITE 1 - RIVER ACCESS PATH WITH CURVED TREES

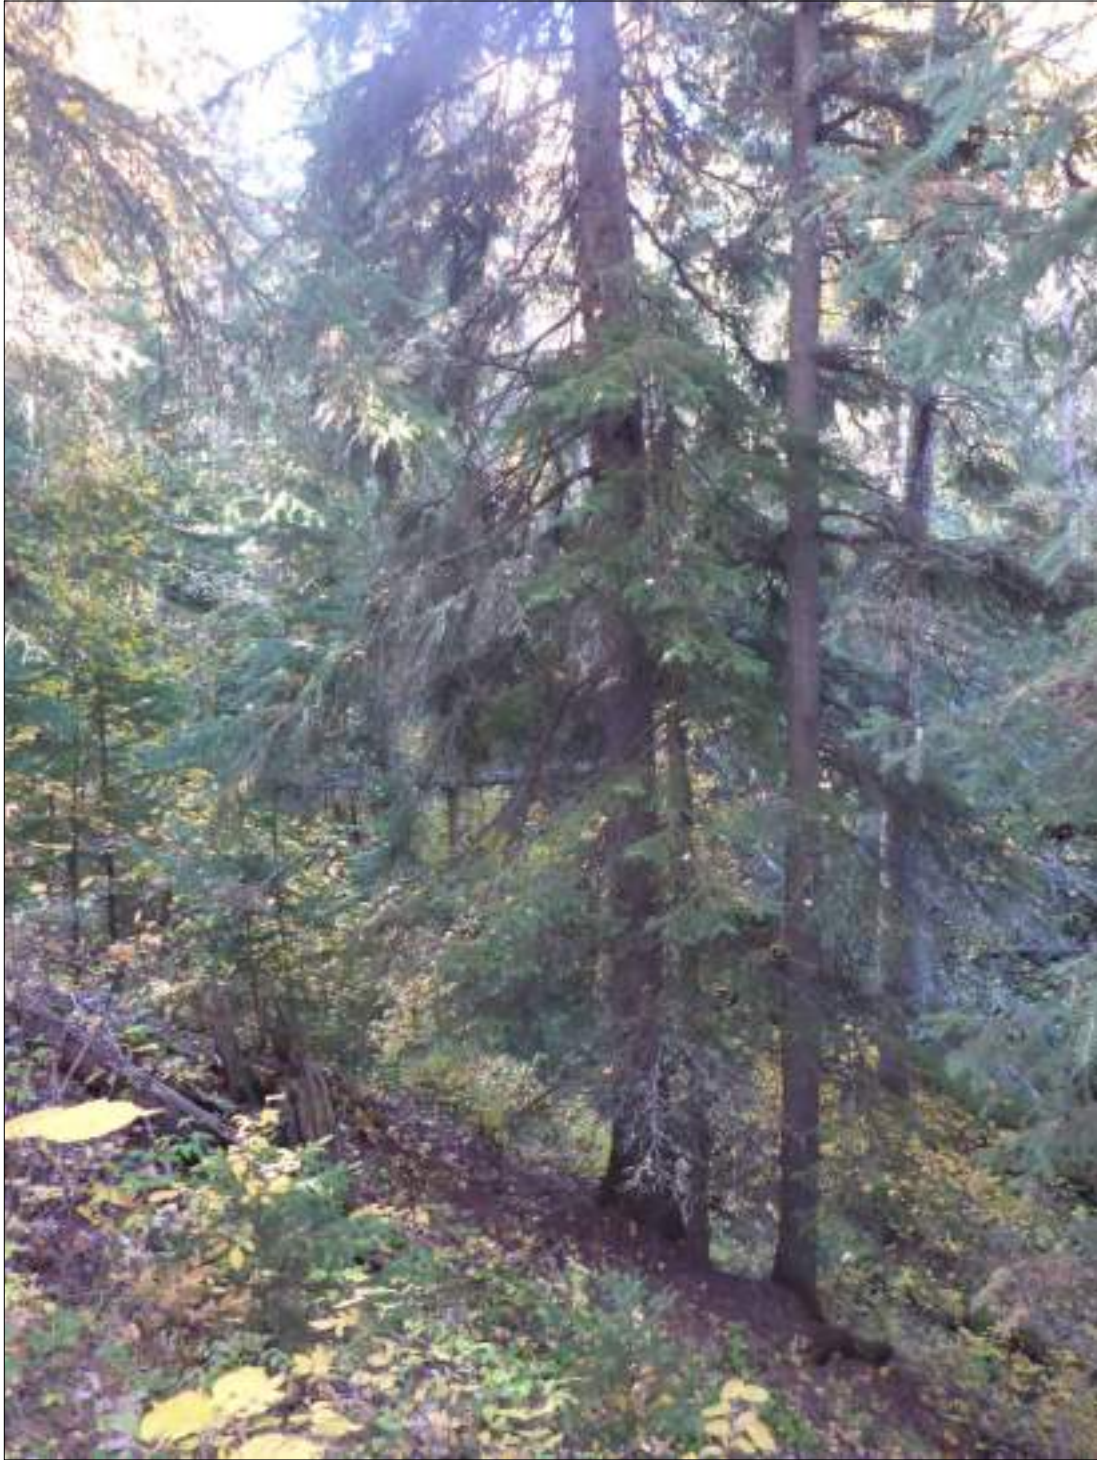
The slopes were steep enough and heavily wooded in most areas that they could not be easily traversed by foot (Photos 3, 4, and 5, Appendix C), which prohibited accessing a great deal of the river's edge and the associated slopes. These conditions are also not favourable for future aerial drone flights as the west bank of the river could not be easily accessed either.

PHOTO 3 SITE 1 - TYPICAL SLOPE VEGETATION CONDITIONS

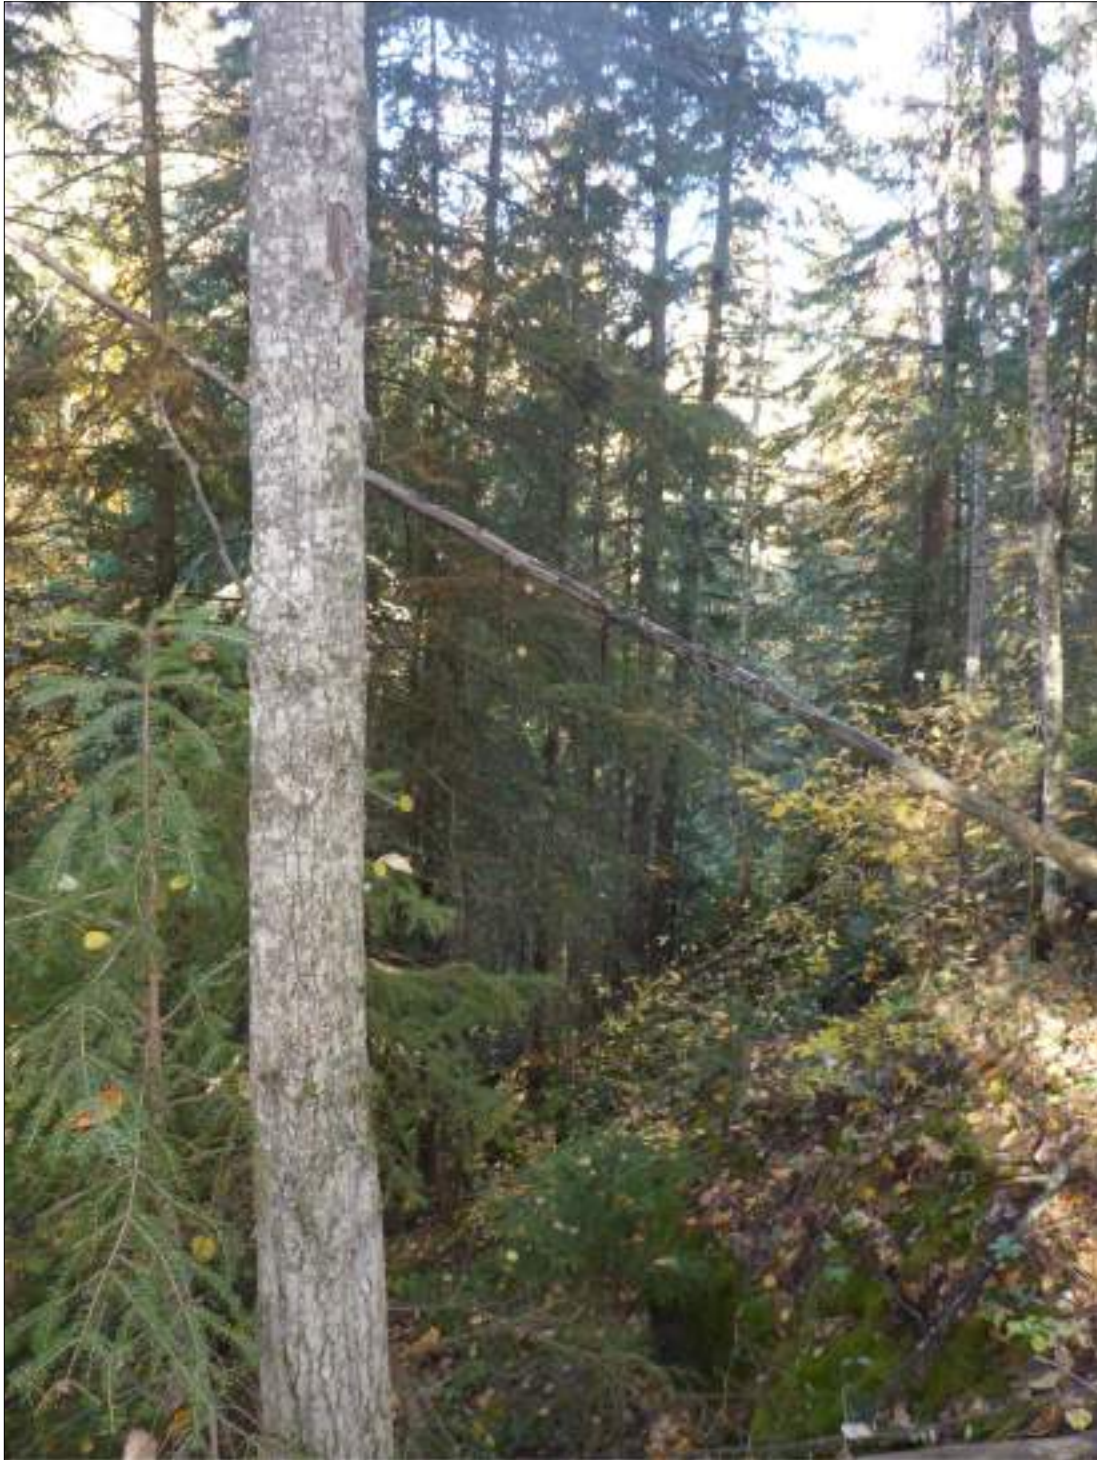
PHOTO 4 SITE 1 - TYPICAL SLOPE VEGETATION CONDITIONS

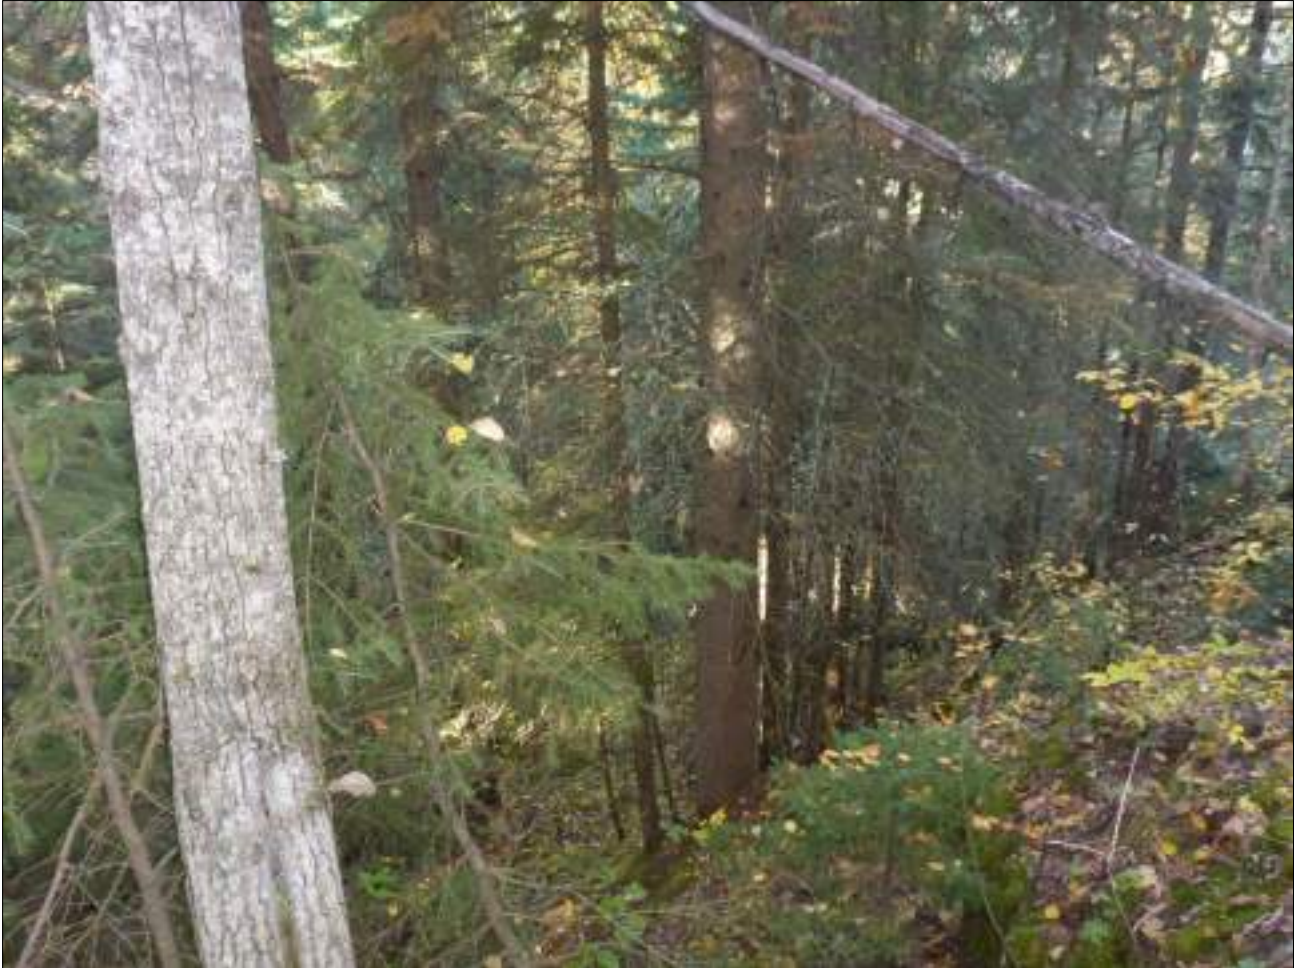
PHOTO 5 SITE 1 - TYPICAL SLOPE VEGETATION CONDITIONS

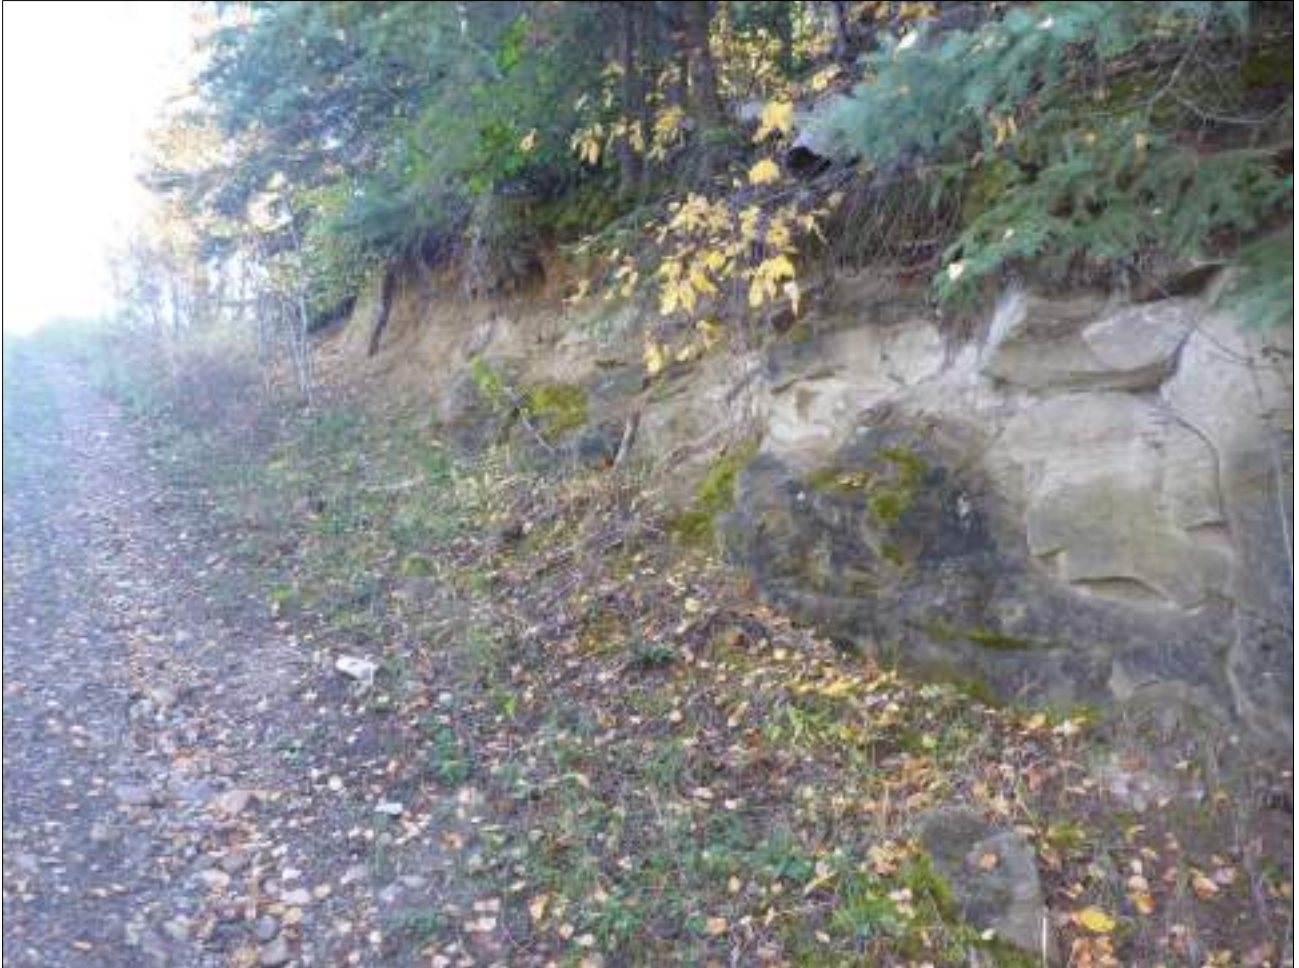
PHOTO 6 SITE 1 - EXPOSED SANDSTONE OUTCROP

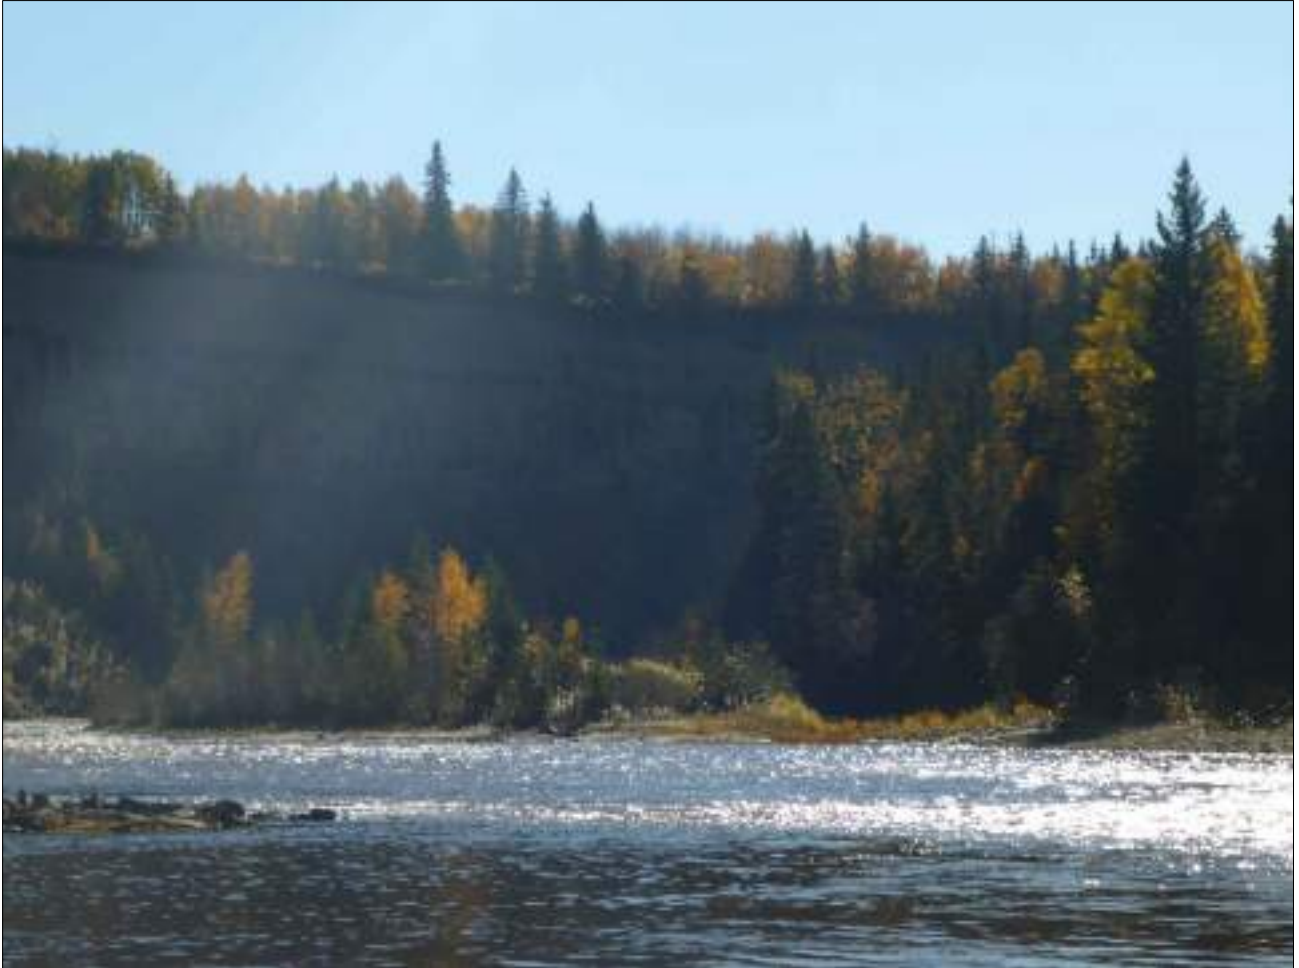
PHOTO 9 SITE 2 - EXPOSED SANDSTONE VERTICAL SLOPE

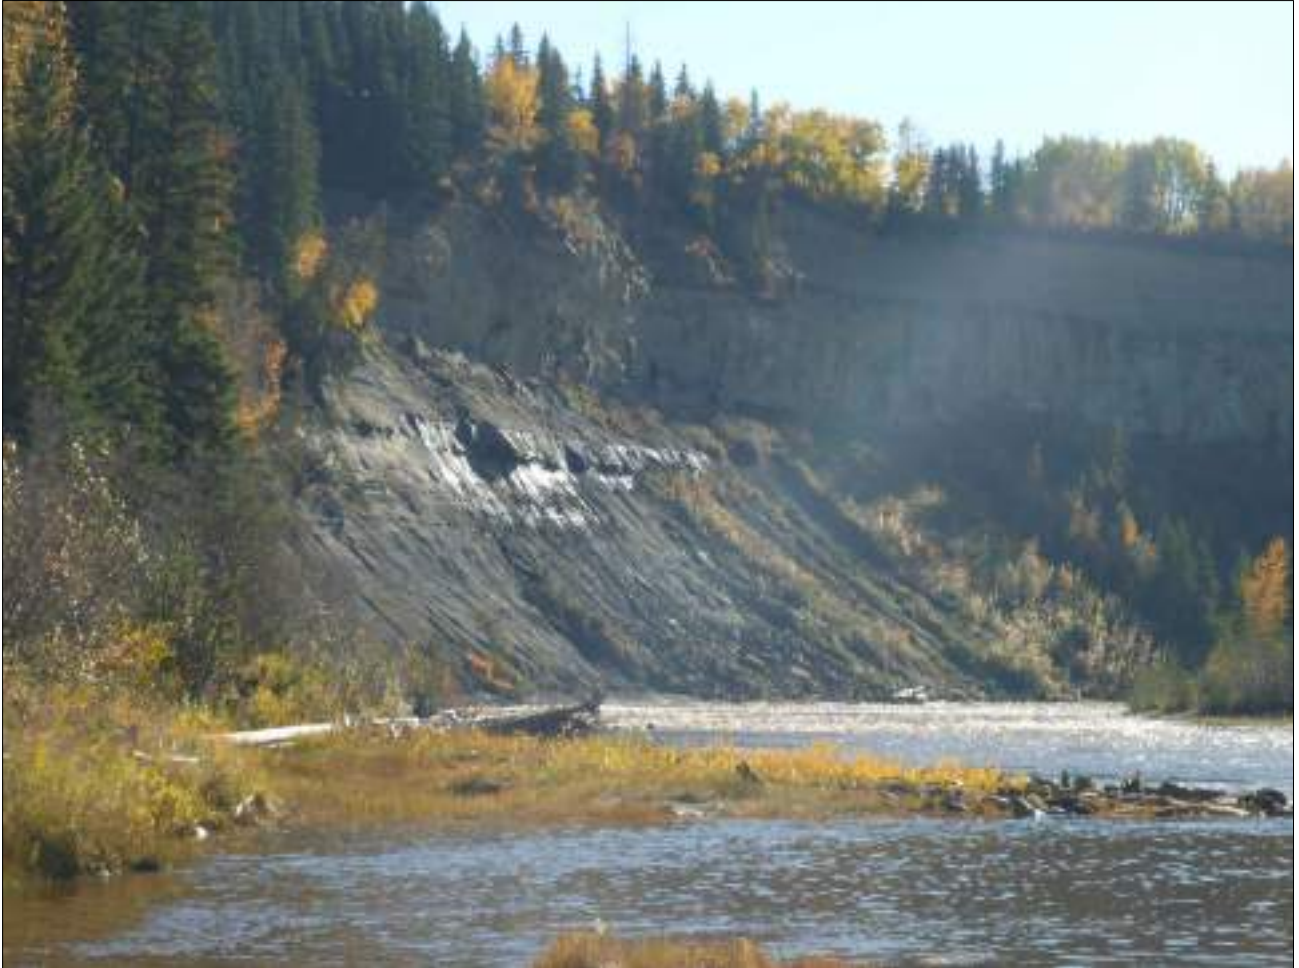
From the accessible vantage points it is difficult to assess the condition of the lower colluvial slopes where they interact with the upper exposed vertical bedrock zones. As was observed at Site 2, some seepage out of the slopes was being experienced. Following the completion of this primary reconnaissance it was decided to proceed with a secondary reconnaissance using a remote controlled aerial drone fitted with a video camera to observe the condition of the upper slopes, where access can be gained (Sites 2, 3, and 4). Secondary reconnaissance of Site 1 was deemed unnecessary due the access difficulty, as well as its lack of proximity to development.

PHOTO 10 SITE 2 - MIDSLOPE SEEPAGE AND COLLUVIUM SLOPE

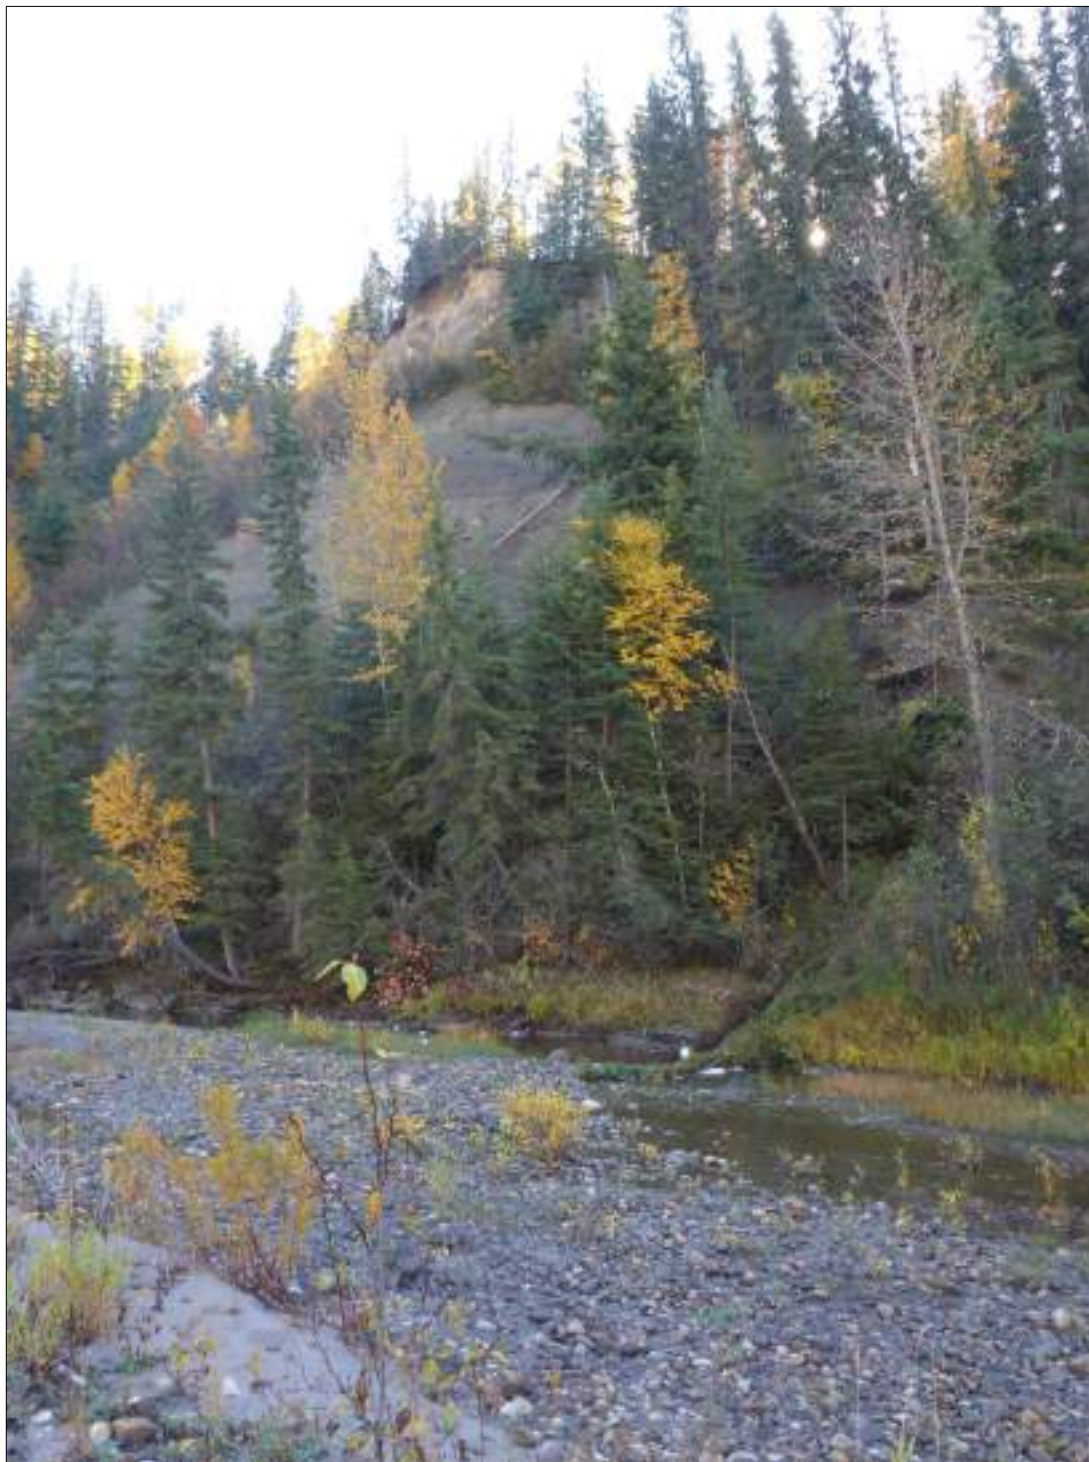
LiDAR data indicates that the majority of slopes in this area are in the range of 20 to 45 degrees with some of the upper slopes greater than 45 degrees. Towards the south end of the site, an exposed slope could be observed (Photo 14, Appendix C) where a possible landslide zone

could be situated (Photo 17, Appendix C). Aerial drone reconnaissance was highly recommended for this site at this time to understand the state of the upper slopes at this south end.

PHOTO 17 SITE 3 - TOE OF POSSIBLE LANDSLIDE ZONE

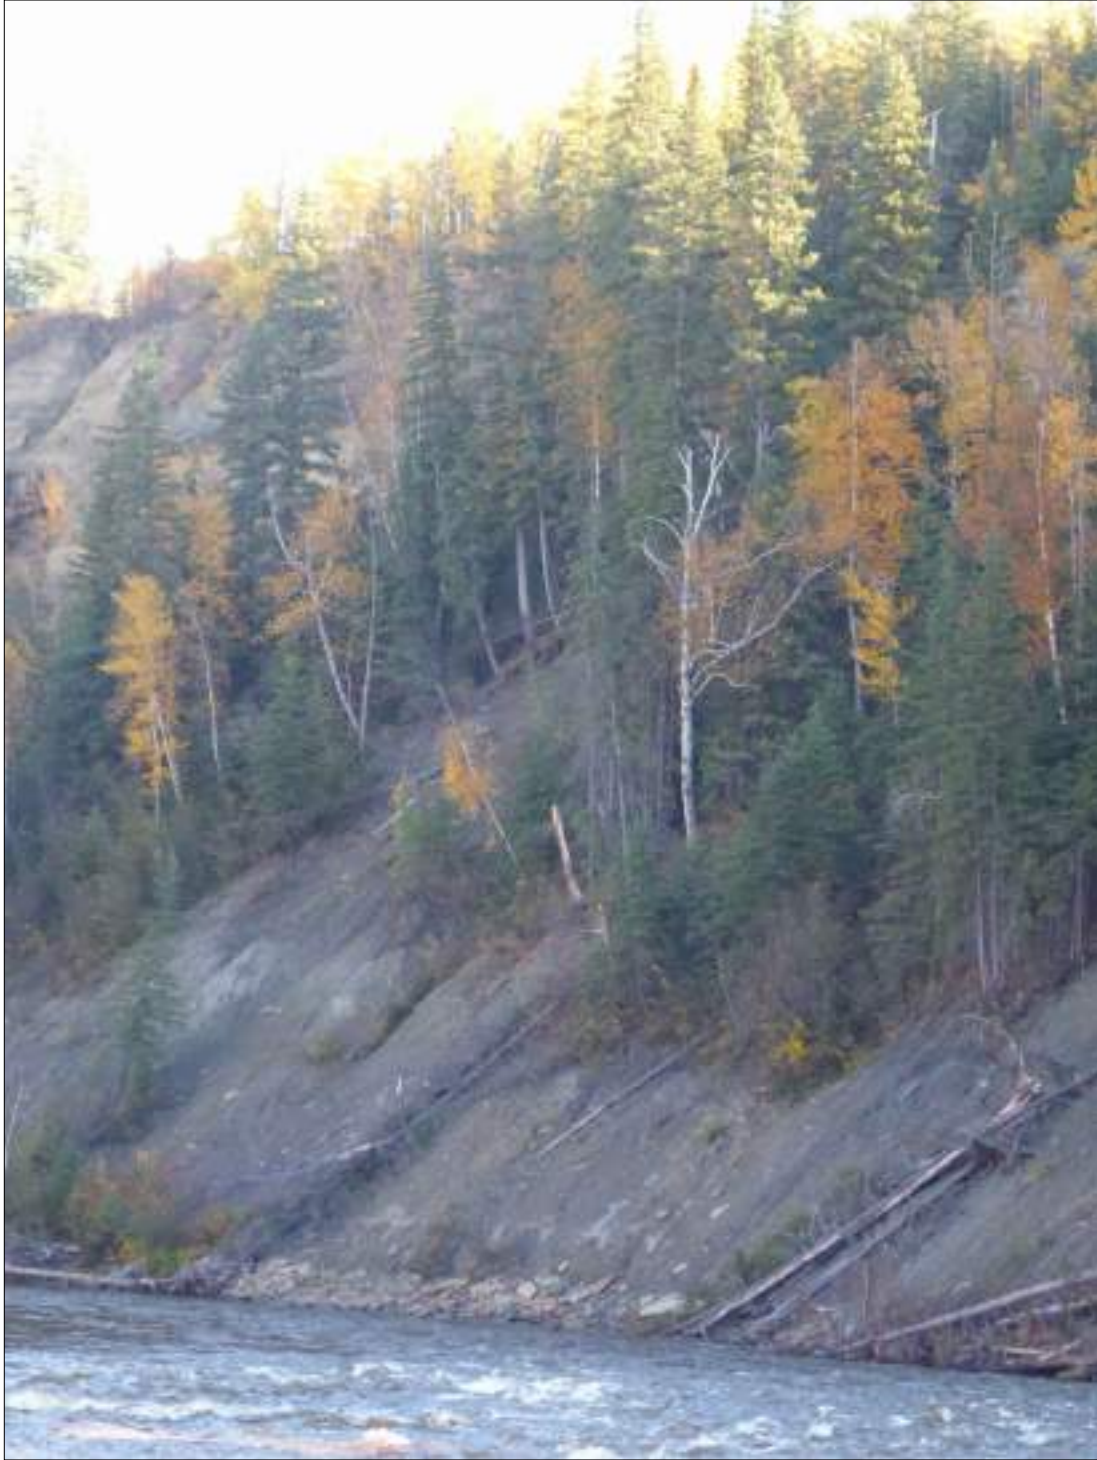
PHOTO 18 SITE 3 - COLLUVIUM SLOPES

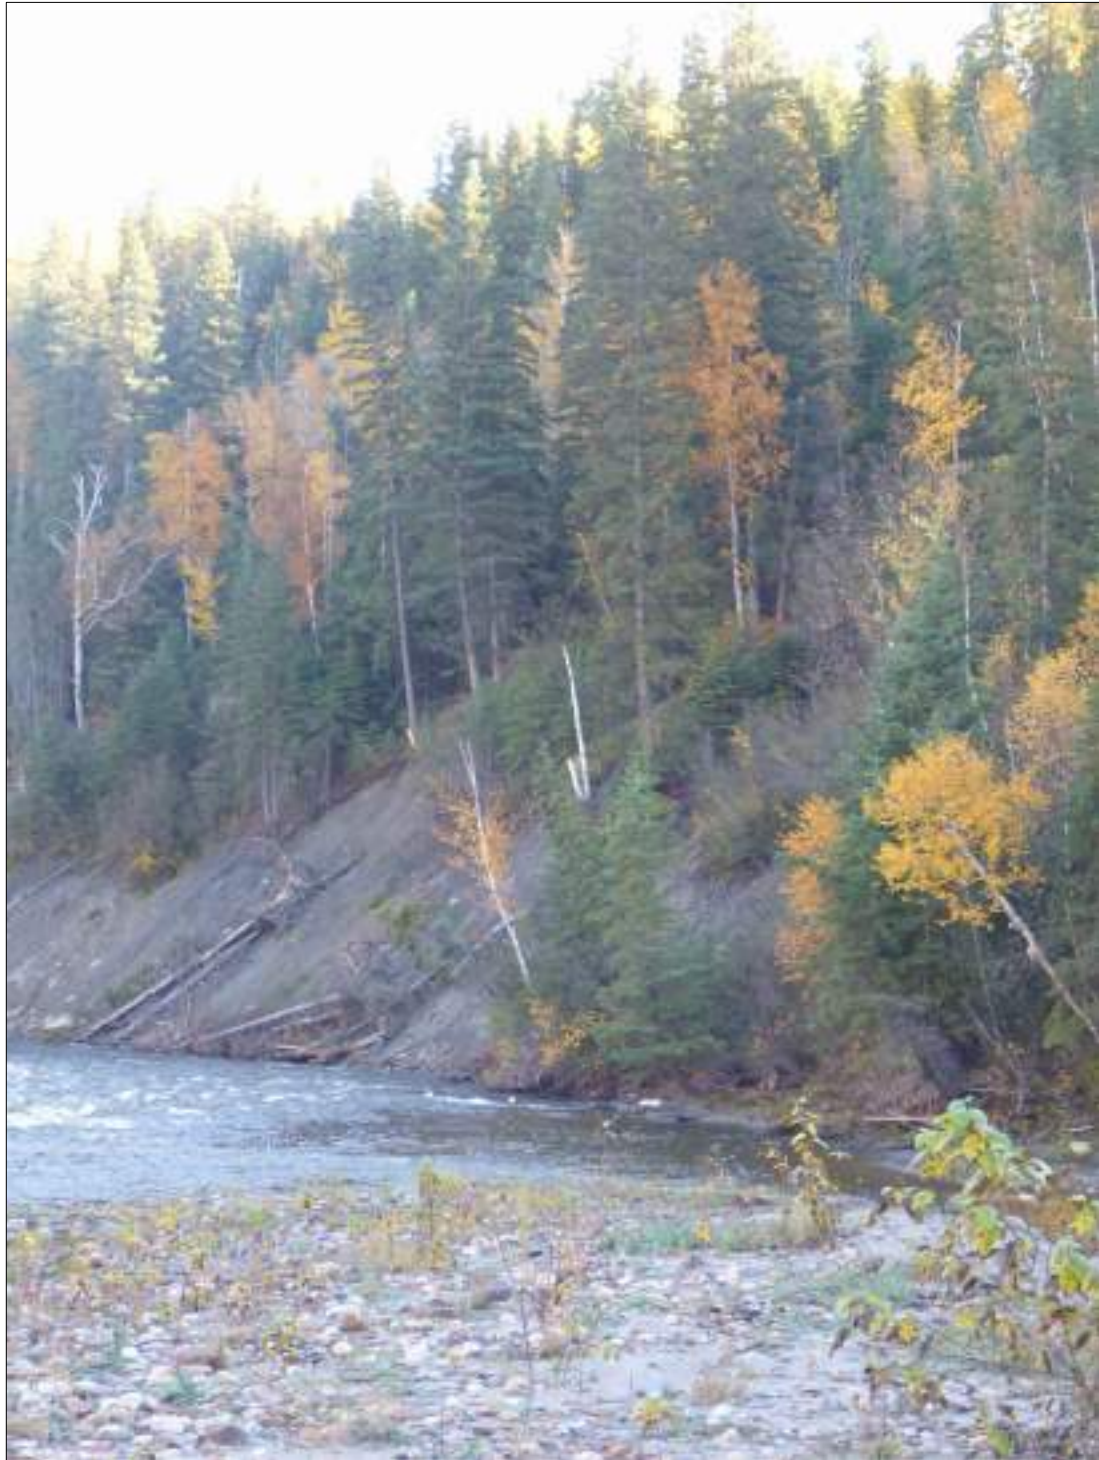
PHOTO 19 SITE 3 - COLLUVIUM SLOPES

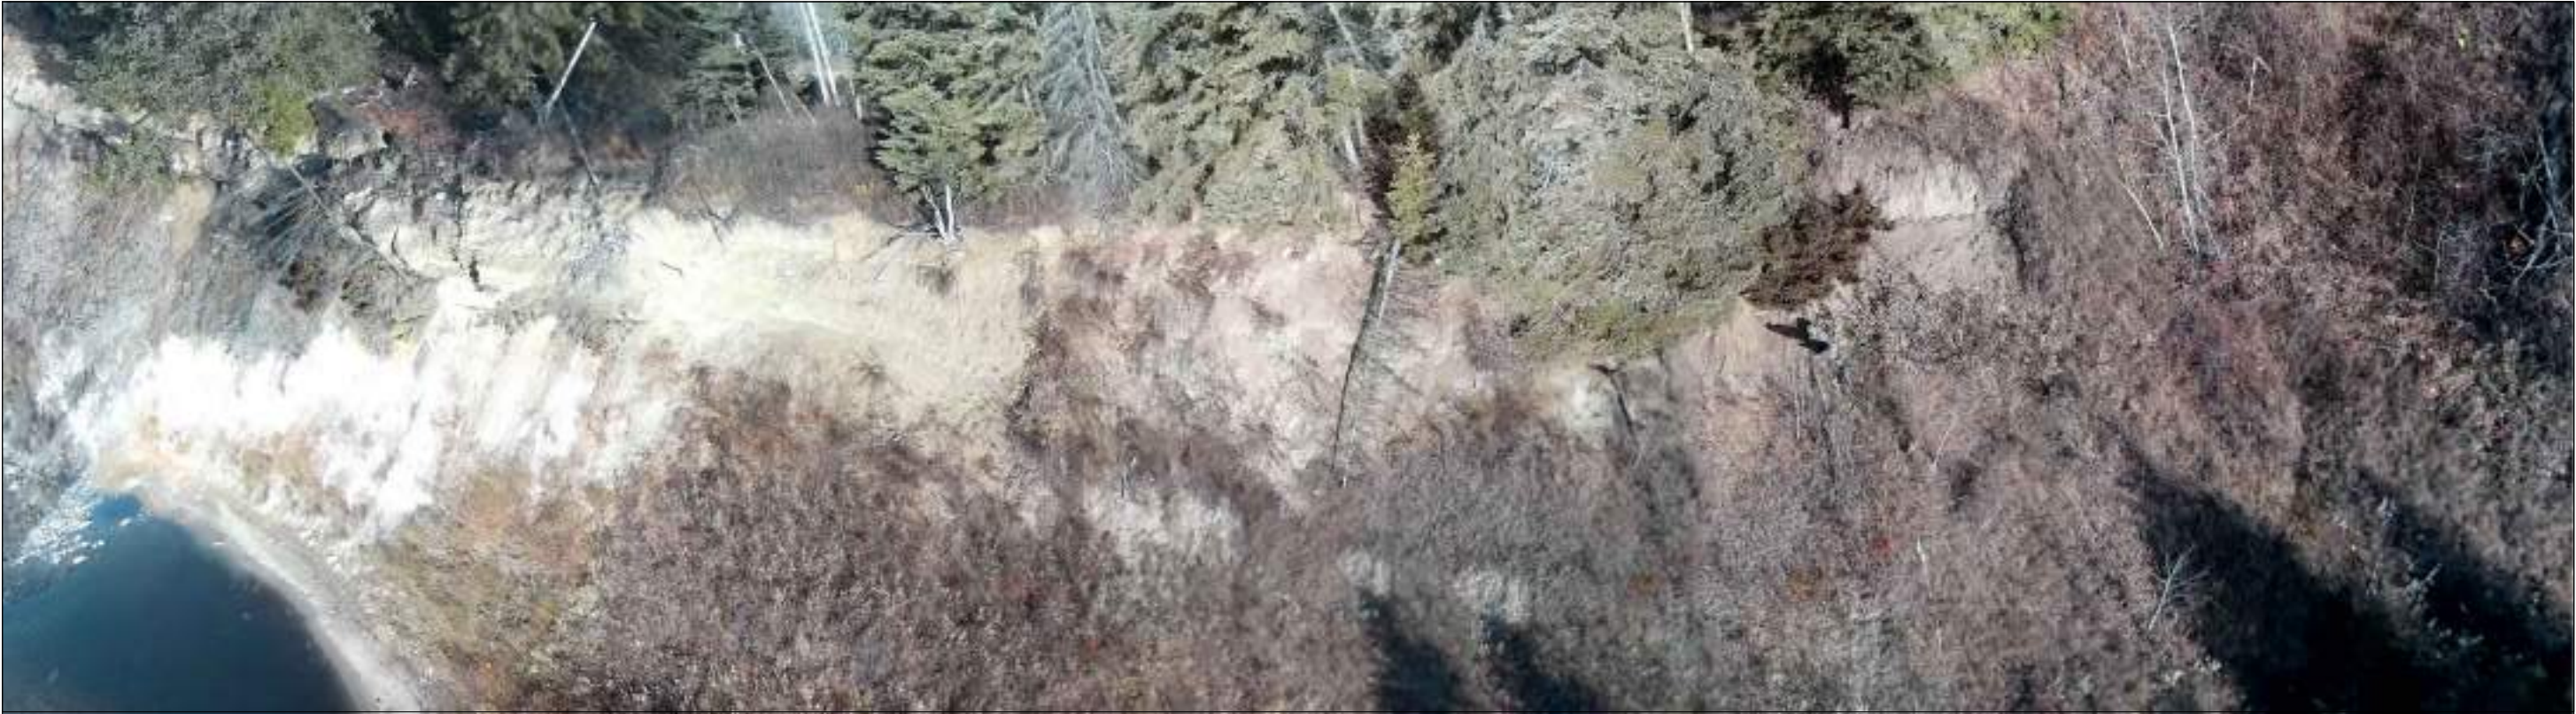
PHOTO D1 SITE 2 NORTH

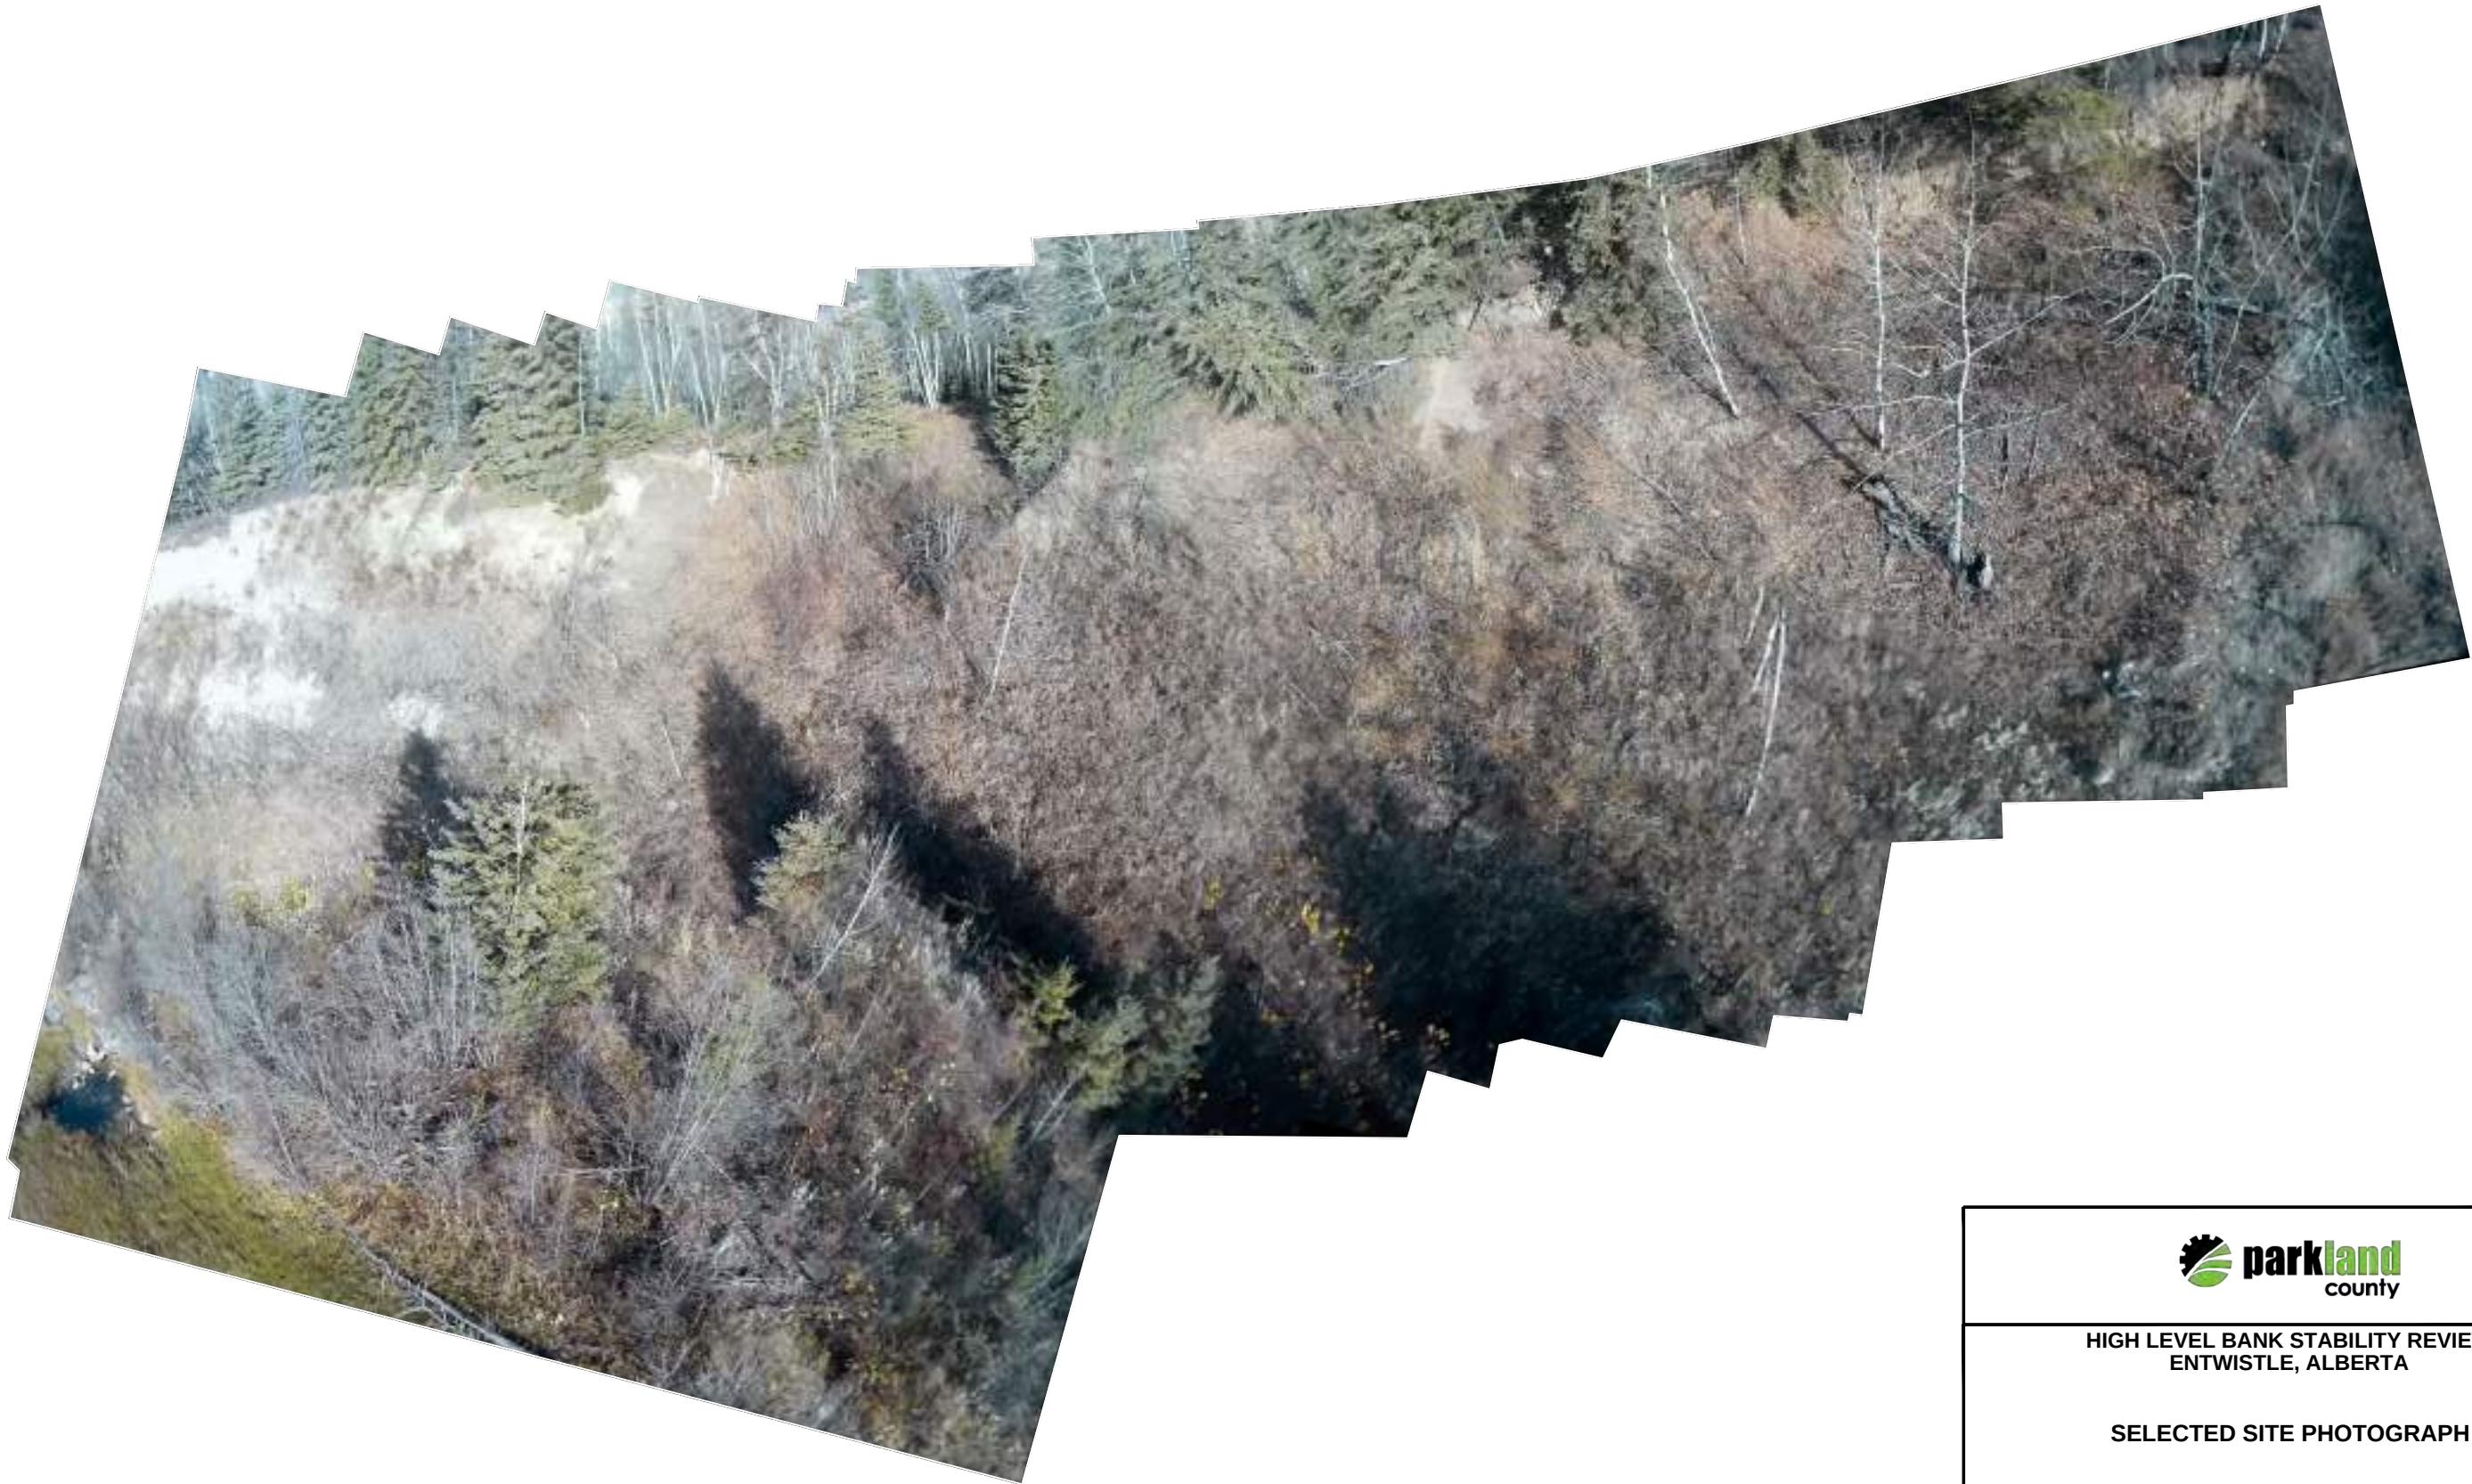
PHOTO D2 SITE 2 SOUTH
