**HIGH LEVEL BANK STABILITY REVIEW  
PEMBINA RIVER VALLEY  
ENTWISTLE, ALBERTA  
REVISION 1**

**Report  
to  
Parkland County**

Date: November 29, 2017  
File: 18683

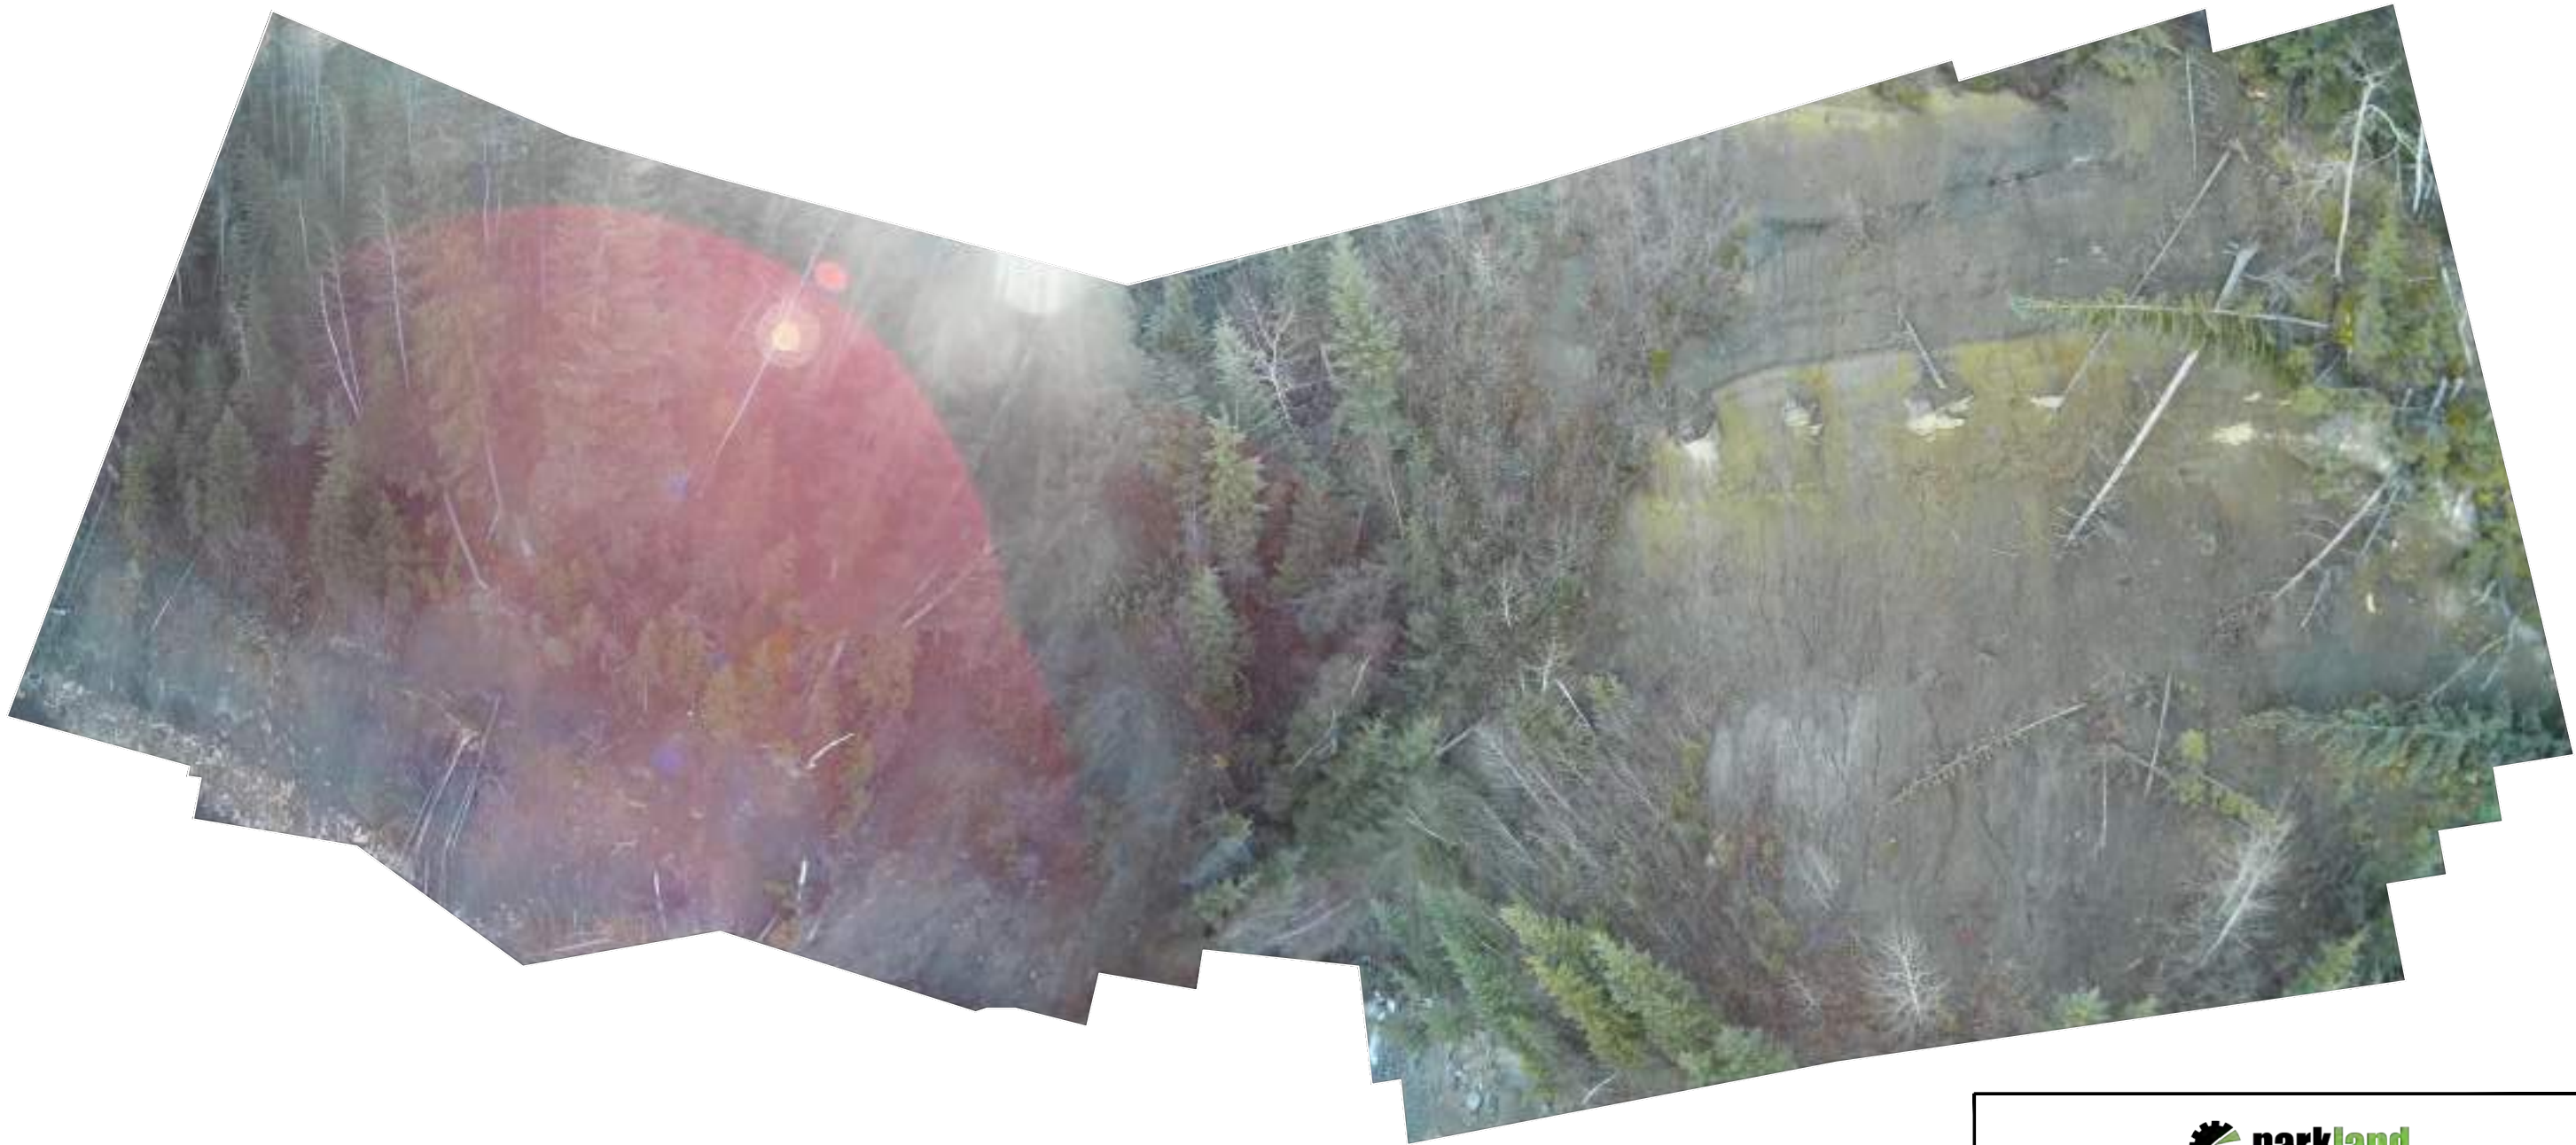
PHOTO D3 SITE 3

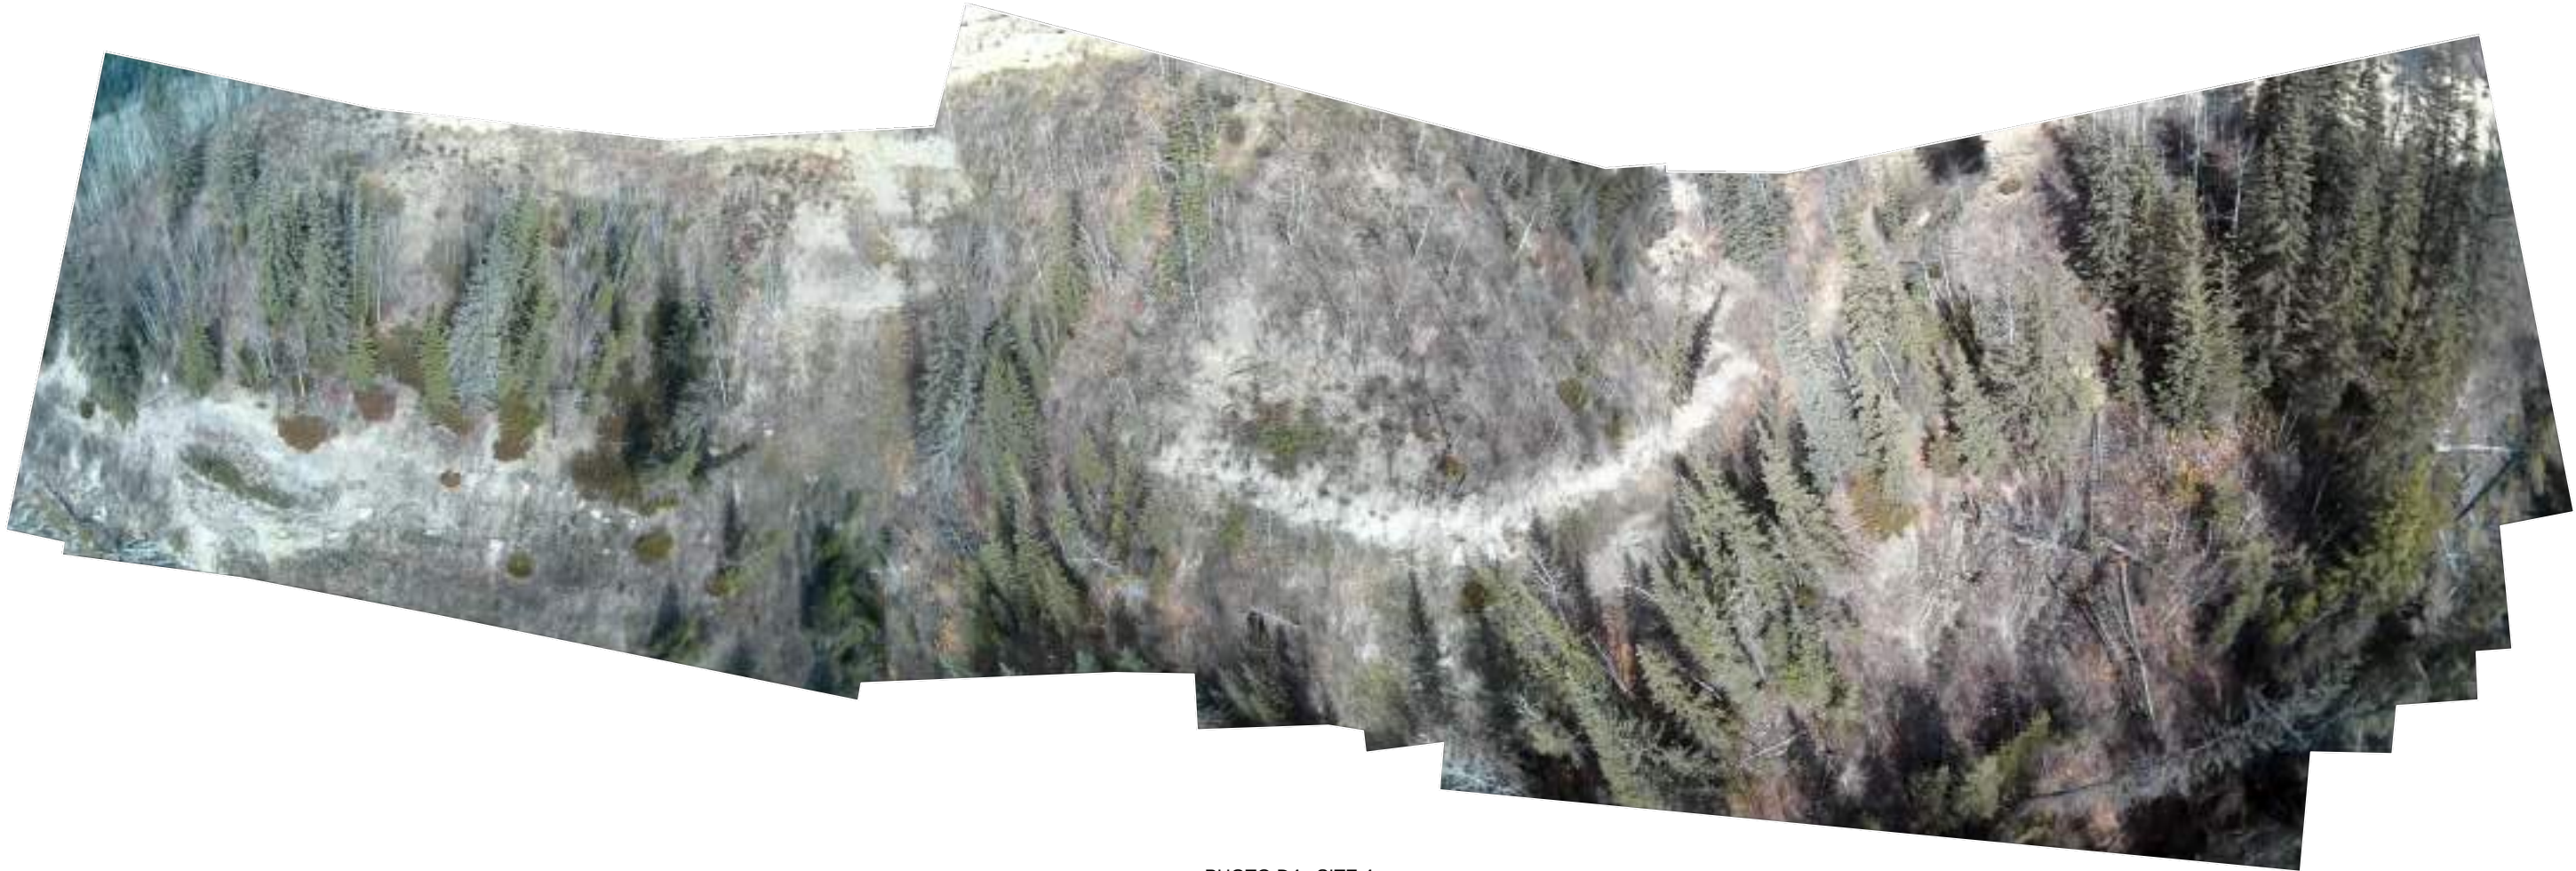
PHOTO D4 SITE 4
