# **Middle, East and Ellis Creeks Fluvial Geomorphological Assessments**

**Maple Grove Road Class EA  
Fountain Street to Hespeler Road  
The Regional Municipality of Waterloo**

October 21, 2019  
GEO Morphix Project No. 18116

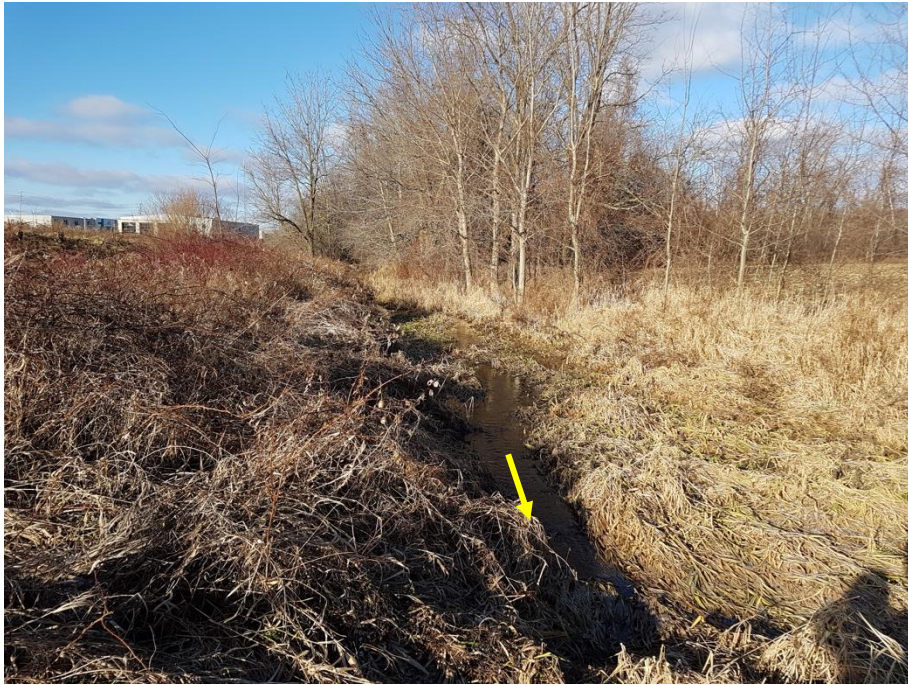
Photo 1  
Middle Creek Reach MC-1

Poorly-defined channel along embankment on north side of stormwater management pond.

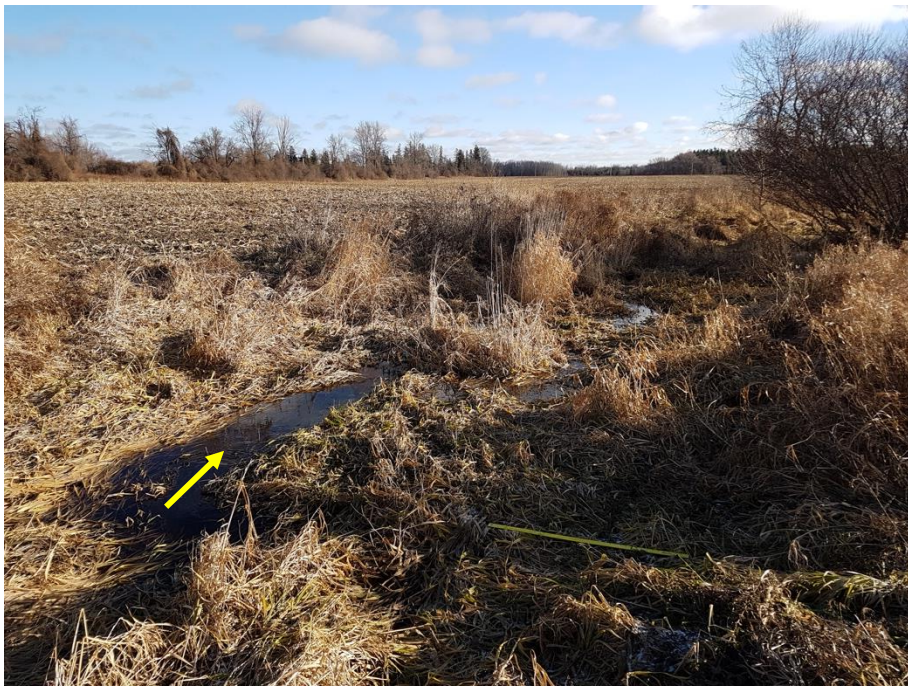
Photo 2  
Middle Creek Reach MC-1

Flow path through herbaceous vegetation with an agricultural field on the left (north).

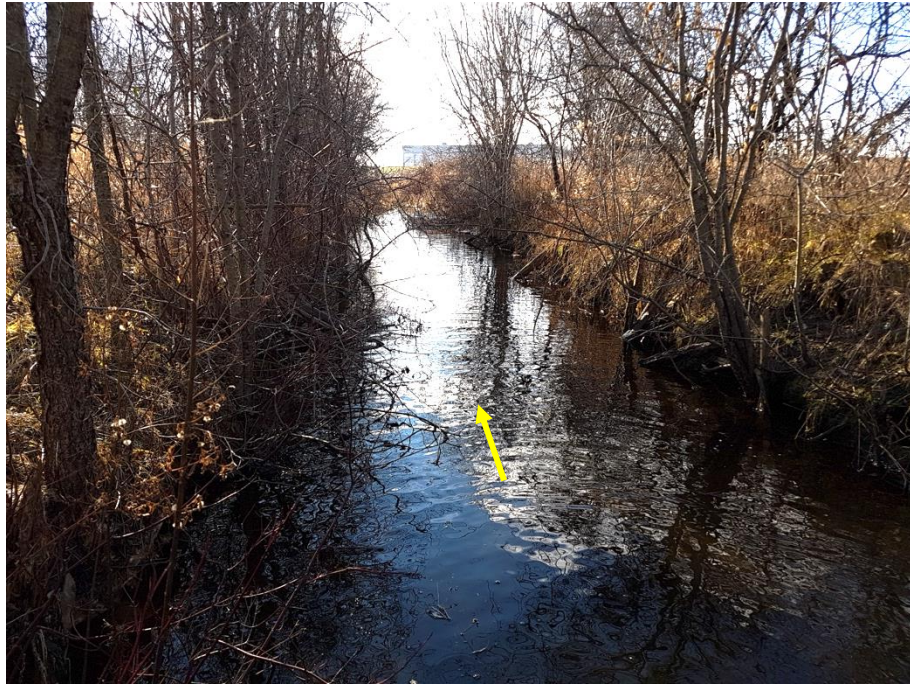
Photo 3  
Middle Creek Reach MC-2

Straight channel with trees along the banks. The channel has a rectangular cross section with limited evidence of bank erosion.

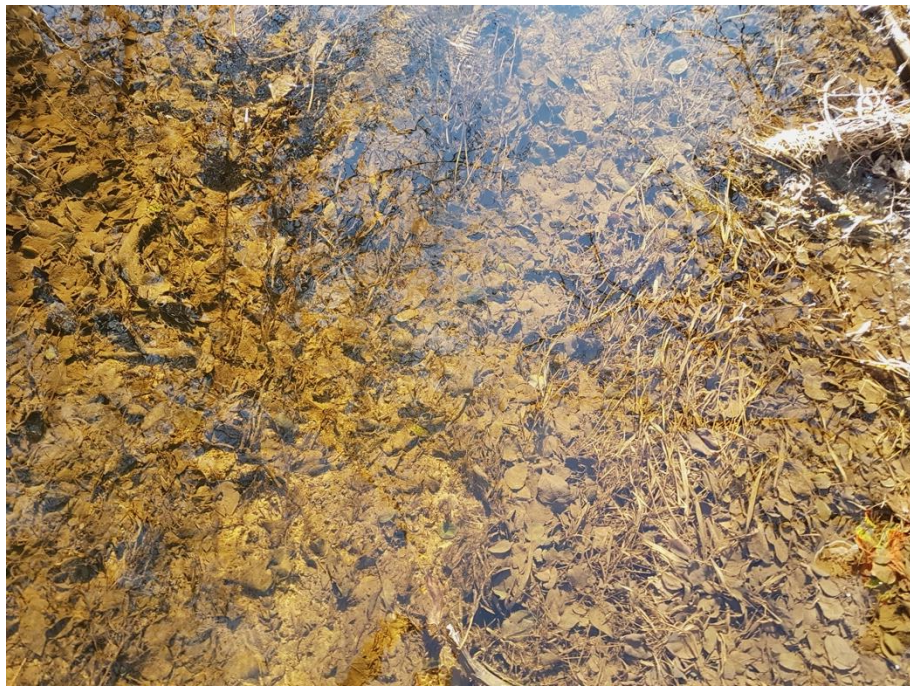
Photo 4  
Middle Creek Reach MC-2

General plane bed comprised of most sand with submergent vegetation and leaf litter. The leaf litter suggests that the channel has low energy.

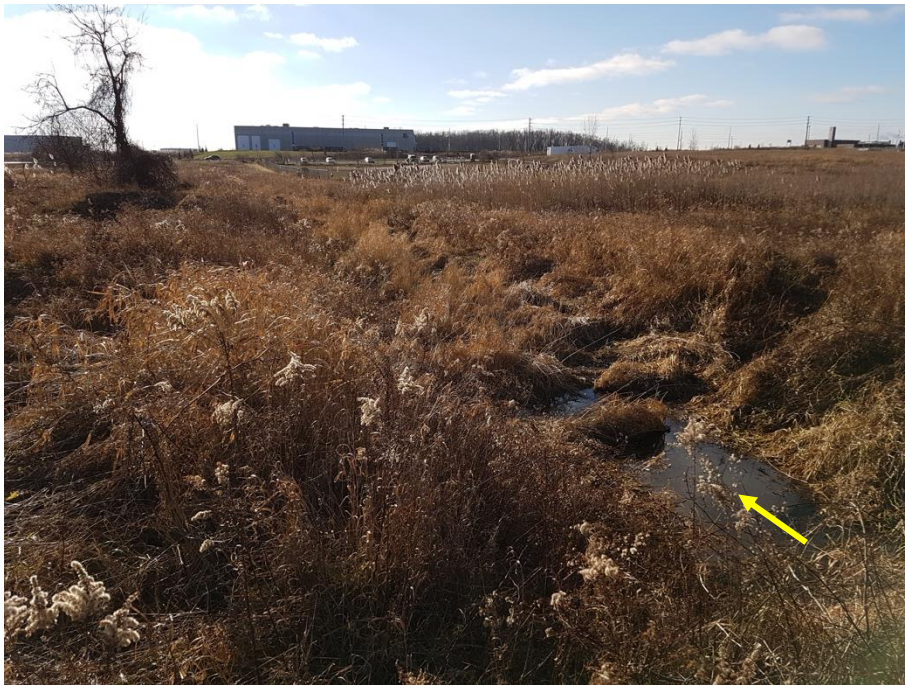
Photo 5  
Middle Creek Reach MC-3

Straight channel through a wide corridor lined with herbaceous vegetation.

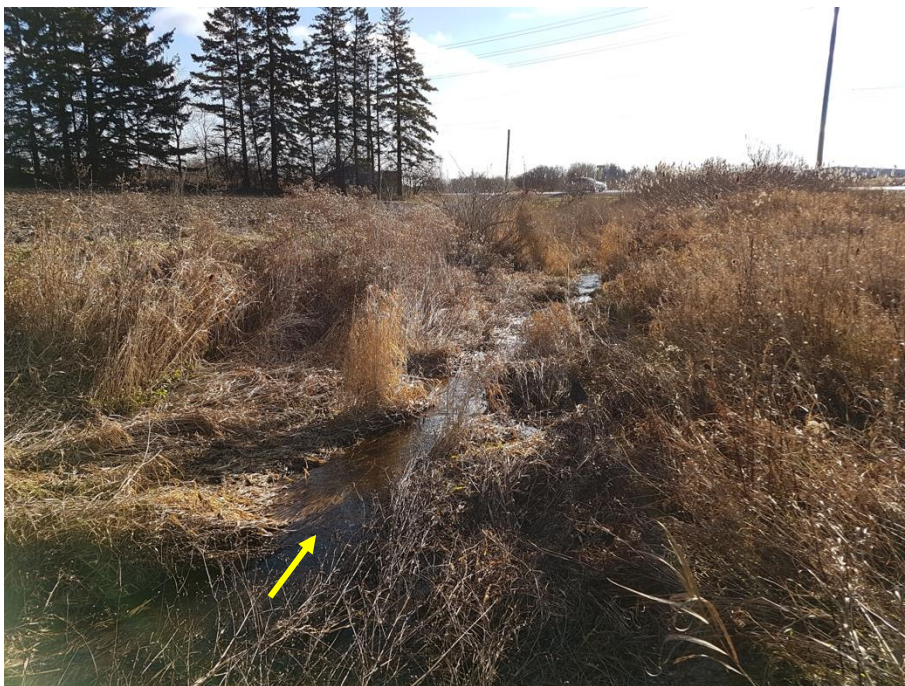
Photo 6  
Middle Creek Reach MC-3

For most of the reach, there is a flow path through vegetation and no defined channel.

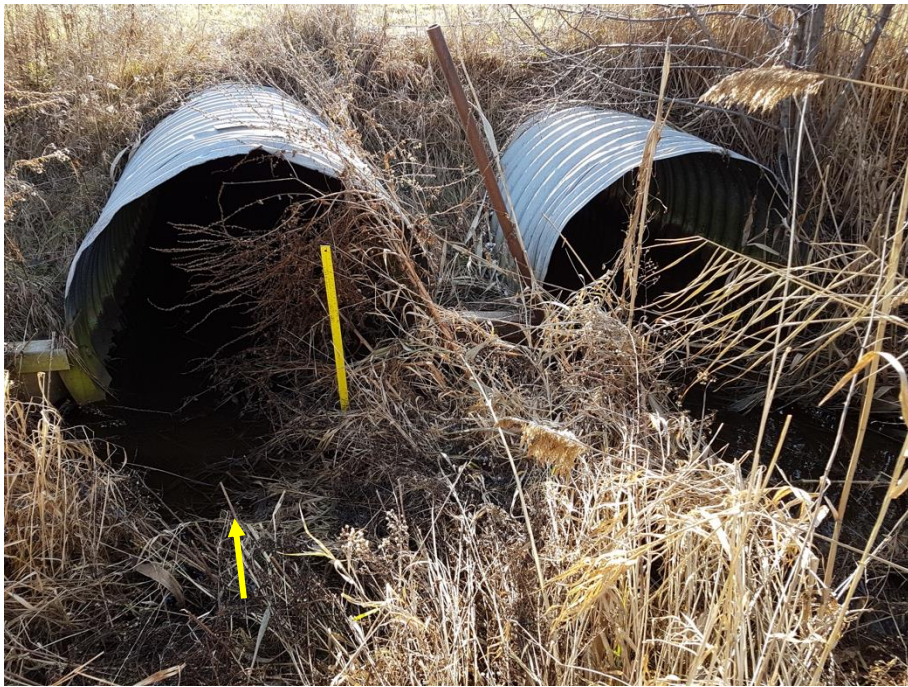
Photo 7  
Middle Creek Reach MC-3

Twin corrugated steel pipe culvert inlet at Maple Grove Road. The pipes are partially embedded.

Should the twin CSP culvert at Maple Grove Road need to be replaced, an open-bottom crossing structure should be considered as this would not only locally restore connectivity between the surface water and groundwater. Natural substrate, hydraulically sized to resist entrainment, could also then be placed throughout the length of the replacement culvert to enhance conditions for fish passage. The culvert would ideally have a span equivalent to three times the bankfull channel width, 12.3 m (3 x 4.1 m). Understanding that this may not be possible for various reasons, a 5 m span culvert would be acceptable as a ~4 m wide low flow channel, consistent with that in Reach MC-3, could be constructed through the culvert. A lower span culvert is also an option, but at the cost of establishing a low flow channel.

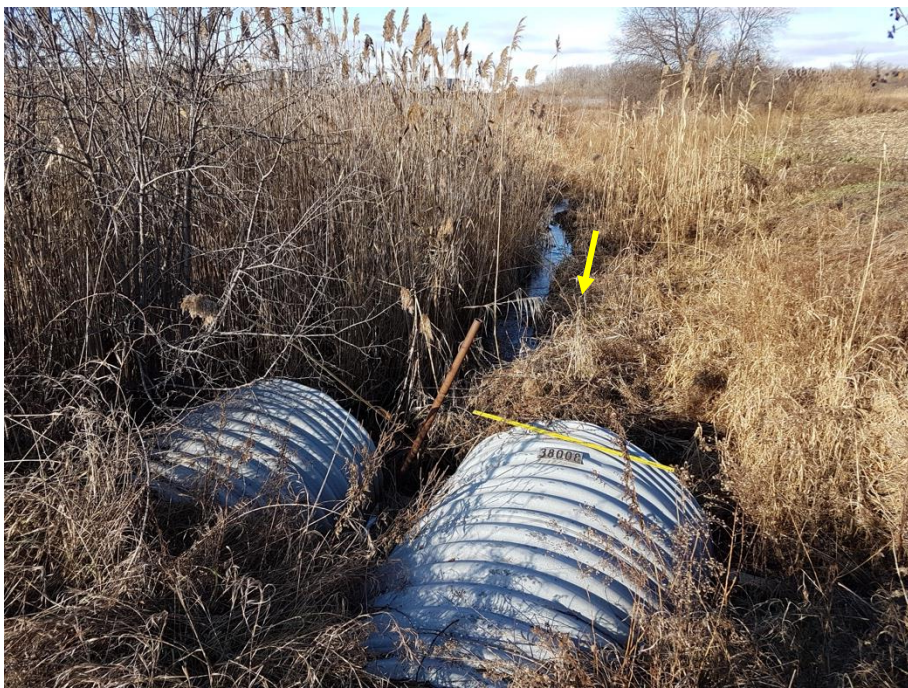
Photo 8  
Middle Creek Reach MC-3

Reach viewed upstream from Maple Grove Road at downstream end of reach.

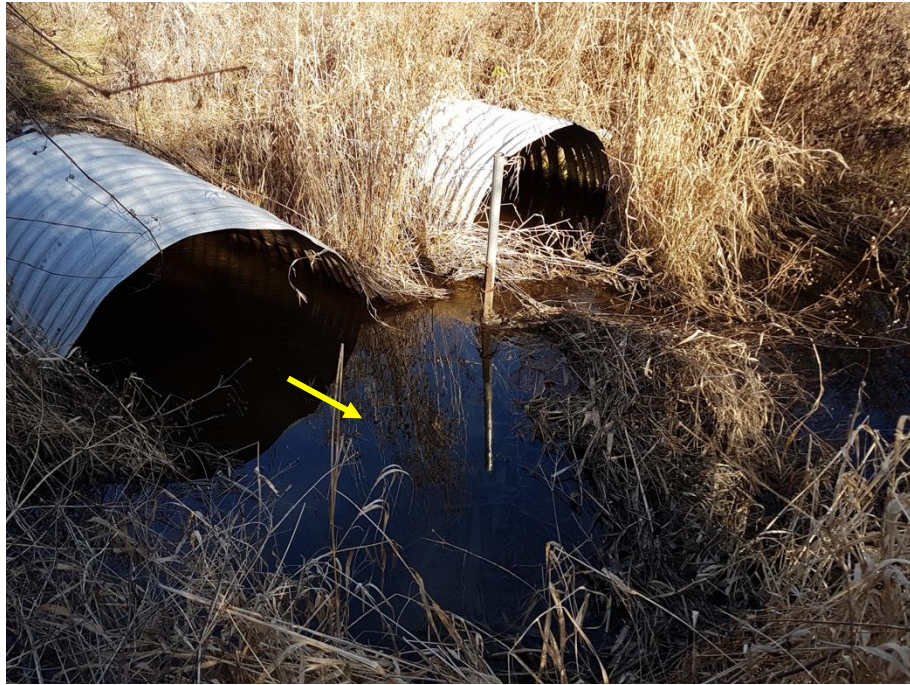
Photo 9  
Middle Creek Reach MC-4

Culvert outlet at upstream end of reach at Maple Grove Road.

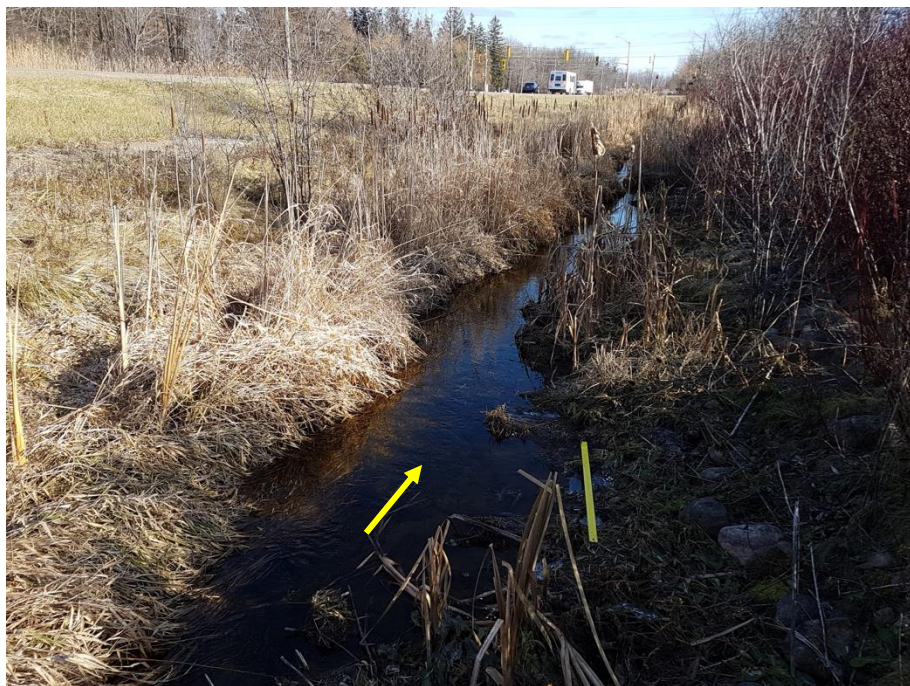
Photo 10  
Middle Creek Reach MC-4

Linear channel along the south side of Maple Grove Road with some riverstone armouring along south bank. The channel along the road is also known as Hunsperger Drain.

With respect to Reach MC-4 along the south side of Maple Grove Road, the Hespeler West Subwatersheds Study Working Committee (HWSSWC, 2004) recommended the restoration of the channel with a natural meandering pattern. While this may be worthy from a fluvial geomorphological perspective as well as for fish habitat improvements, it may not be feasible due to the need to acquire lands in order to accommodate the naturalized channel. A more feasible solution, assuming that the existing channel will be impacted by the works associated with the preferred solution, would be to reconstruct the channel set back farther from the road as a linear feature with greater complexity and riparian buffer/cover. Greater complexity could be provided through the construction of natural bedforms such as riffles, boulder clusters and pools. While this option may still require land acquisition, it could significantly improve channel conditions for fish.

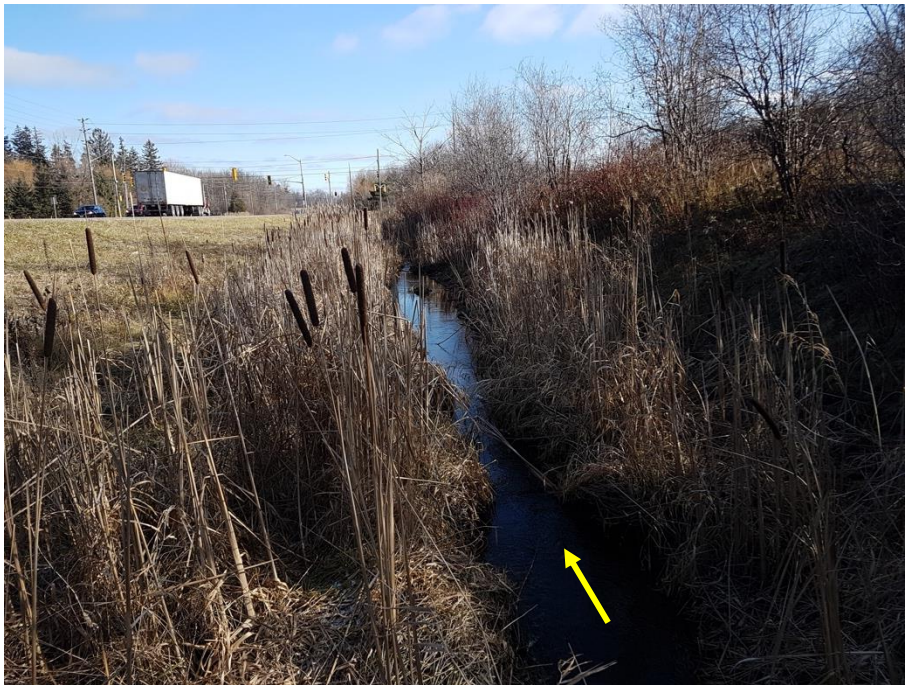
Photo 11  
Middle Creek Reach MC-4

Channel with limited morphological variability due to function as roadside ditch.

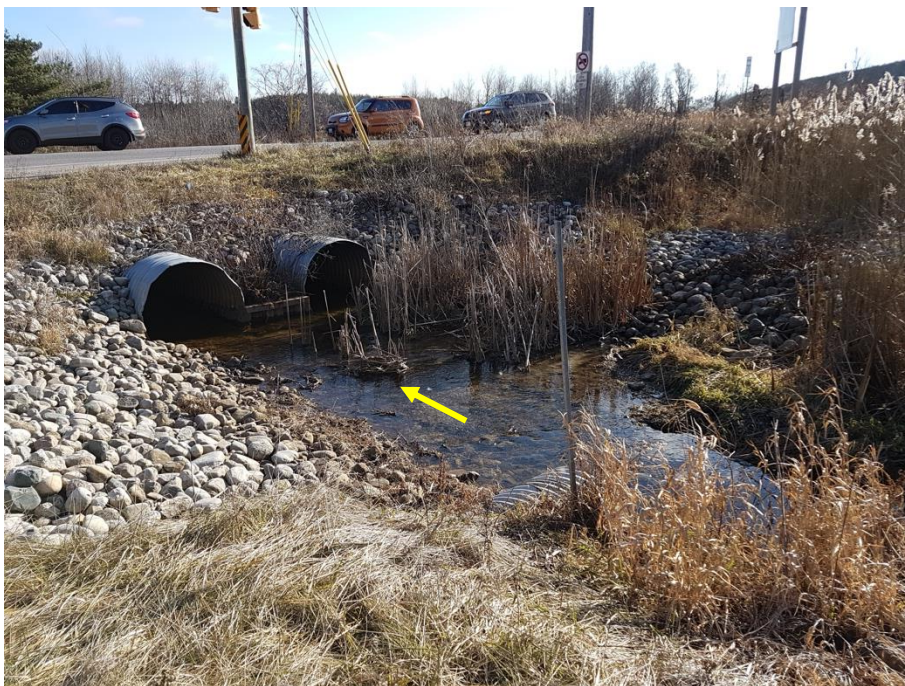
Photo 12  
Middle Creek Reach MC-4

Culvert inlet at Speedville Road. On the right is a riverstone-lined channel associated with an outlet for a stormwater management pond.

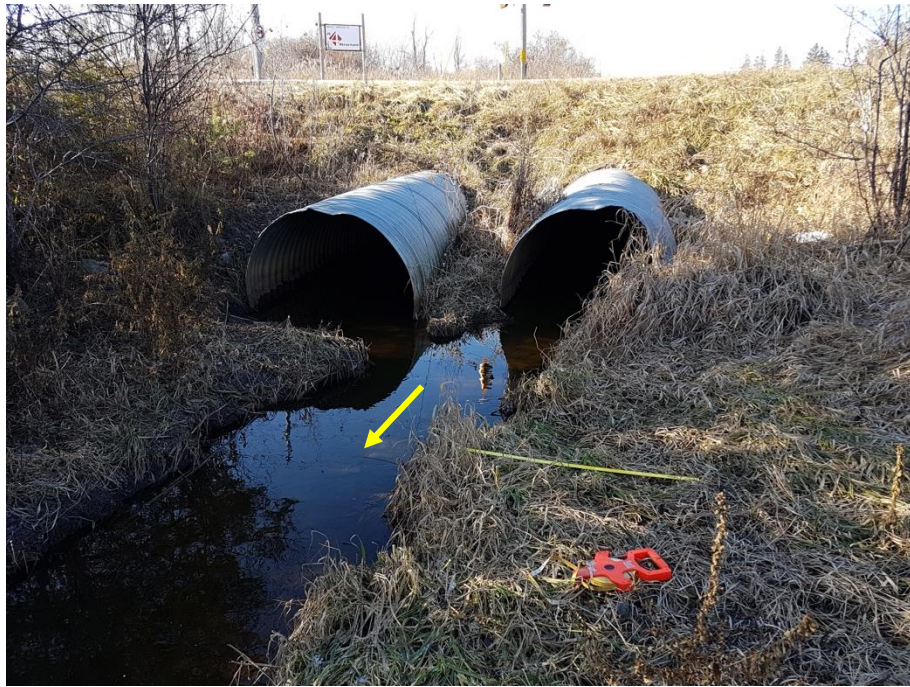
Photo 13  
Middle Creek Reach MC-4

Speedville Road culvert outlet.

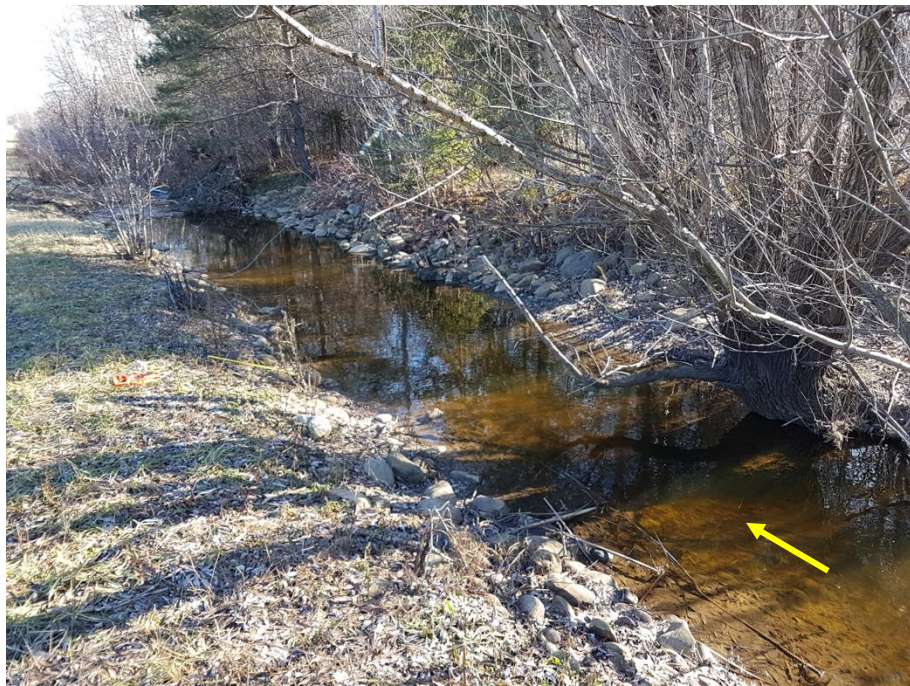
Photo 14  
Middle Creek Reach MC-4

Plane bed with riverstone bank armouring along channel.

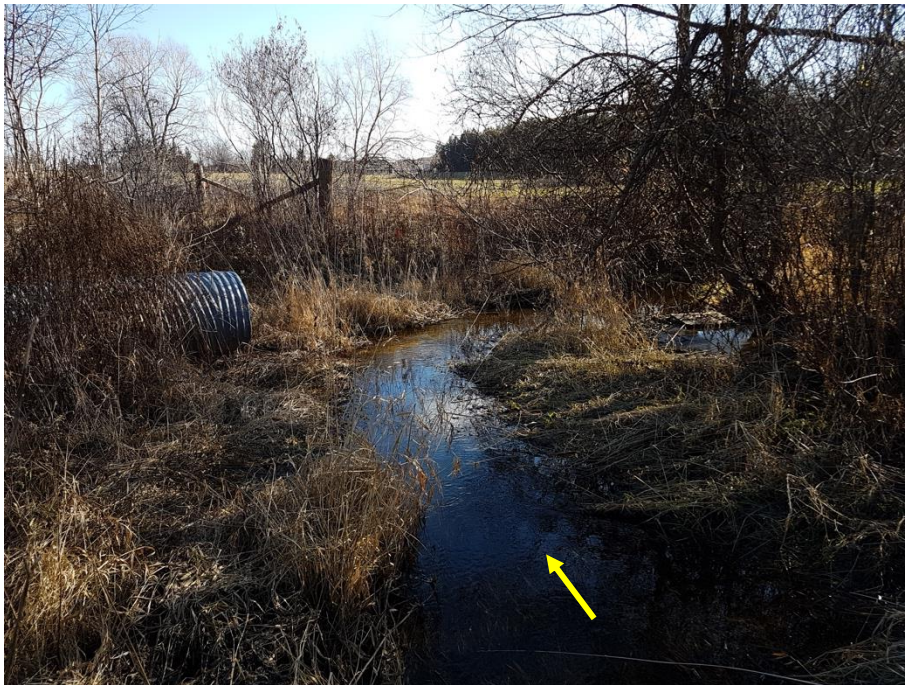
Photo 15  
Middle Creek Reach MC-4

Downstream end of reach where the channel turns away from the road.

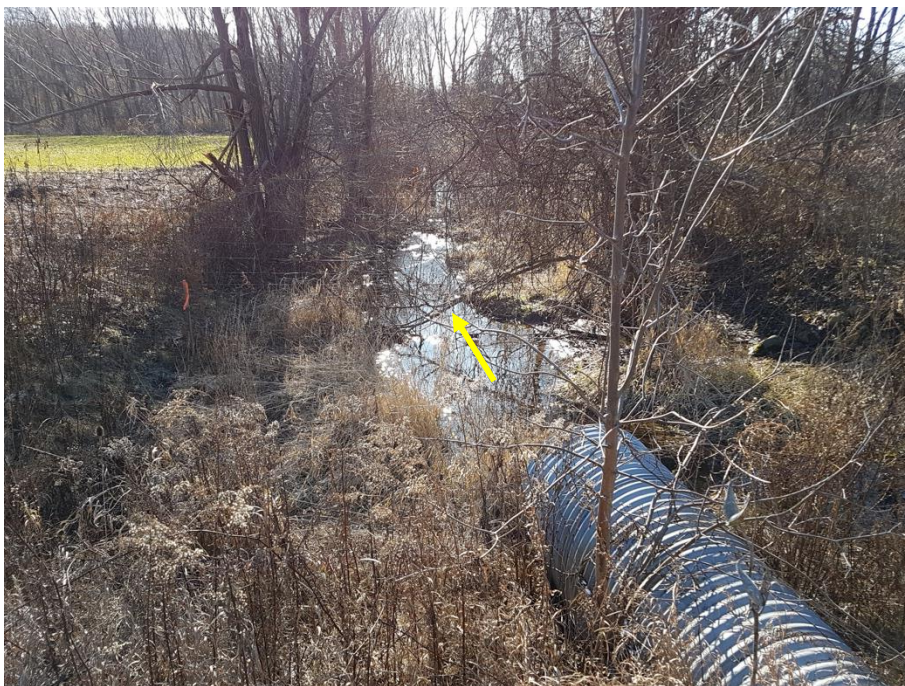
Photo 16  
Middle Creek Reach MC-5

Upstream end of reach viewed downstream from Maple Grove Road. A CSP culvert conveys flow from the north side of Maple Grove Road into the reach.

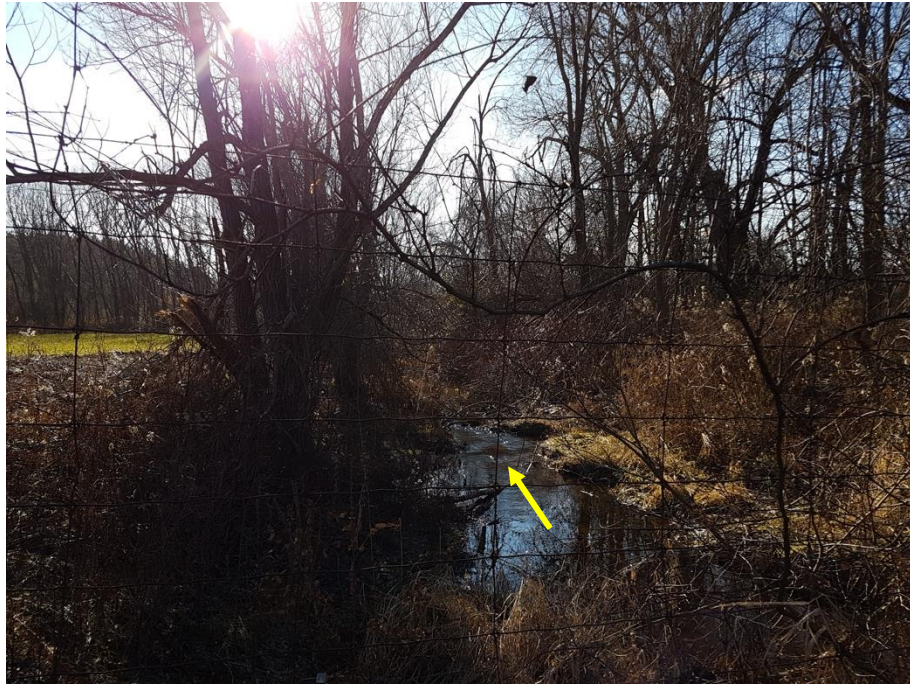
Photo 17  
Middle Creek Reach MC-5

Generally straight channel with a narrow woody riparian zone.

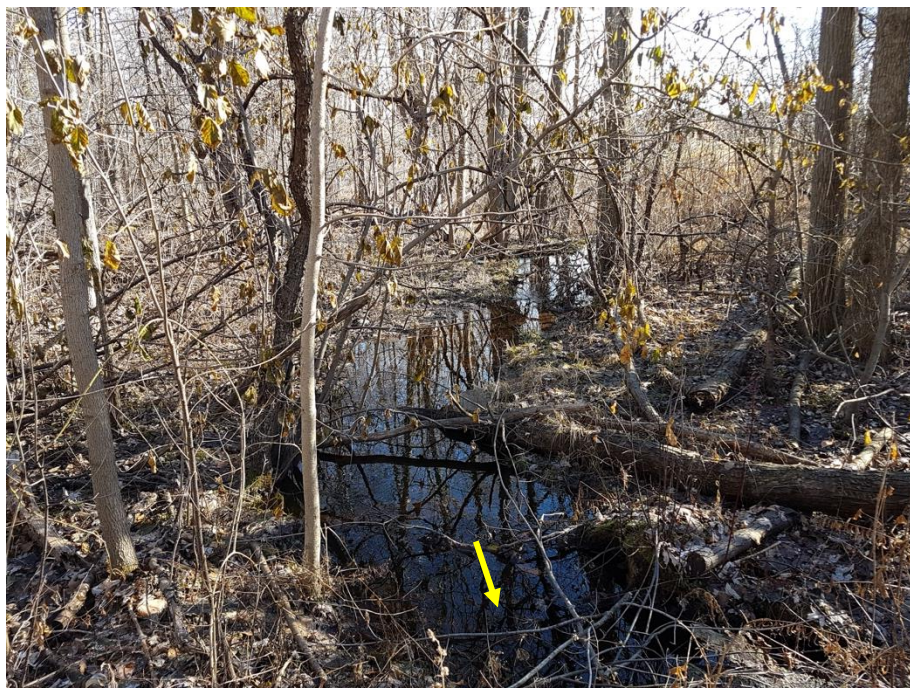
Photo 18  
East Creek Reach EC-1

Watercourse with poorly-fined channel through a swamp.

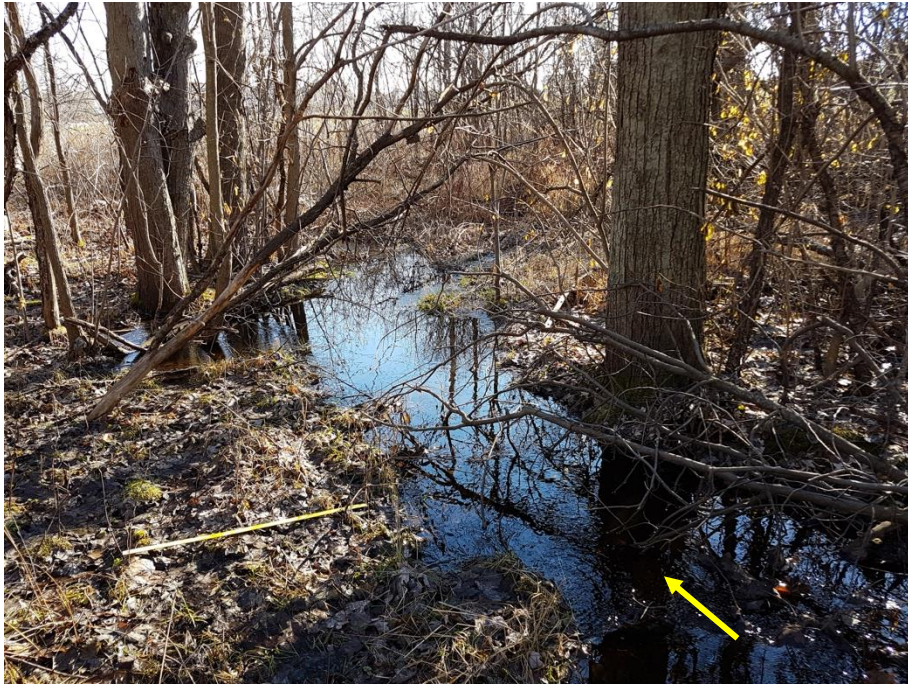
Photo 19  
East Creek Reach EC-1

The depth of flow is close to matching surrounding grades during dry periods, which suggests that the area is frequently inundated.

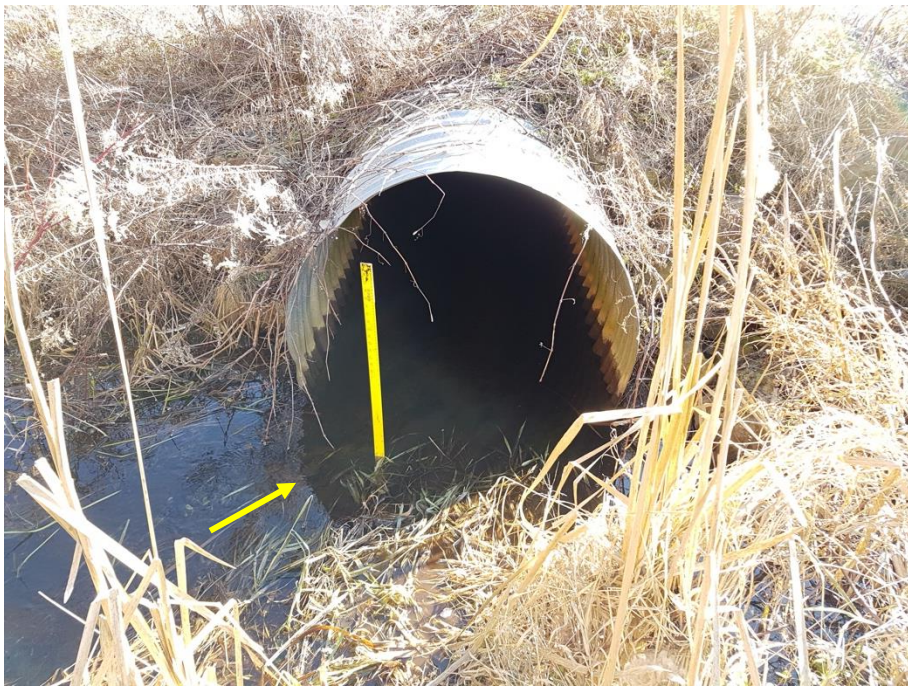
Photo 20  
East Creek Reach EC-1

CSP culvert inlet at downstream end of reach (Maple Grove Road).

If a replacement culvert is required for East Creek, similar recommended improvements associated with the Middle Creek culvert could also be employed. Here, however, the upstream reach, Reach EC-1, is a marsh with a poorly defined channel and therefore the bankfull channel dimension through the culvert would need to be approximated based on the hydraulic model output assuming that the bankfull discharge is roughly equivalent to the storm flows associated with the 1.5 or 2 year recurrence interval.

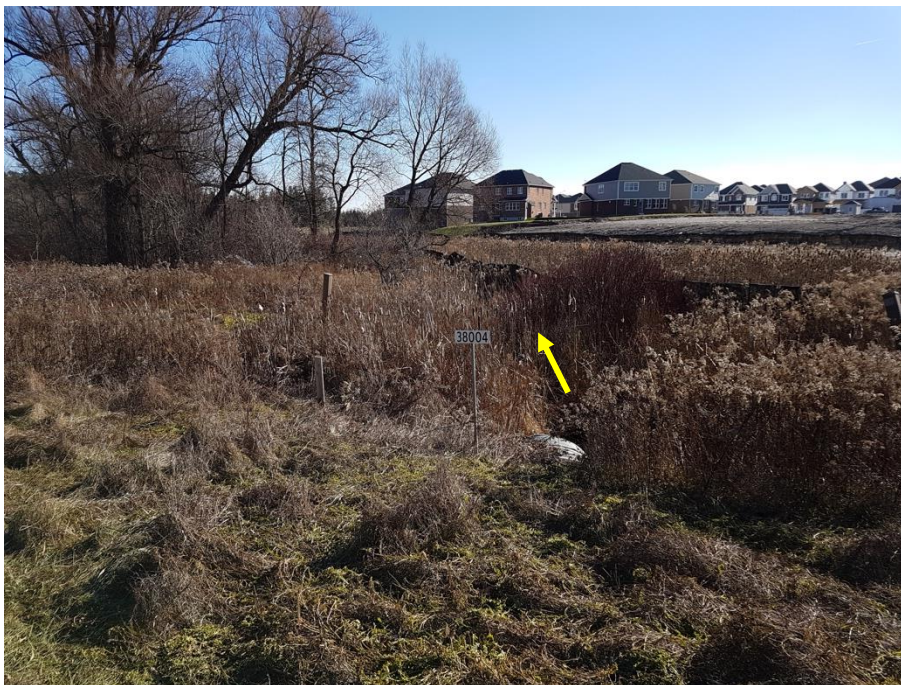
Photo 21  
East Creek Reach EC-2

Reach viewed downstream from Maple Grove Road.

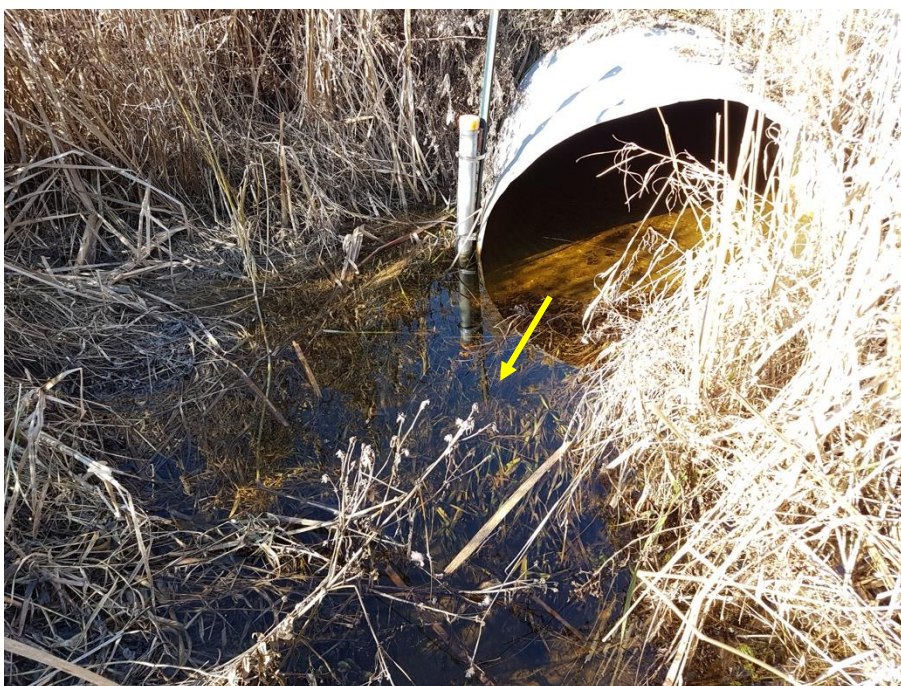
Photo 22  
East Creek Reach EC-2

CSP culvert outlet at Maple Grove Road.

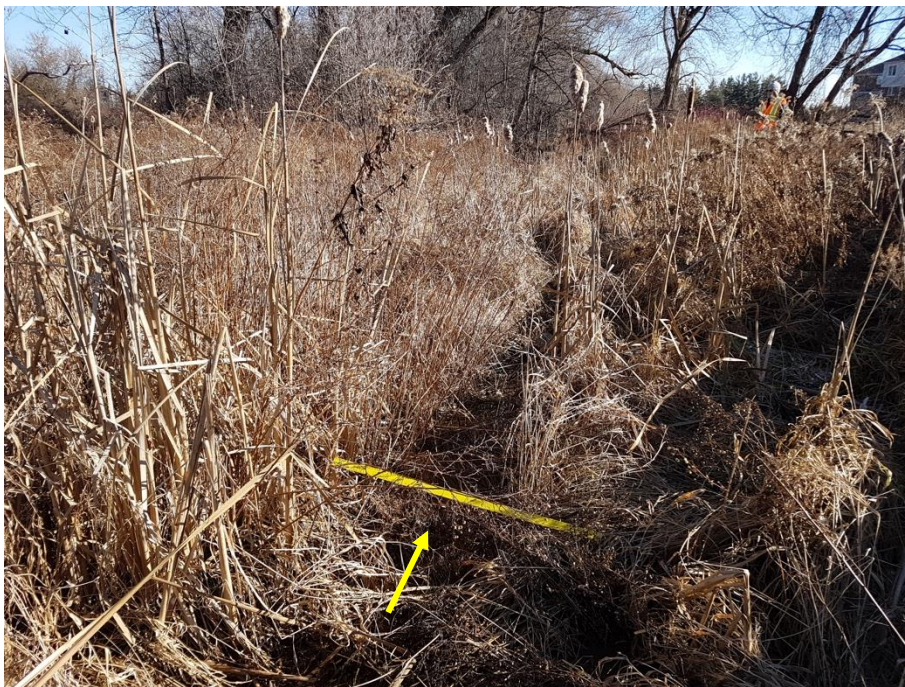
Photo 23  
East Creek Reach EC-2

Low-flow channel near Maple Grove Road with herbaceous vegetation.

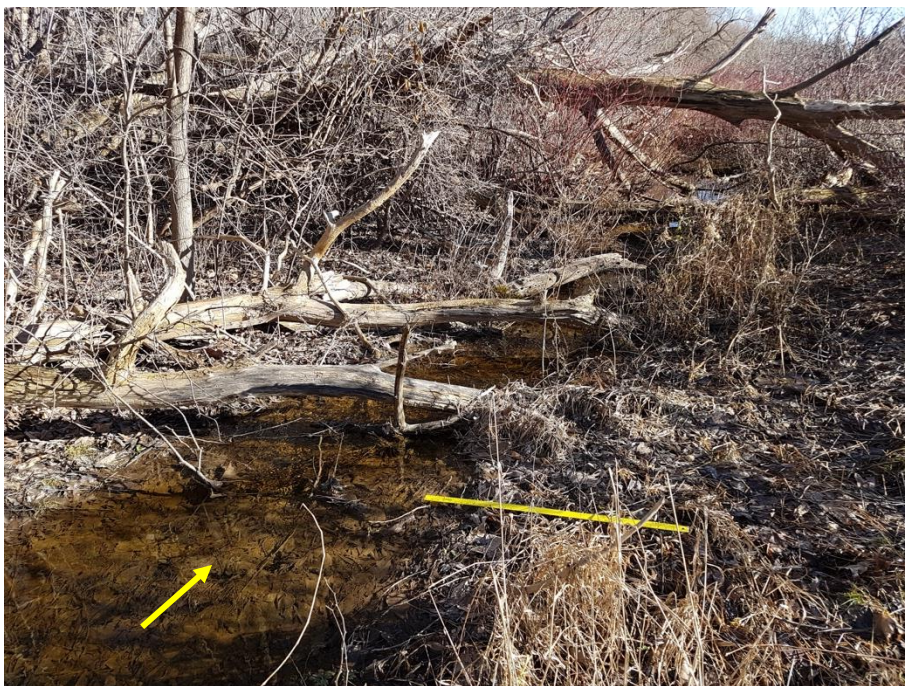
Photo 24  
East Creek Reach EC-2

Typical channel in reach with limited morphological bed variability, barely perceptible flow, fallen trees and riparian trees along left bank.

Among other suggested management activities for East Creek elsewhere in the system, the HWSSWC (2004) also recommended the rehabilitation of the channel downstream of Maple Grove Road adjacent to a sod farm. This is referring to the Reach EC-2 channel, which was previously straightened and removed of riparian vegetation along the south side of the channel.

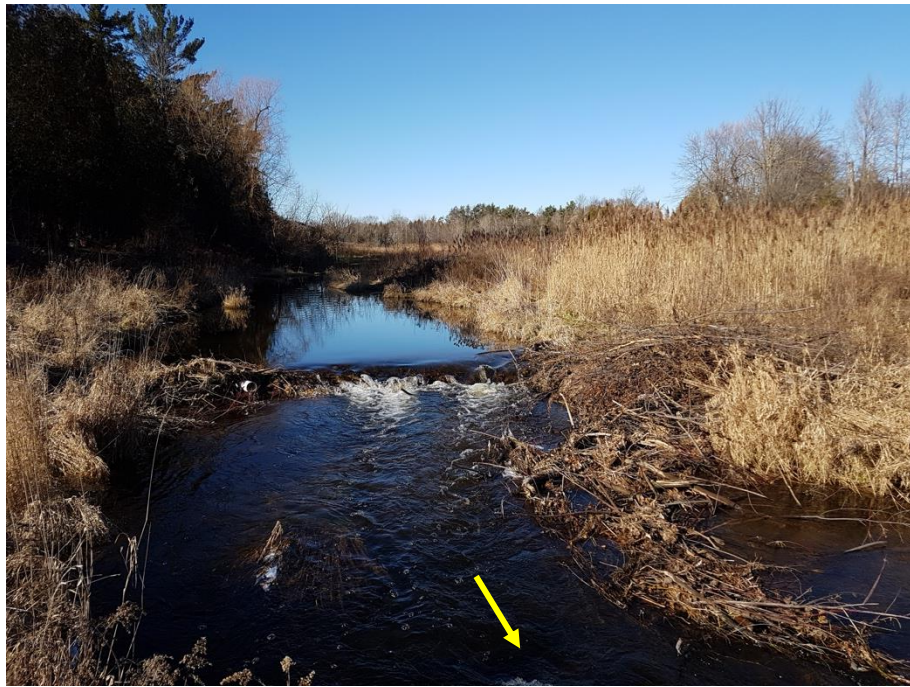
Photo 25  
Chilligo Creek Reach CC-1

Beaver dam with overtopping flow.

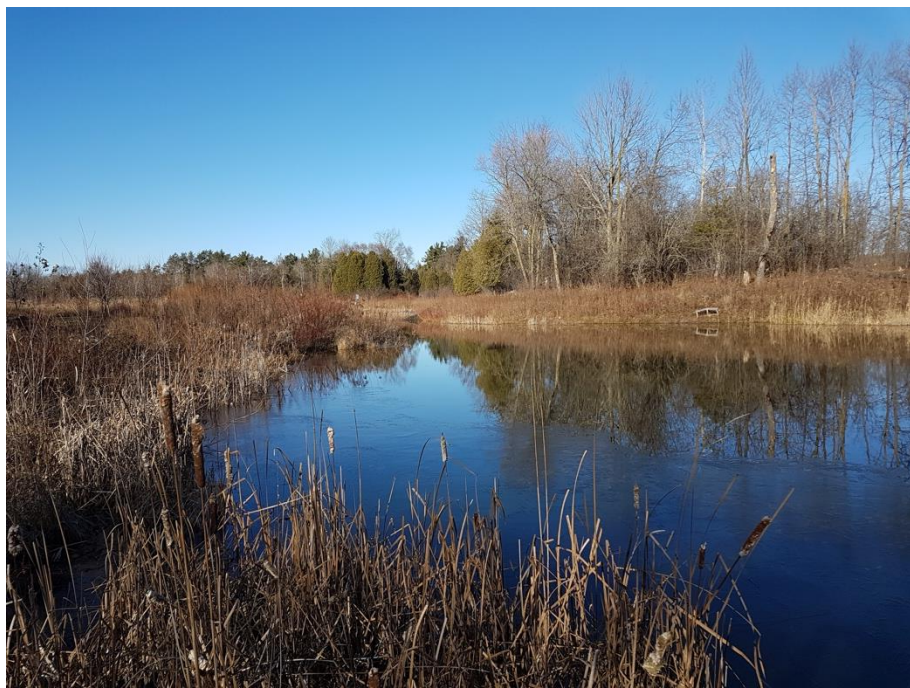
Photo 26  
Chilligo Creek Reach CC-1

Offline pond on the east side of channel at the upstream end of reach.

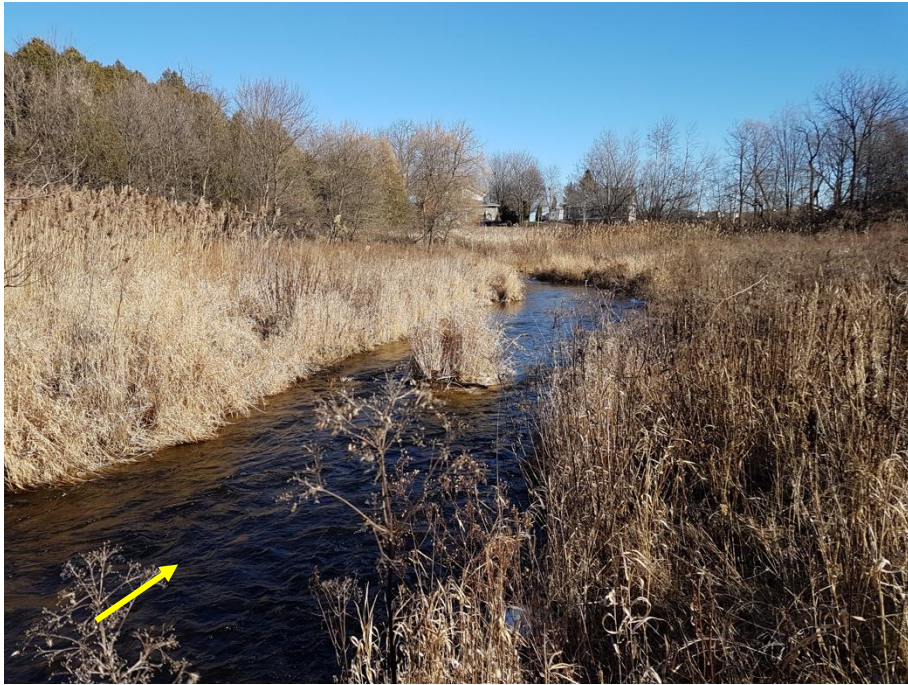
Photo 27  
Chilligo Creek Reach CC-1

Herbaceous riparian vegetation including abundant moisture-tolerant plants.

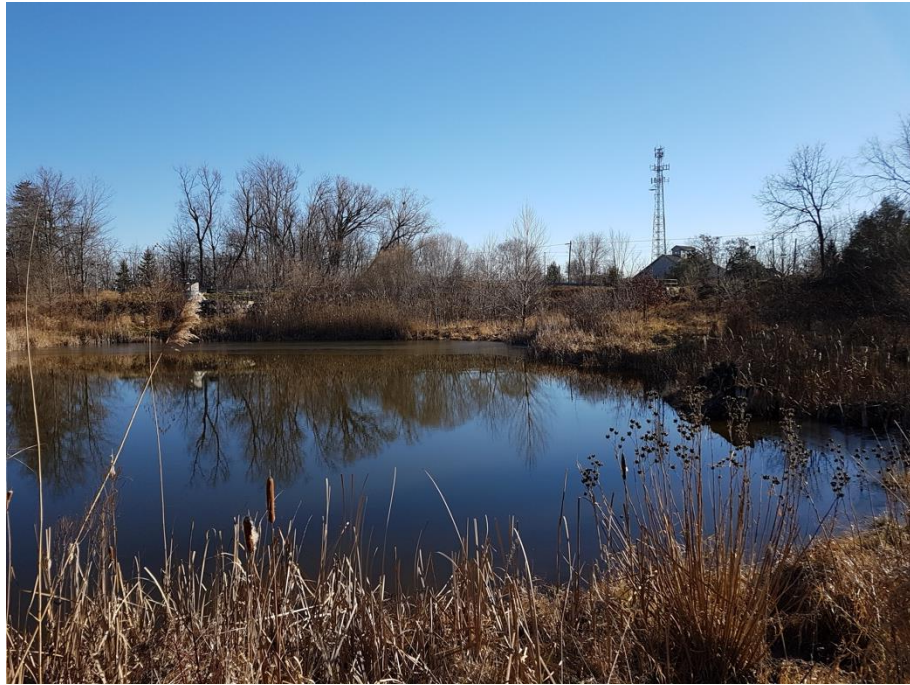
Photo 29  
Chilligo Creek Reach CC-1

Offline pond on the east side of channel at the downstream end of reach.

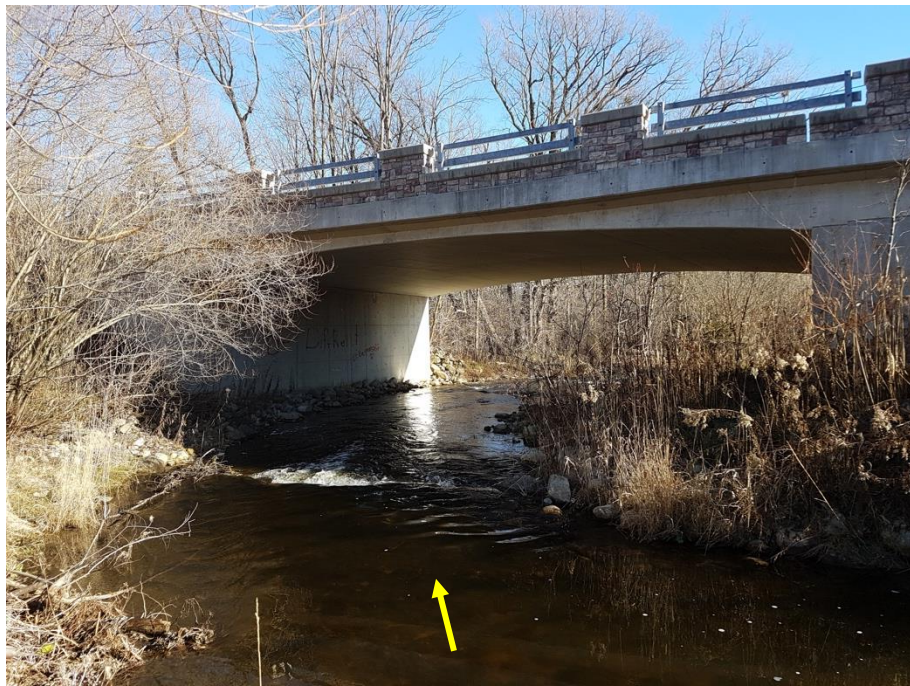
Photo 30  
Chilligo Creek Reach CC-1

Chilligo Road bridge at the downstream end of reach. A weir is positioned just upstream of the bridge and provides upstream channel bed grade control.

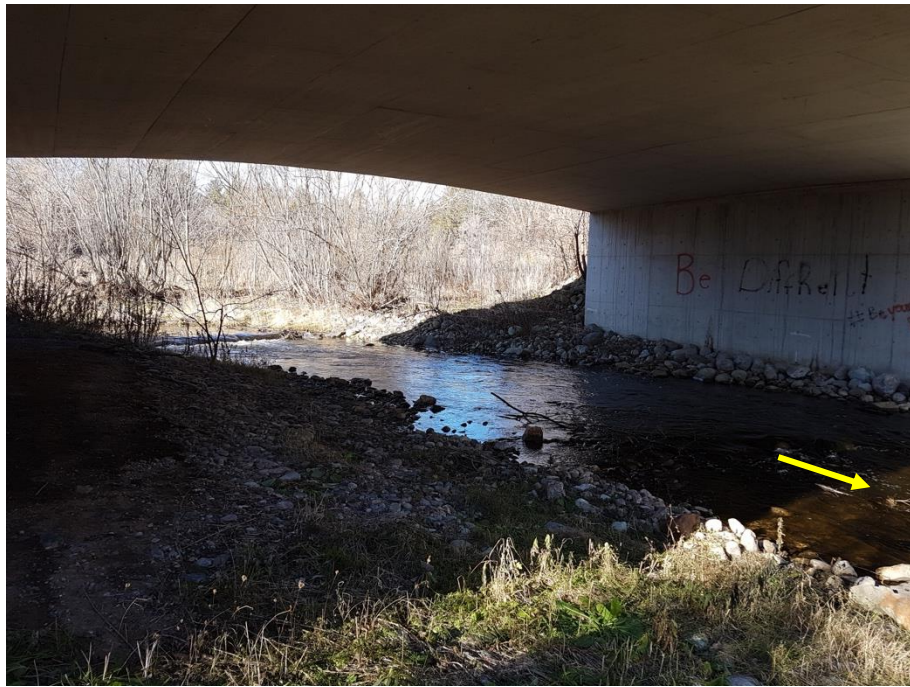
Photo 31  
Chilligo Creek Reach CC-1

Rock-lined channel through the Chilligo Road bridge. The rock may have been placed to not only protect the bridge, but to also form the channel.

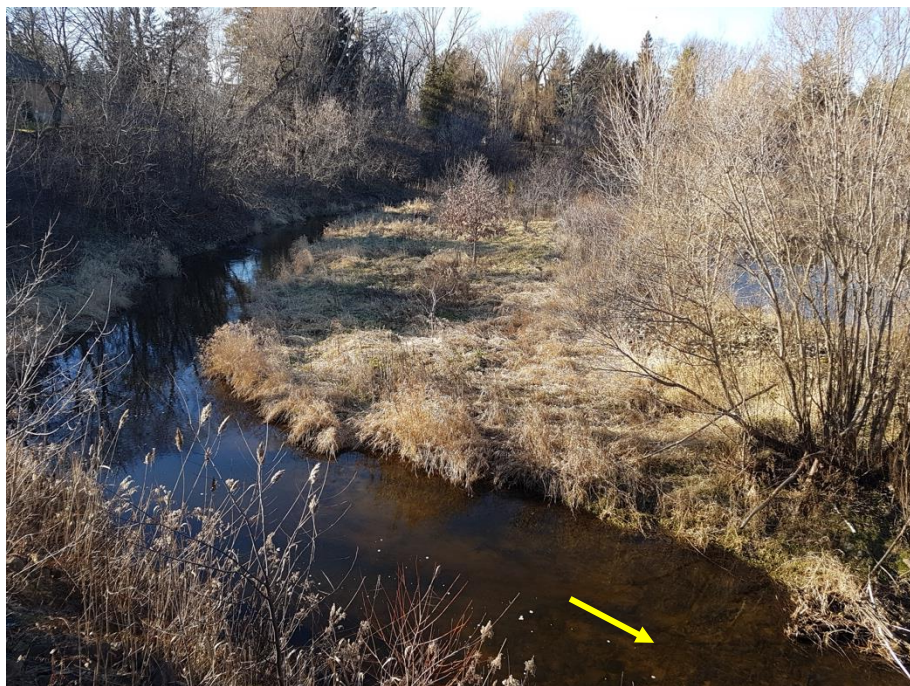
Photo 32  
Chilligo Creek Reach CC-1

Reach viewed upstream from Chilligo Road bridge. Note the valley wall contact to the left.

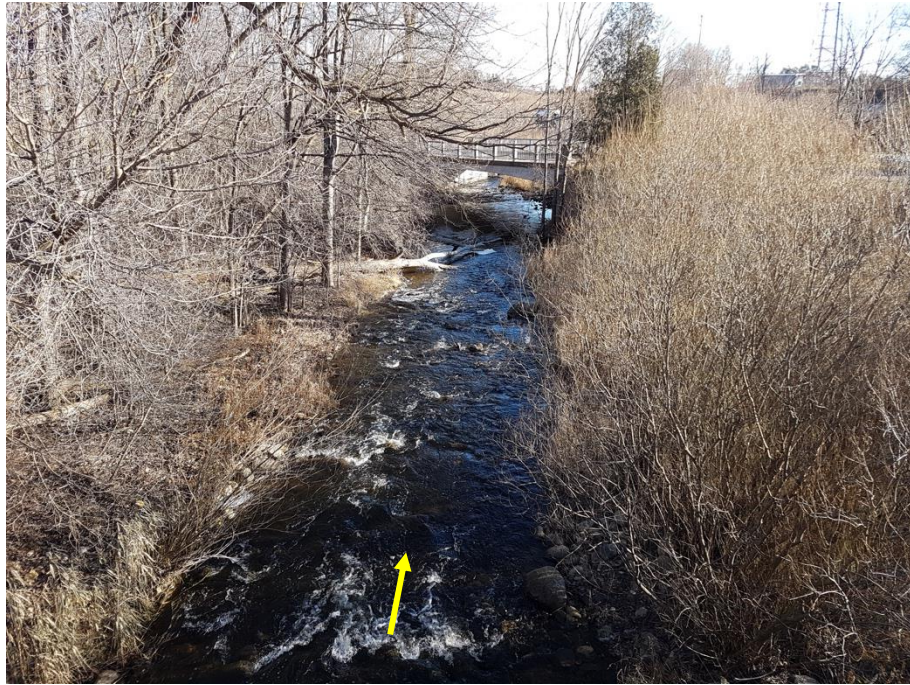
Photo 33  
Chilligo Creek Reach CC-2

Reach viewed downstream from Chilligo Road bridge towards the Fisher Mills Road bridge.

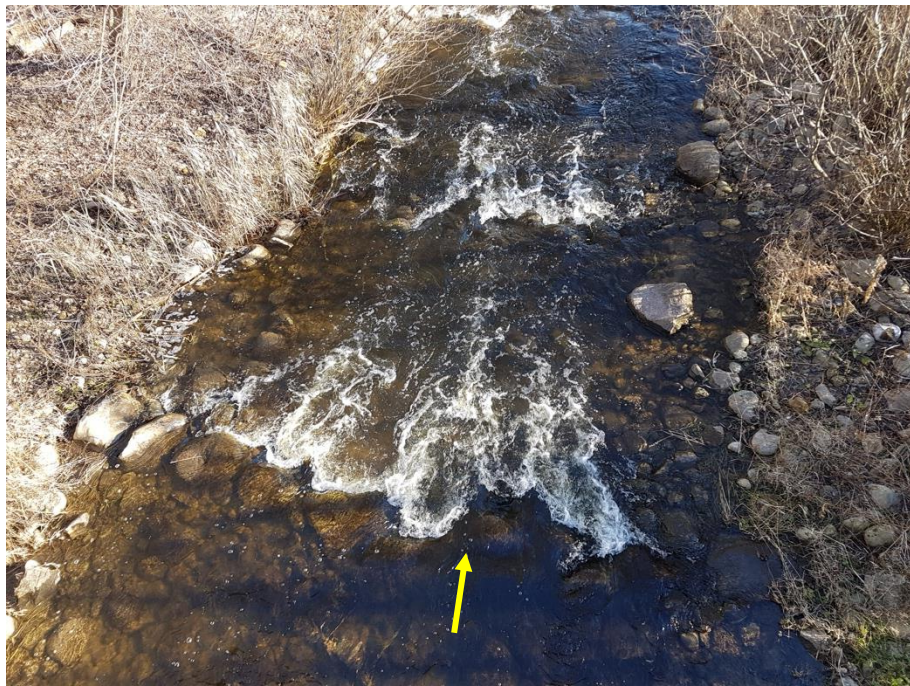
Photo 34  
Chilligo Creek Reach CC-2

Rock weirs constructed across channel to control bed grade and concentrate flow through centre of channel.

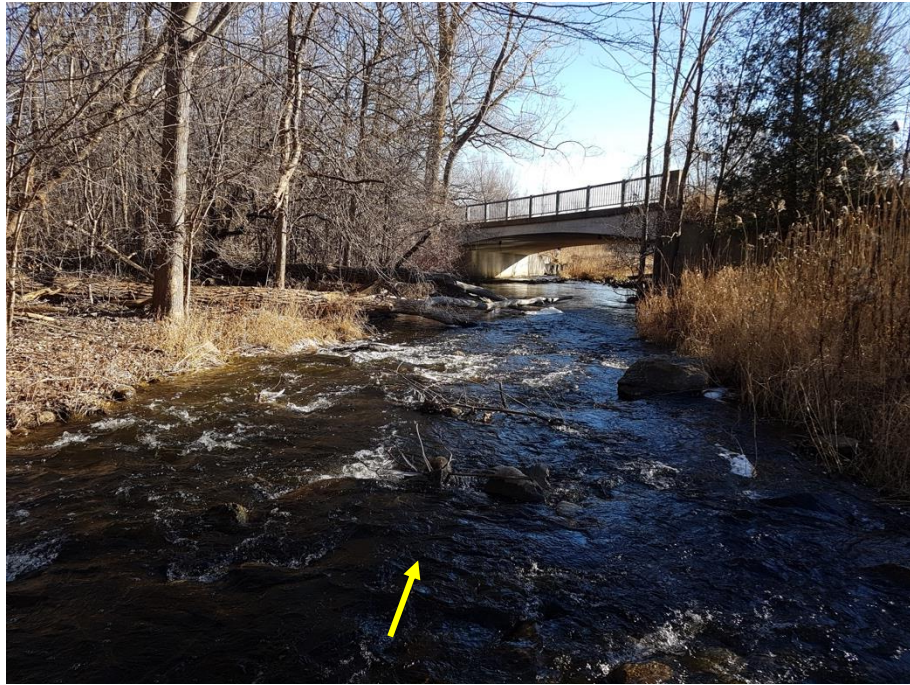
Photo 35  
Chilligo Creek Reach CC-2

Channel approach to Fisher Mills Road. The channel has a relatively high gradient and energy and therefore larger substrate in the cobble and boulder range.
