# **Middle, East and Ellis Creeks Fluvial Geomorphological Assessments**

**Maple Grove Road Class EA  
Fountain Street to Hespeler Road  
The Regional Municipality of Waterloo**

October 21, 2019  
GEO Morphix Project No. 18116

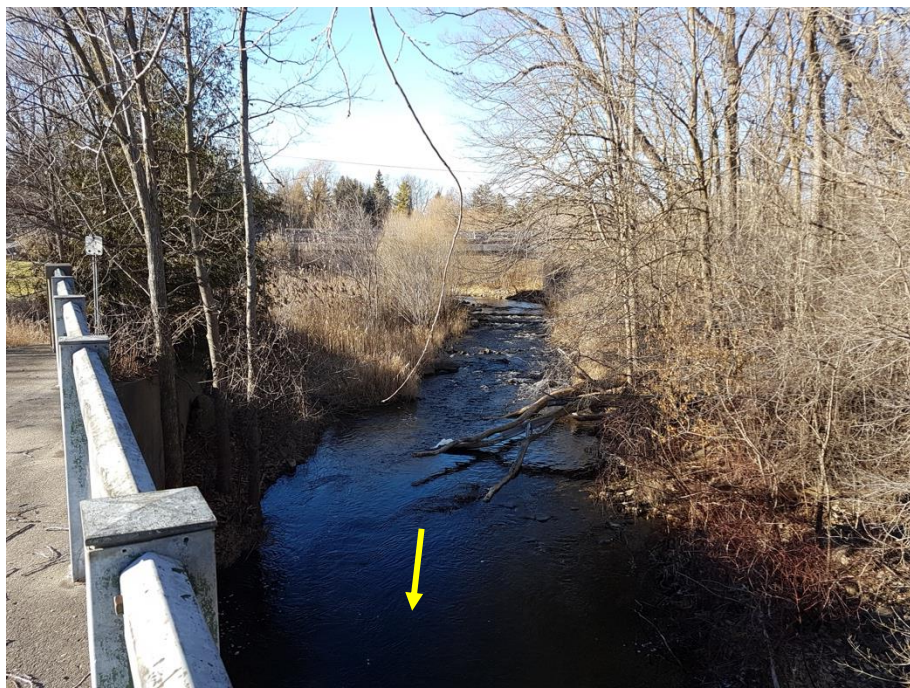
Photo 36  
Chilligo Creek Reach CC-2

Reach viewed upstream from Fisher Mills Road bridge.

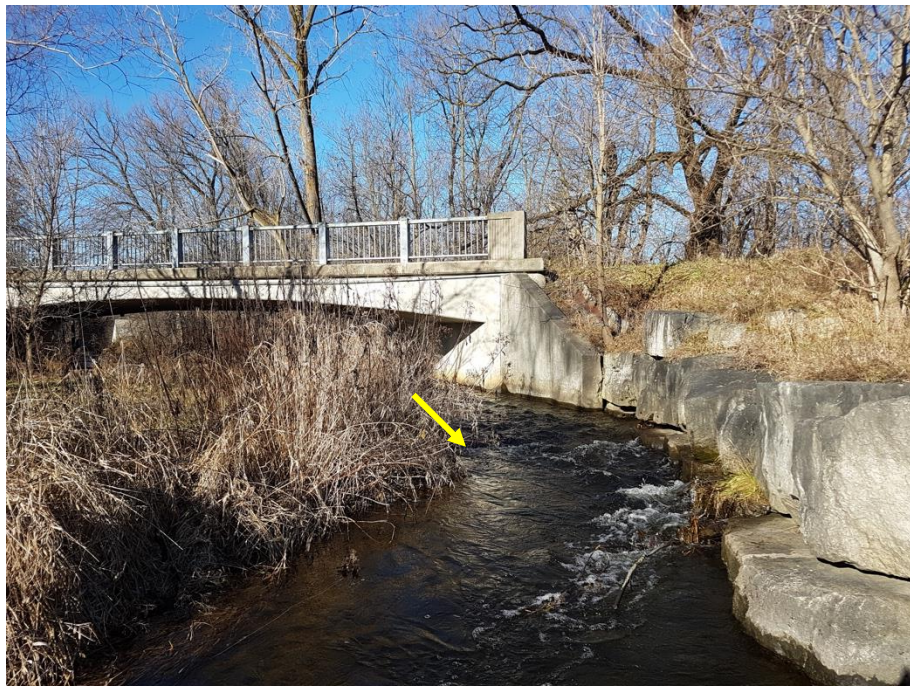
Photo 38  
Chilligo Creek Reach CC-2

Armourstone along the outside bank of a bend, downstream of Fisher Mills Road.

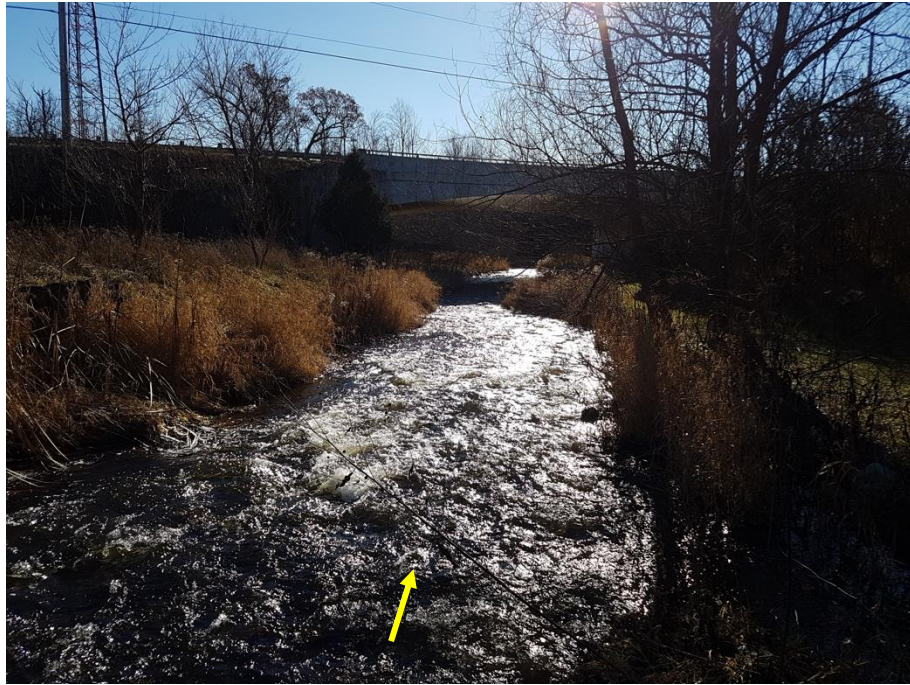
Photo 39  
Chilligo Creek Reach CC-2

Riffle section with rapid flow upstream of Maple Grove Road.

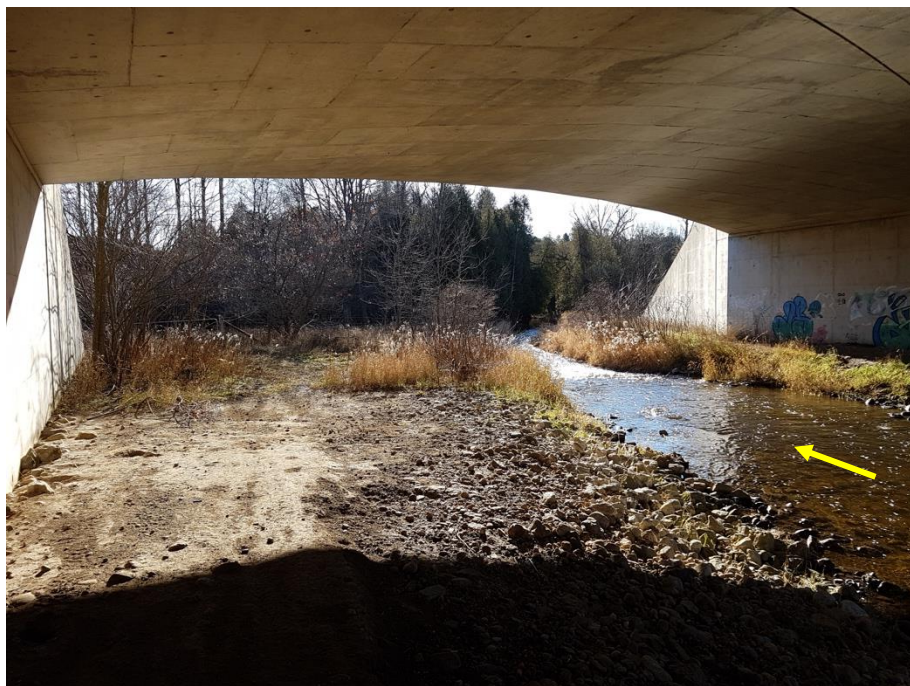
Photo 40  
Chilligo Creek Reach CC-2

Channel and overbank area under the Maple Grove Road bridge.

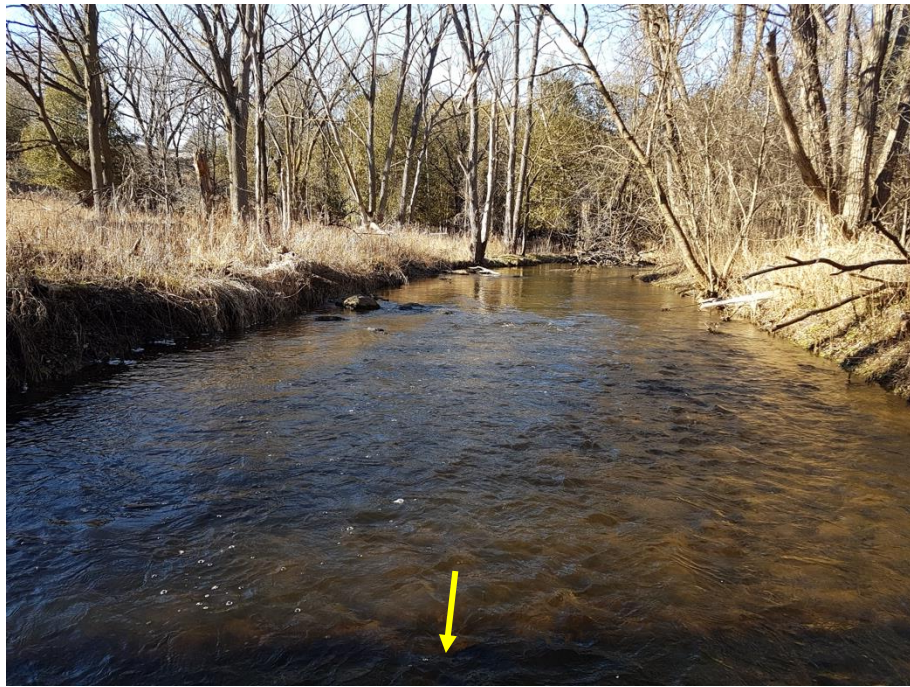
Photo 47  
Chilligo Creek Reach CC-3

Straight riffle section upstream of Hespeler Road. Erosion of bank on left and leaning tree on right suggest channel widening.

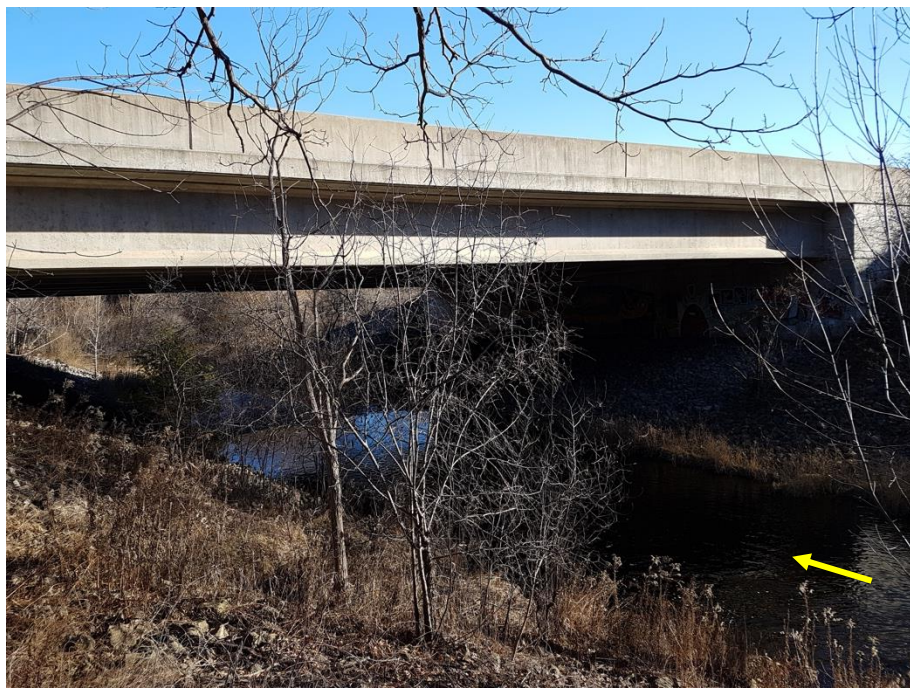
Photo 48  
Chilligo Creek Reach CC-3

Hespeler Road bridge with rock protection along abutments.
