# Appendix M – Detailed Bridge Condition Survey of Ellis Creek Bridge (Orbit Engineering)

Detailed Bridge Condition Survey of  
Site Number 3801, Maple Grove Road over Ellis Creek Bridge

OE18761AC

October 24, 2018

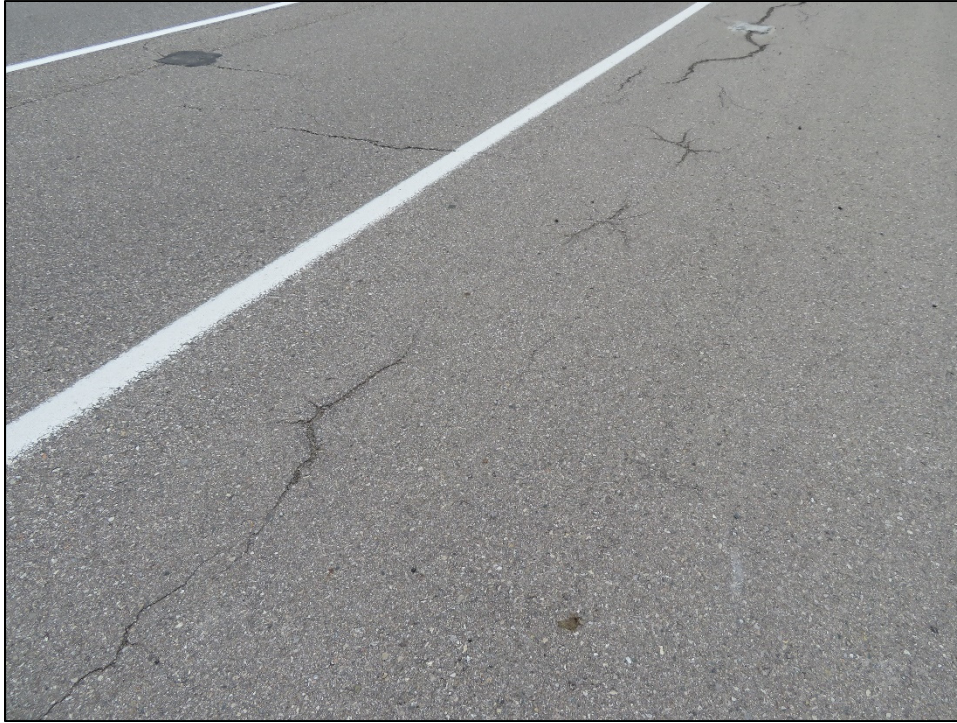
General overview photographs of Site Number 3801, Maple Grove Road over Ellis Creek Bridge are shown in Photos P1 (north elevation), P2 (south elevation), P3 (aerial overview) and P4 (aerial overview). The asphalt-covered riding surface was typically in fair condition exhibiting evidence of unsealed (179.5 m), as summarized on Drawing No. 1. Asphalt thicknesses ranged from 70 to 110 mm, with an average asphalt thickness of 87 mm. The concrete cover in the cores and sawn samples ranged from 70 to 95 mm, with an average concrete cover of 77 mm. The typical condition of the asphalt riding surface is shown in Photo P9 to P10.

**Photo P9 – Typical Condition of Asphalt Riding Surface** (fair condition – unsealed cracking)

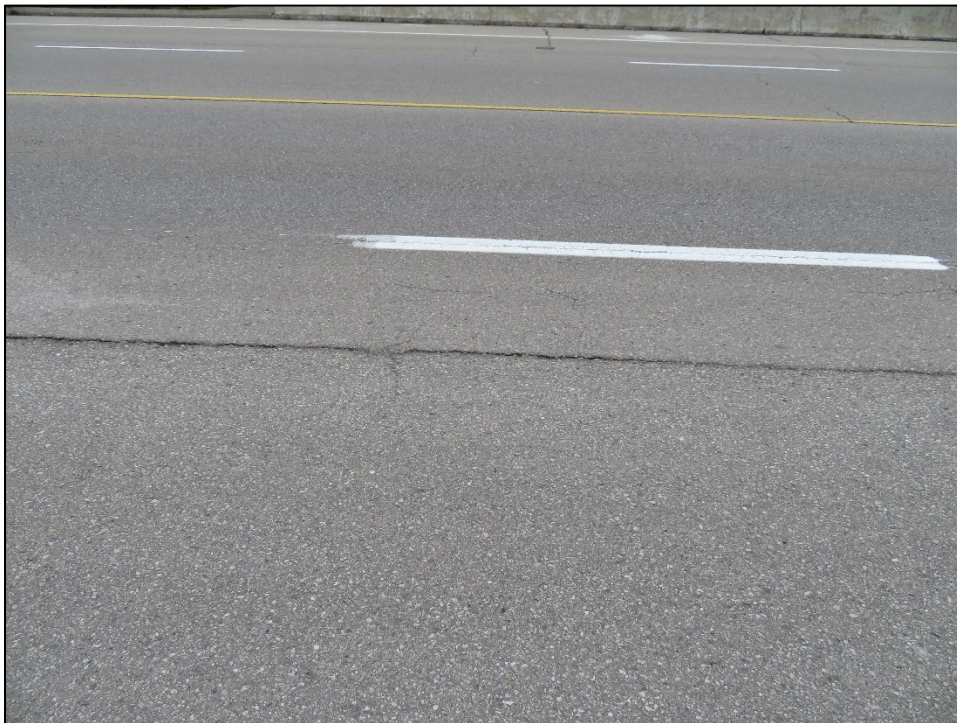
**Photo P10 – Typical Condition of Asphalt Riding Surface** (fair condition – unsealed cracking)

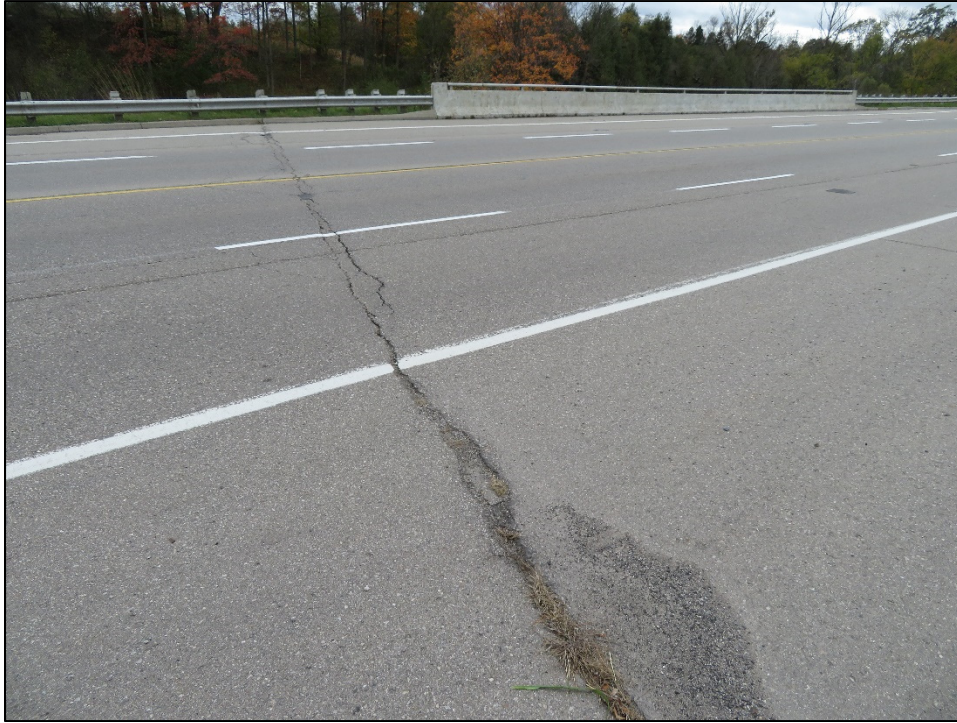
The asphalt wearing surface of the approaches were typically in fair condition, exhibiting evidence of cracking, as shown in Photos P11 (east) and P12 (west). Core C1 confirmed the existence of concrete approach slabs below the asphalt.

**Photo P11 – Typical Condition of East Approach** (fair condition – unsealed cracking)

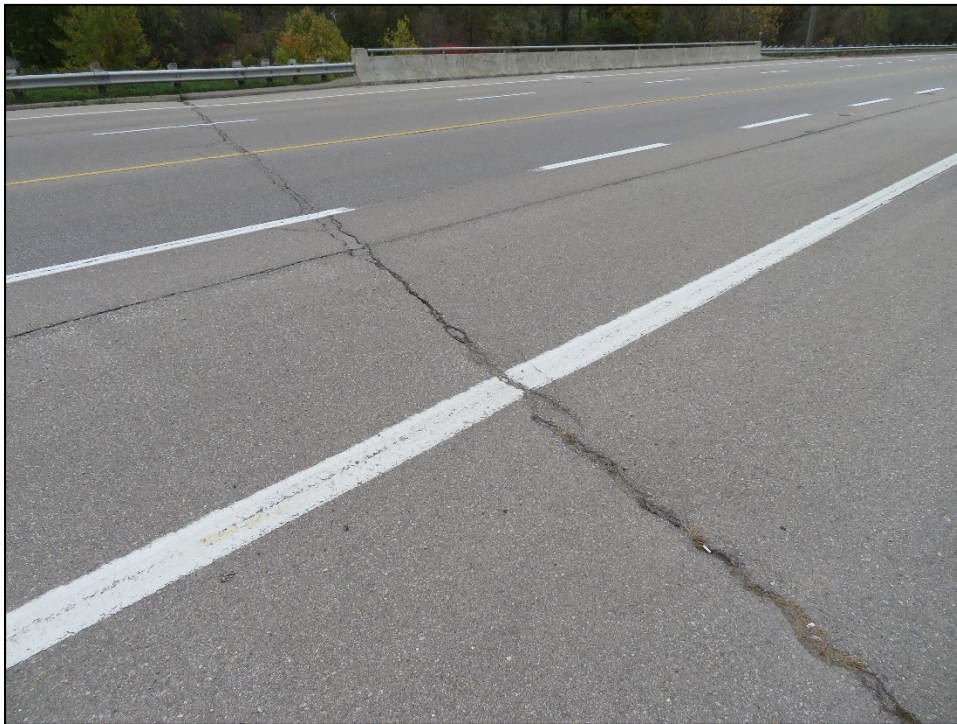
**Photo P12 – Typical Condition of West Approach** (fair condition – unsealed cracking)

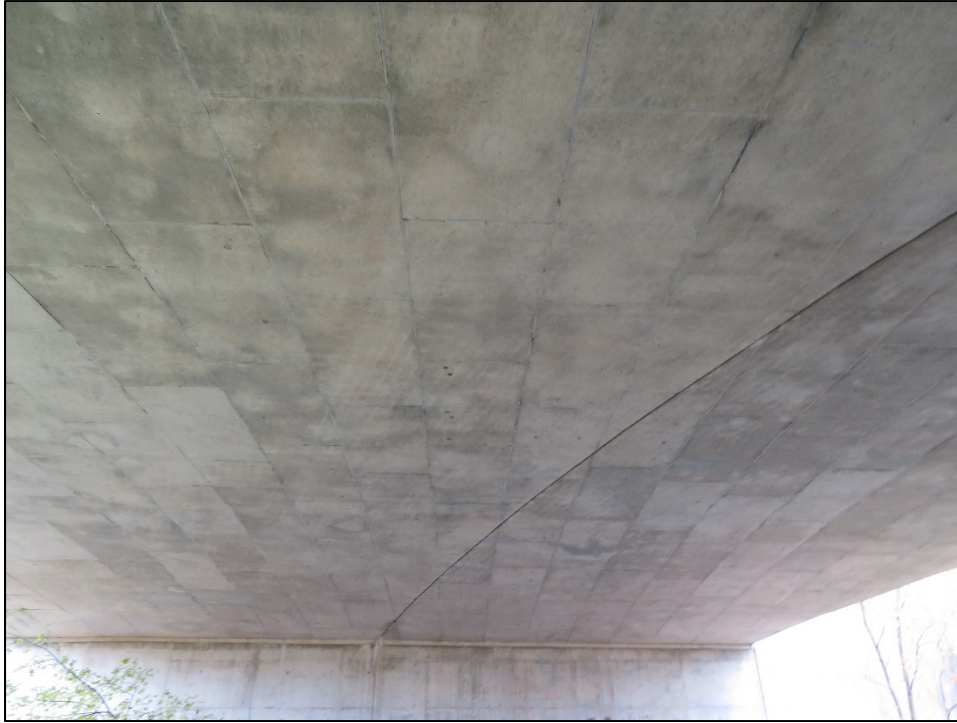
The soffit was typically in fair-to-good condition exhibiting evidence of a spall (0.02 m<sup>2</sup>) and wet areas (1.7 m<sup>2</sup>) as shown in Photos P13 to P16. The soffit exhibited efflorescence coming from the construction joint in the centre where the wet areas are located.

**Photo P13 – Typical Condition of Soffit from West** (fair-to-good condition – wet areas and efflorescence staining at construction joint)

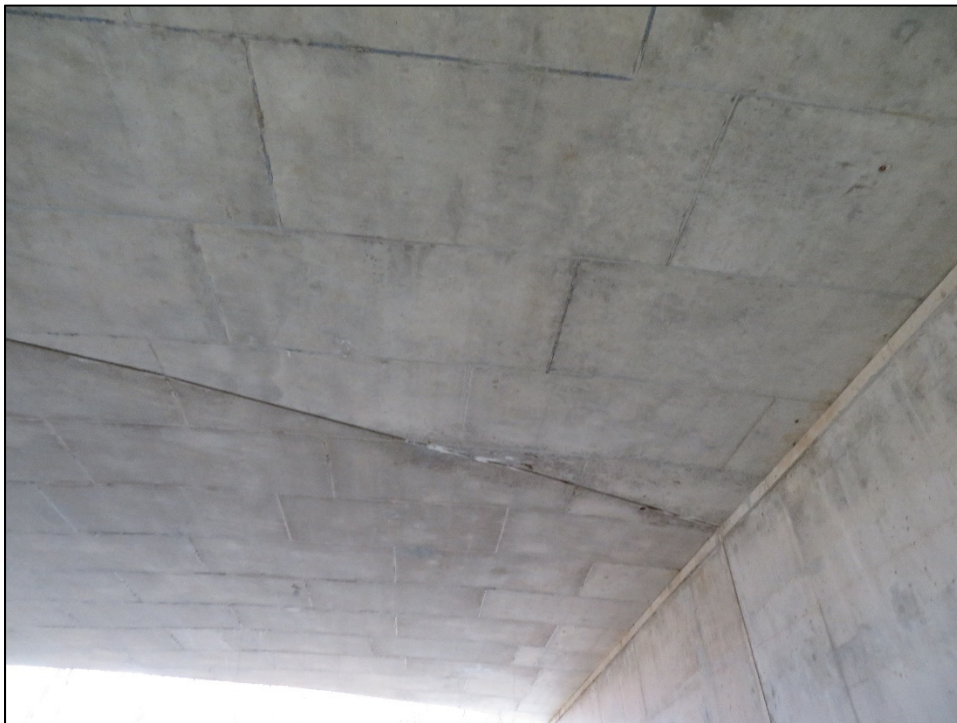
**Photo P14 – Typical Condition of Soffit @ West** (fair-to-good condition – wet areas and efflorescence staining at construction joint)

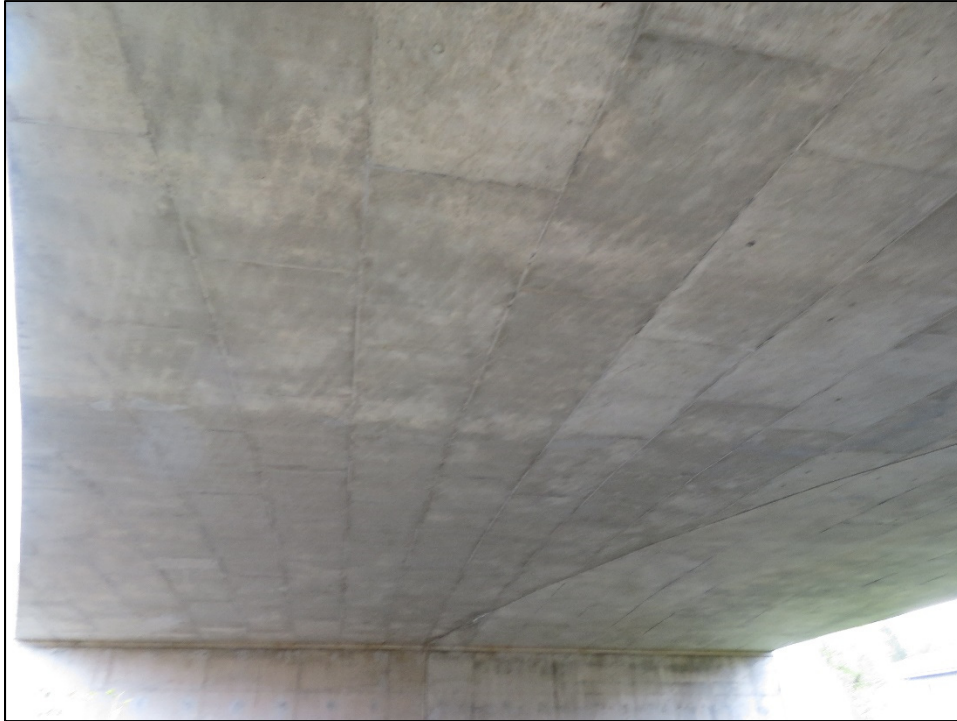
**Photo P15 – Typical Condition of Soffit from East** (fair-to-good condition – wet areas and efflorescence staining at construction joint)

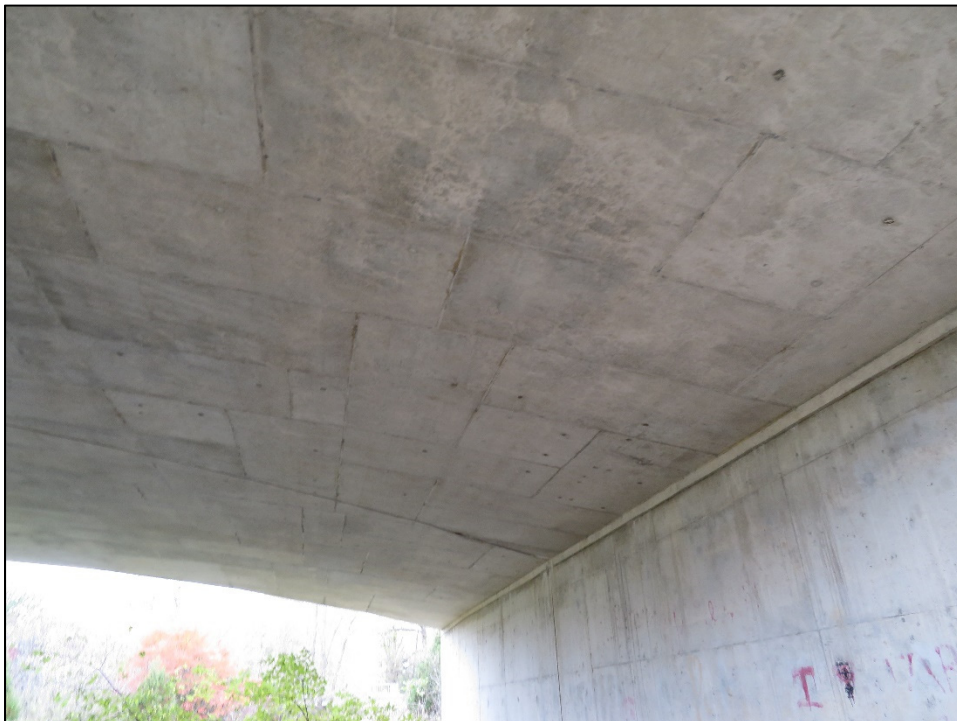
**Photo P16 – Typical Condition of Soffit @ South-East** (fair-to-good condition – wet areas and efflorescence staining at construction joint)

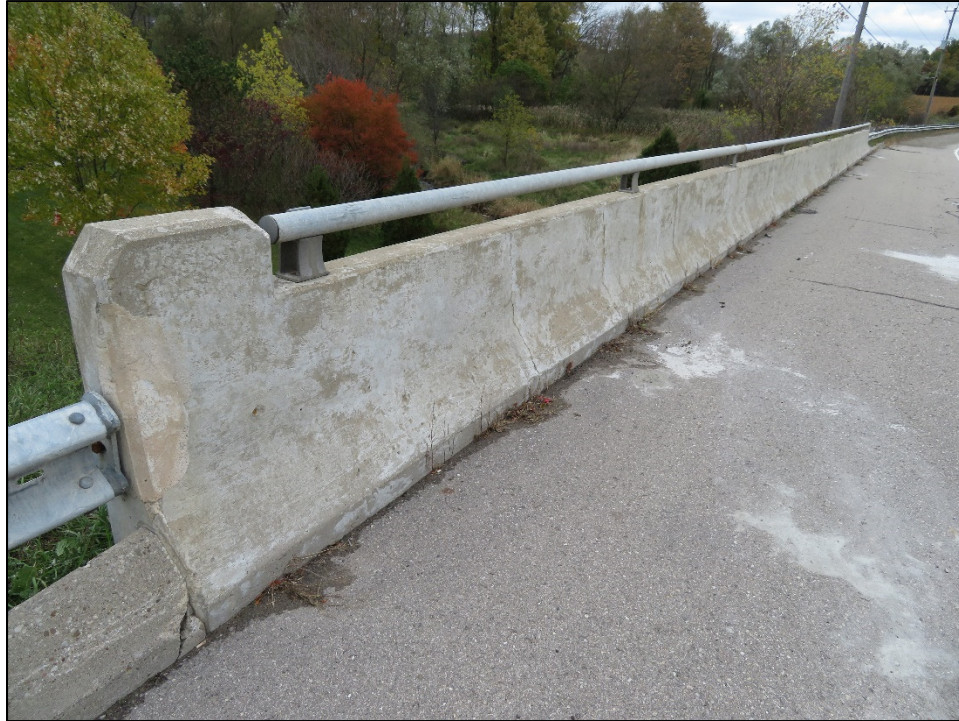
The north and south barrier walls were typically in fair-to-good condition exhibiting evidence of unstained cracking (20.6 m), spalls (0.06 m<sup>2</sup>) and patch (0.09 m<sup>2</sup>) as shown in Photos P17 to P19 (north) and P20 to P22 (south).

**Photo P17 – Typical Condition of North Barrier Wall** (fair-to-good condition – cracking, spalls and patch)

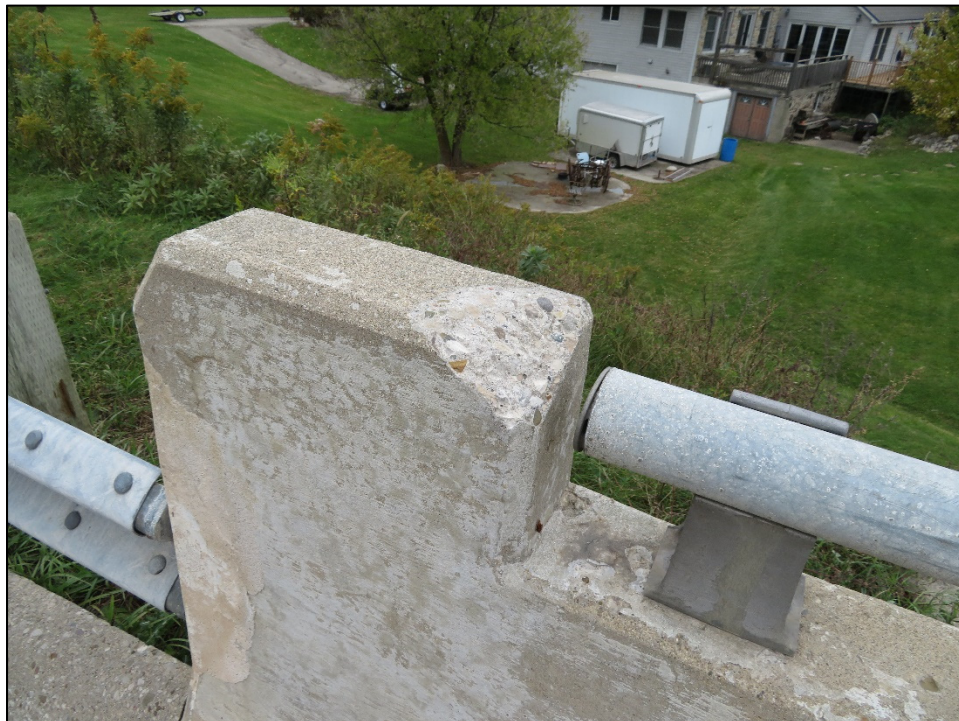
**Photo P18 – Typical Condition of North Barrier Wall** (fair-to-good condition – cracking, spalls and patch)

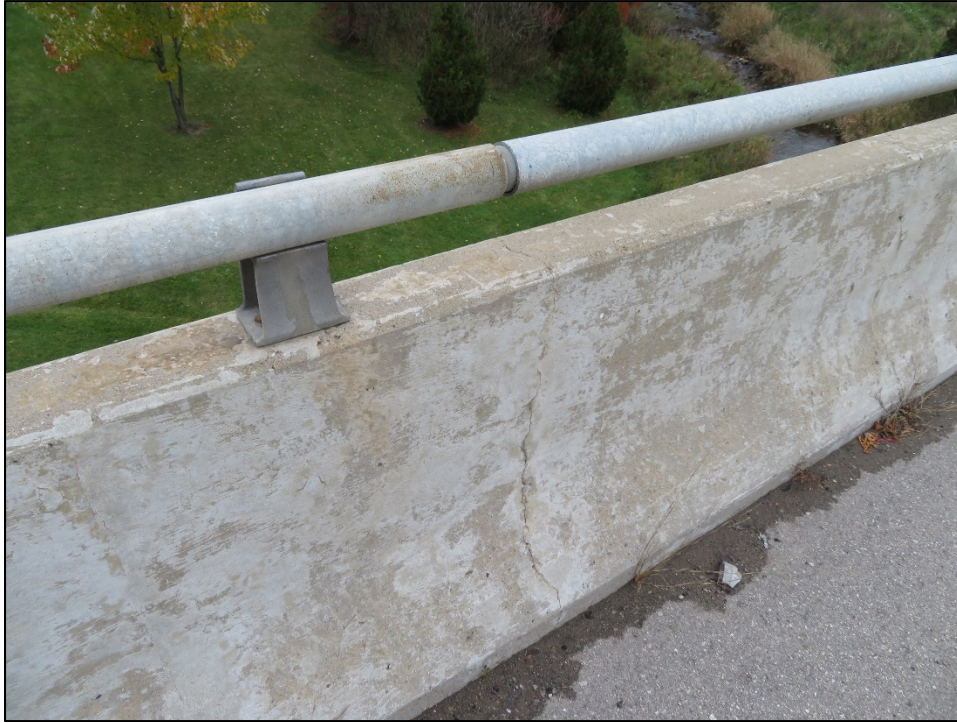
**Photo P19 – Typical Condition of North Barrier Wall** (fair-to-good condition – cracking)

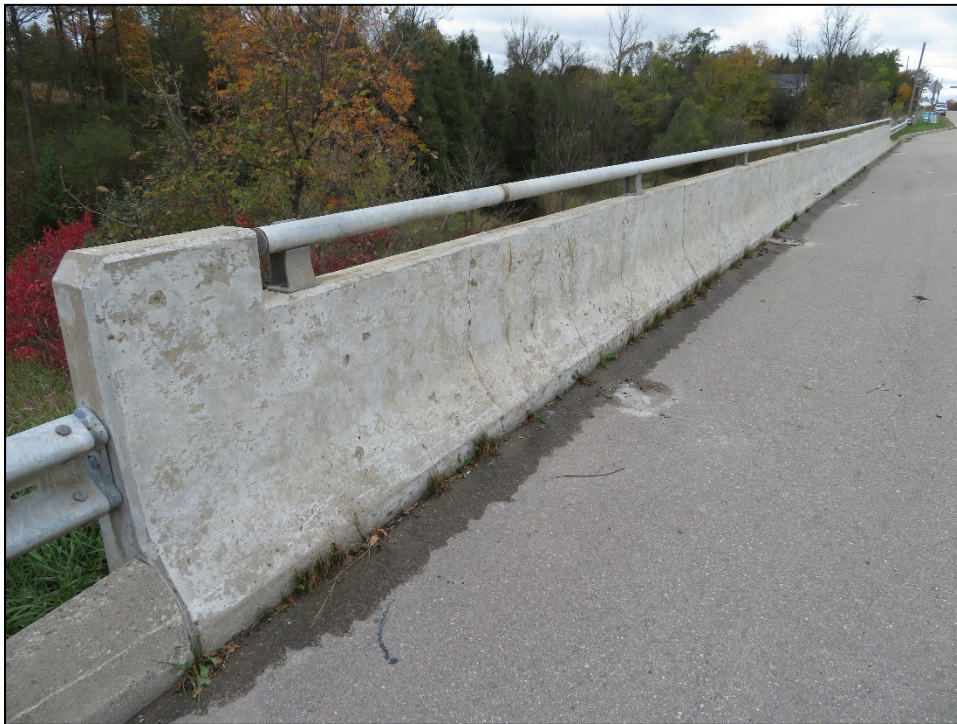
**Photo P20 – Typical Condition of South Barrier Wall** (fair-to-good condition – cracking and spalls)

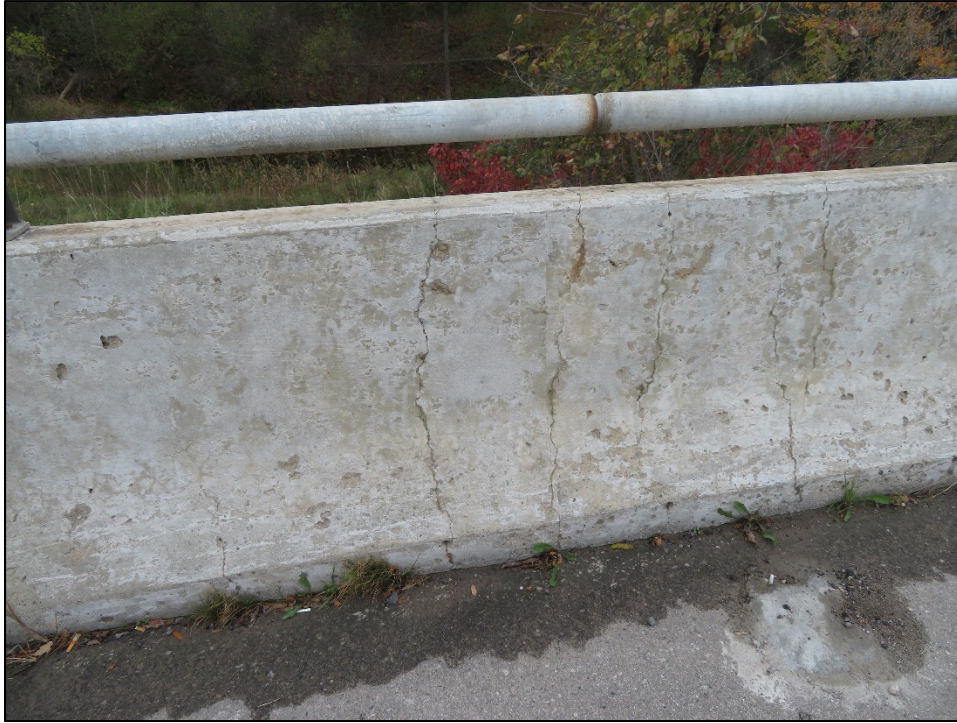
**Photo P21 – Typical Condition of South Barrier Wall** (fair-to-good condition – cracking and spalls)

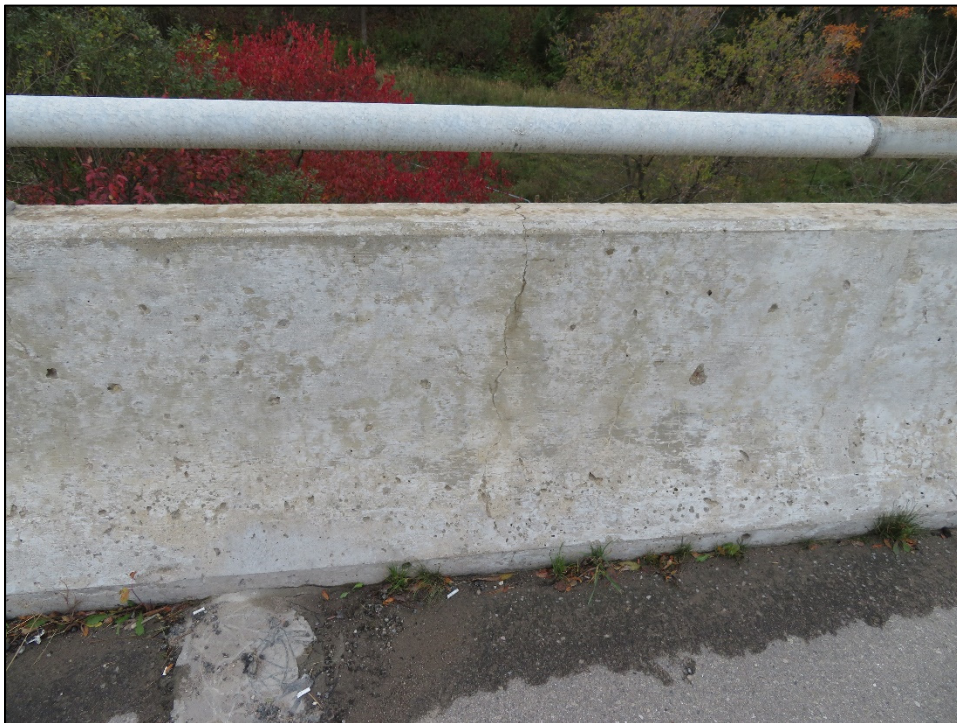
**Photo P22 – Typical Condition of South Barrier Wall** (fair-to-good condition – cracking and spalls)

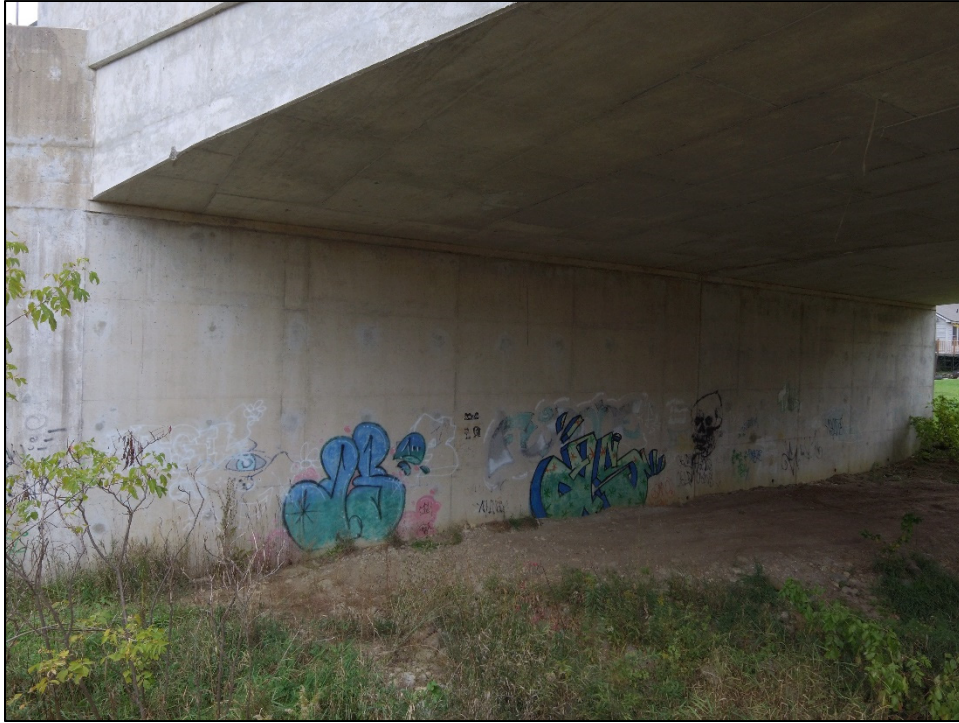
The east abutment was typically in fair-to-good condition exhibiting evidence of unstained cracking (11.7 m) as shown in Photos P23 to P24.

**Photo P23 – Typical Condition of East Abutment** (fair-to-good condition – cracking)

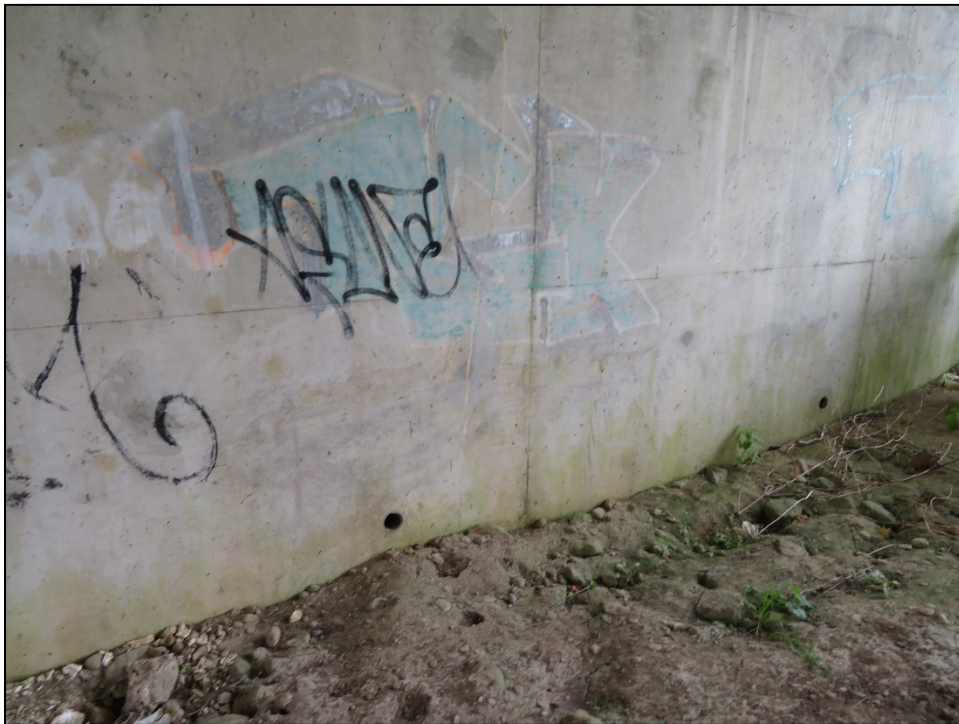
**Photo P24 – Typical Condition of East Abutment** (fair-to-good condition – cracking)

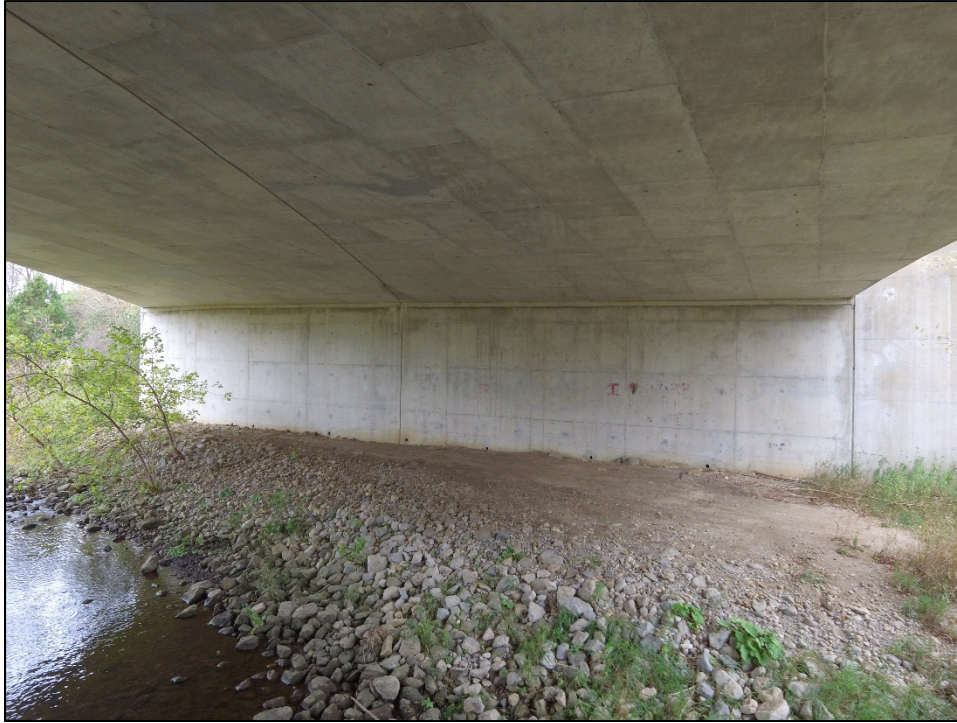
The west abutment was typically in fair-to-good condition exhibiting evidence of unstained cracking (19.6 m) and spall (0.04 m<sup>2</sup>) as shown in Photos P25 to P26.

**Photo P25 – Typical Condition of West Abutment** (fair-to-good condition – cracking)

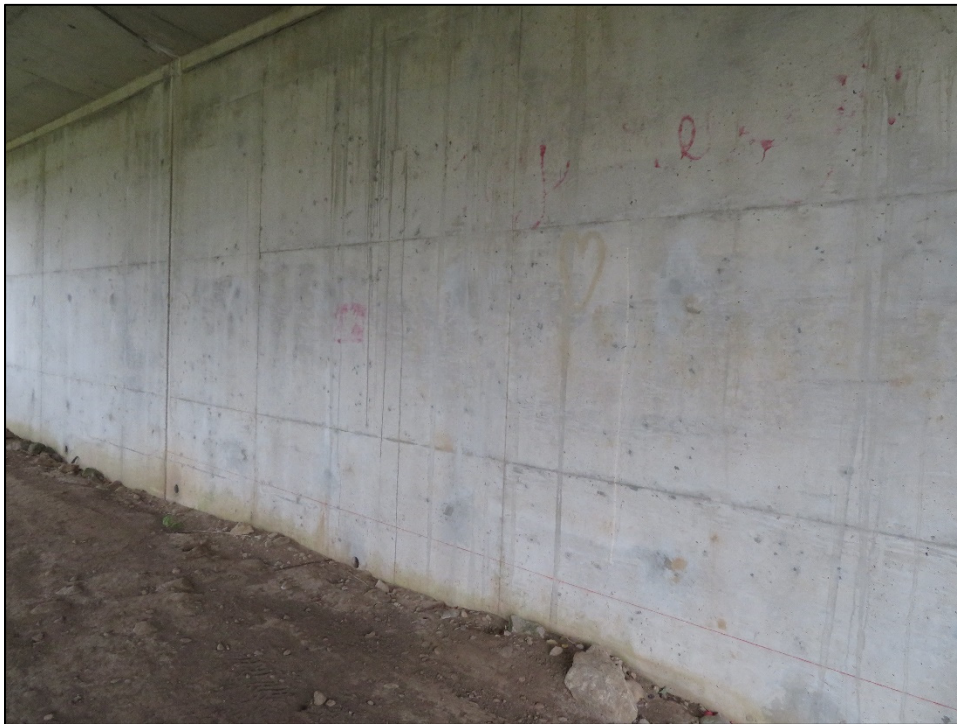
**Photo P26 – Typical Condition of West Abutment** (fair-to-good condition – cracking)

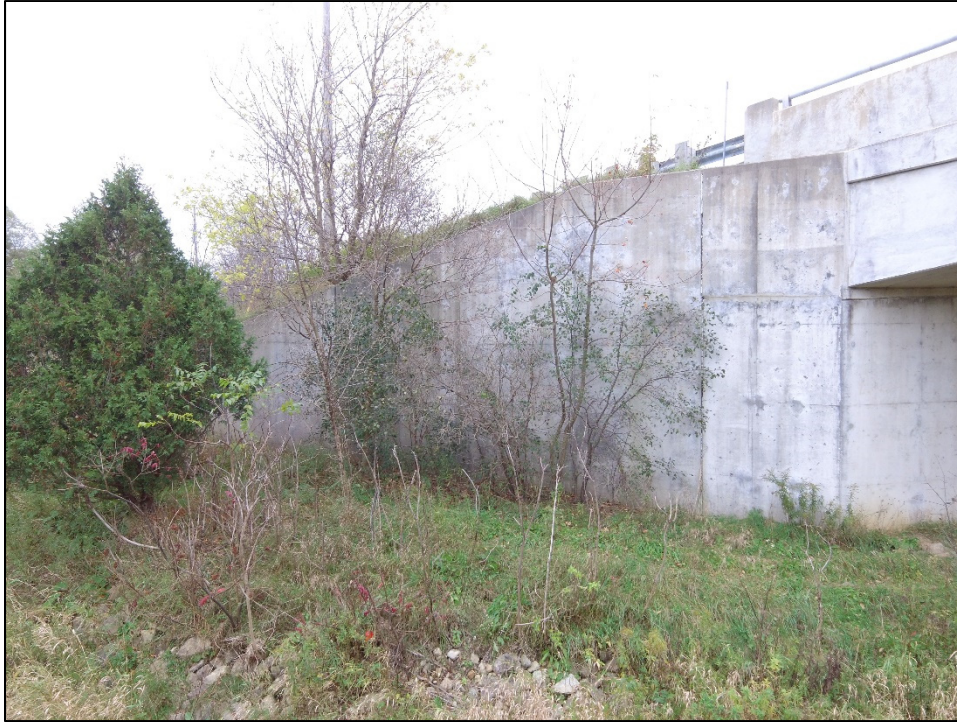
The retaining walls were typically in fair-to-good condition exhibiting evidence of unstained cracking (23.4 m) as shown in Photos P27 to P33. The North-East, North-West and South-West retaining walls exhibited rotational movement of approximately 25mm.

**Photo P27 – Typical Condition of North-East Retaining Wall** (fair condition - cracking)

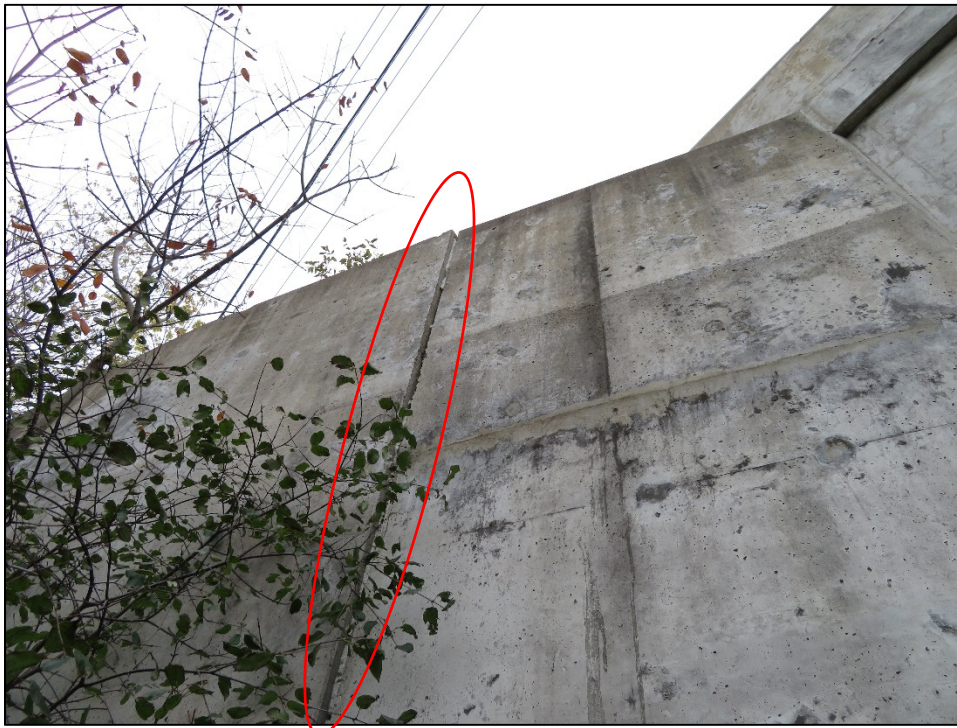
**Photo P28 – Typical Condition of North-East Retaining Wall** (fair condition - movement)

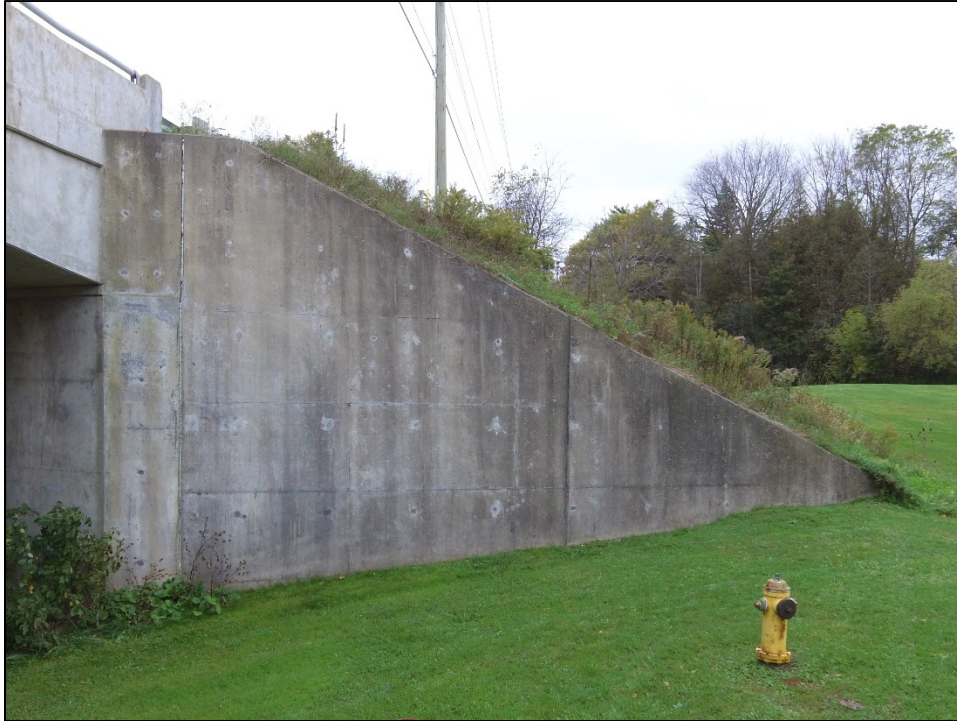
**Photo P29 – Typical Condition of North-West Retaining Wall** (fair condition)

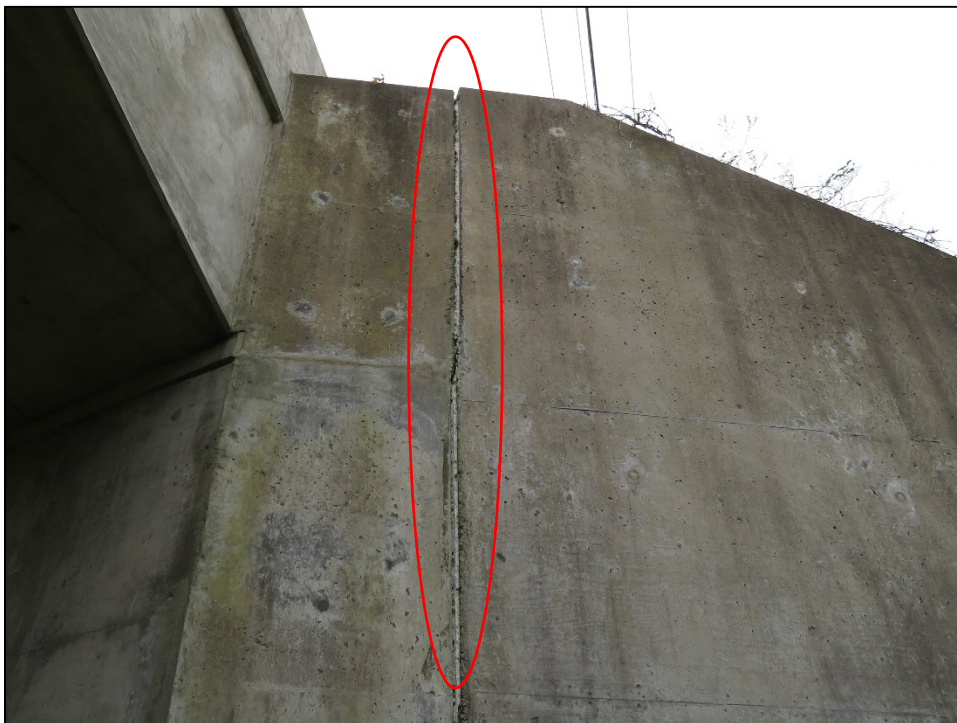
**Photo P30 – Typical Condition of North-West Retaining Wall** (fair condition - movement)

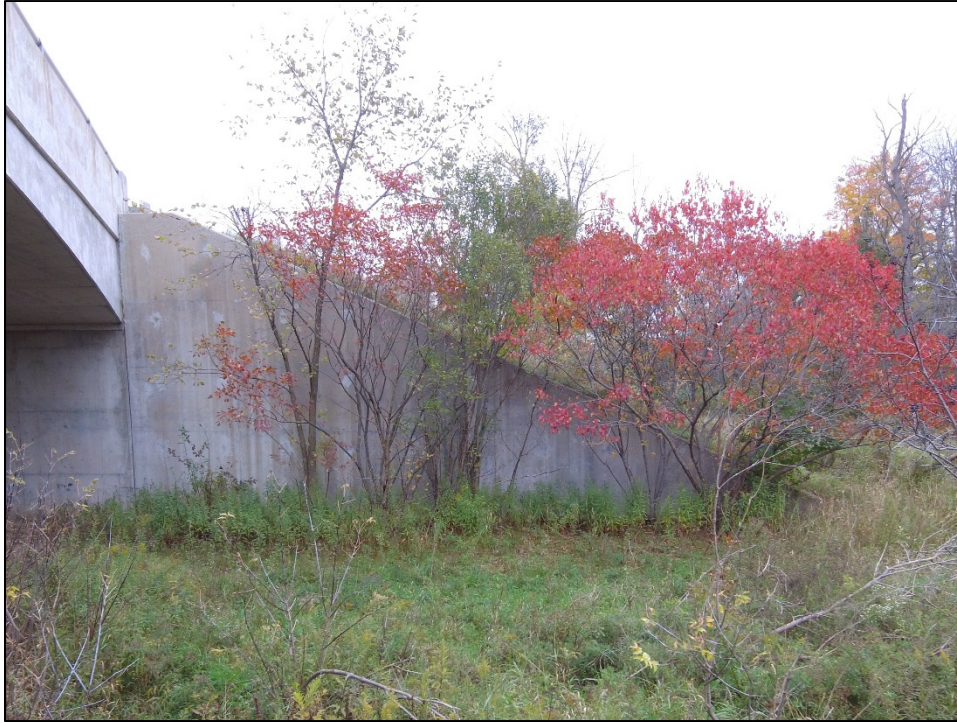
**Photo P31 – Typical Condition of South-East Retaining Wall** (fair condition)

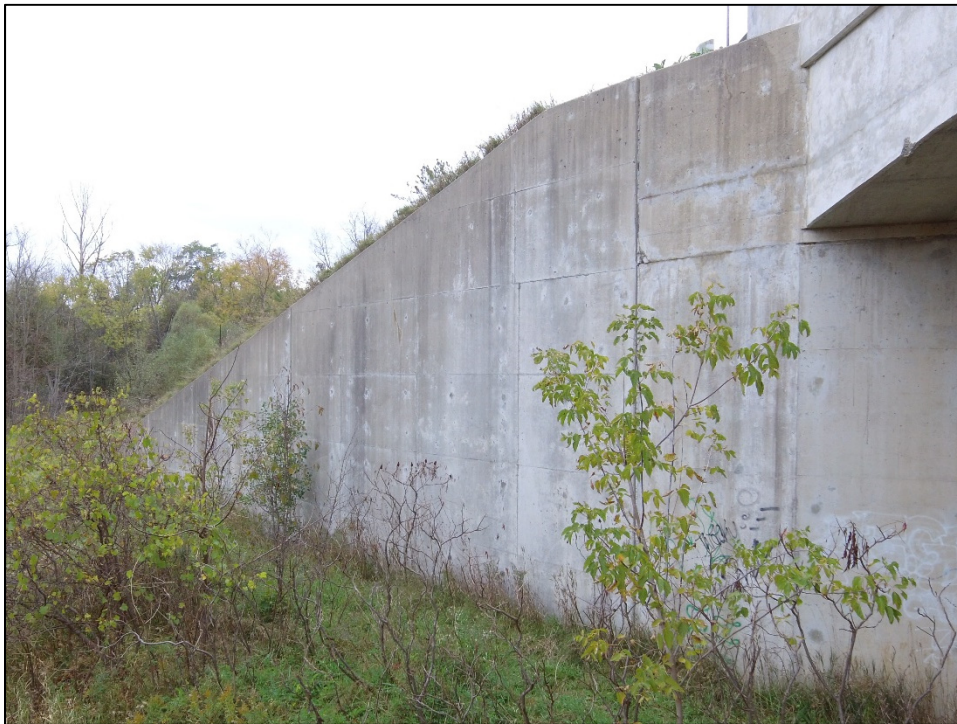
**Photo P32 – Typical Condition of South-West Retaining Wall** (fair condition – cracking)

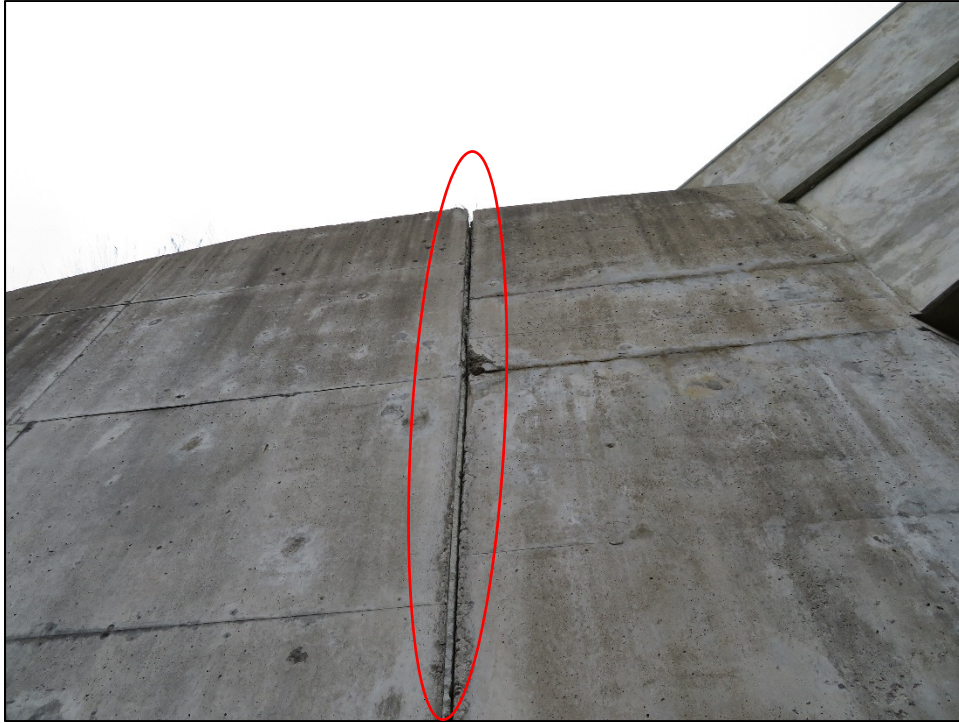
**Photo P33 – Typical Condition of South-West Retaining Wall** (fair condition – movement)

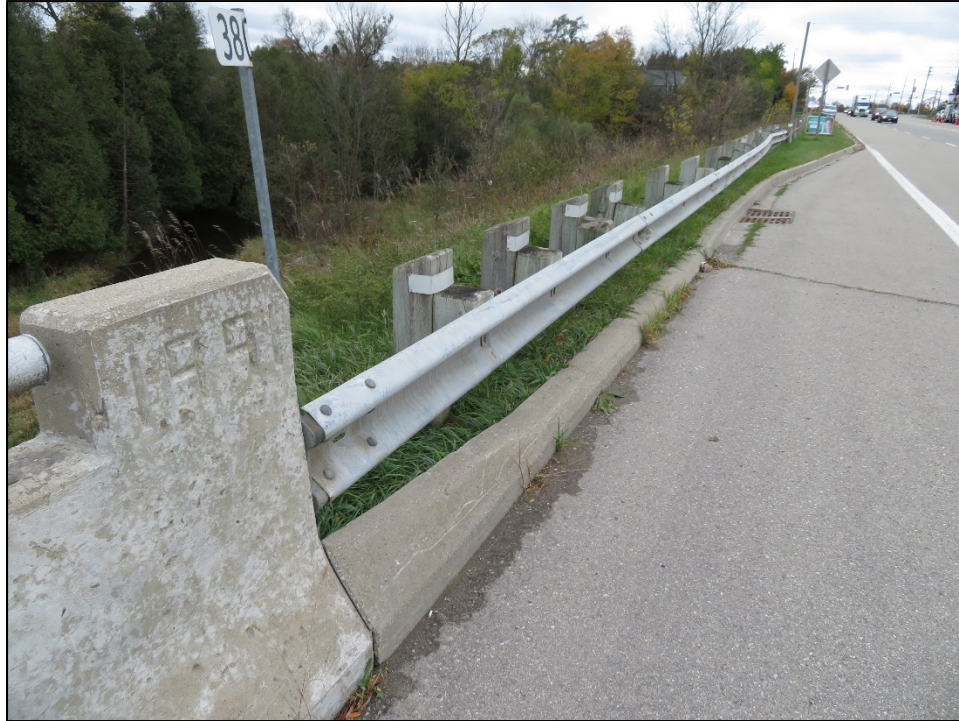
All the galvanized steel guiderails located on each of the quadrants of the structure were typically in fair condition, as shown in Photos P39 to P43. There was some minor impact damage on the guide rails and the connection to the barrier wall end posts was separating.

**Photo P39 – Typical Condition of South-West Guiderail** (connection to end post is separating)

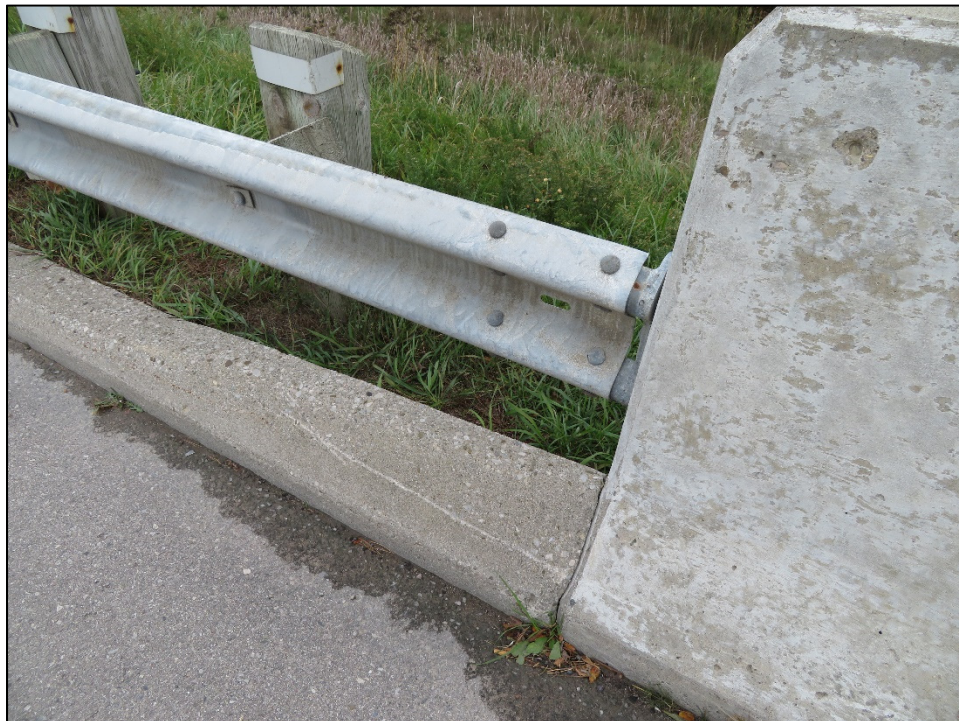
**Photo P40 – Typical Condition of South-East Guiderail** (connection to end post is separating)

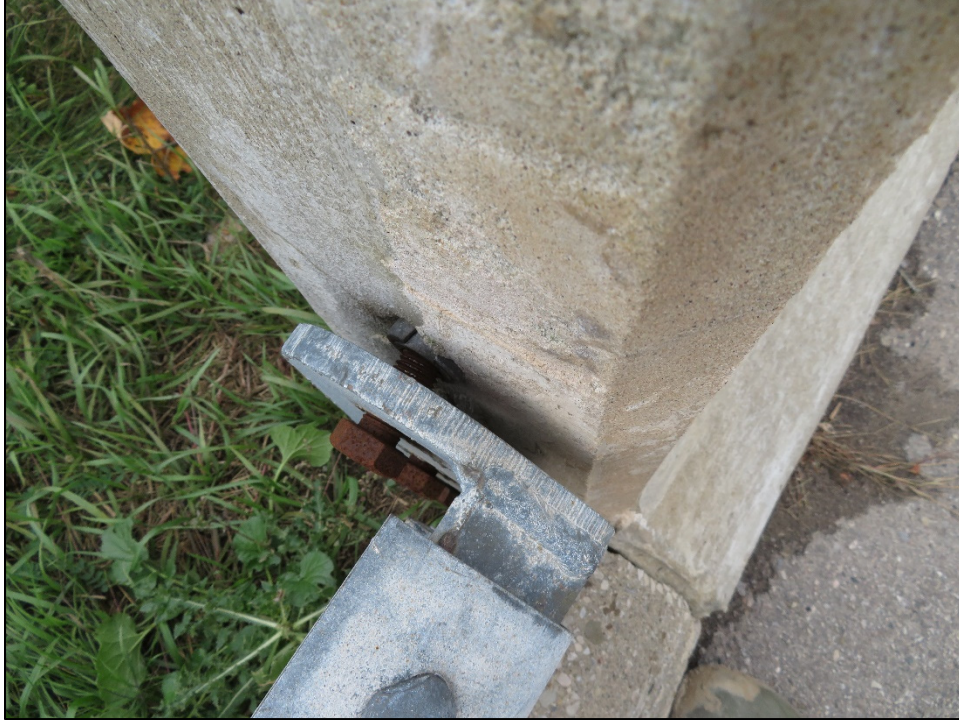
**Photo P41 – Typical Condition of North-West Guiderail** (connection to end post is separating)

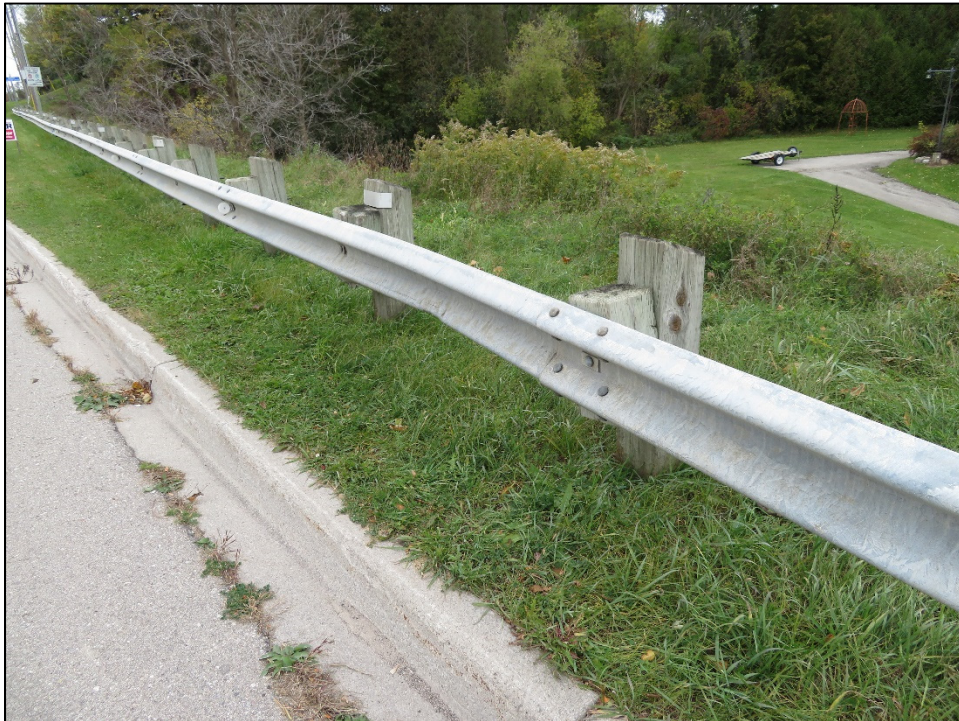
**Photo P42 – Typical Condition of North-West Guiderail** (minor impact damage)

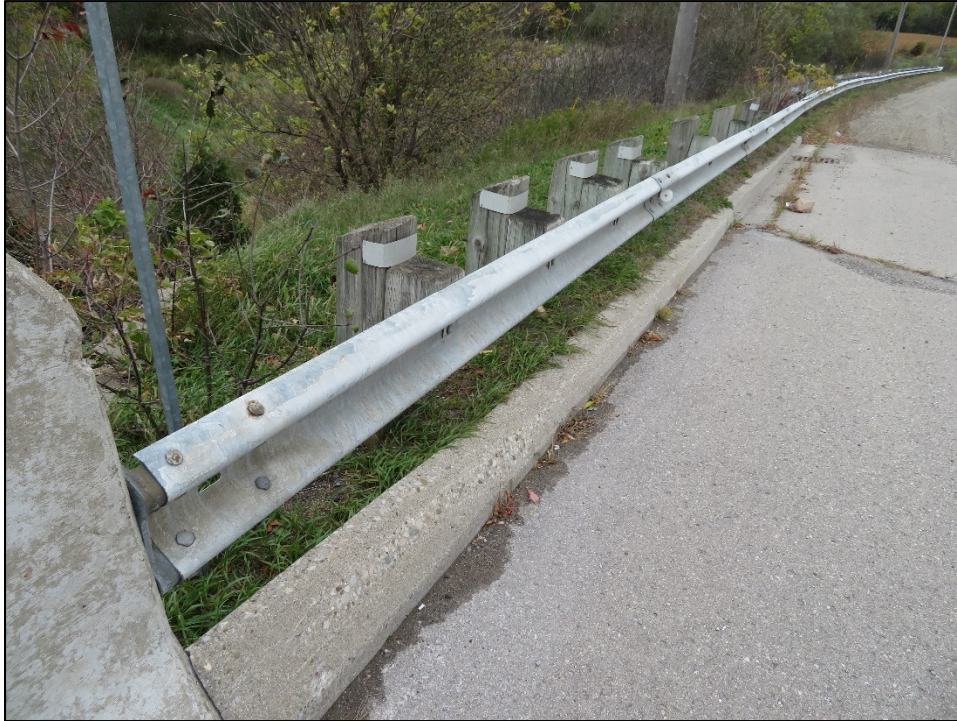
**Photo P43 – Typical Condition of North-East Guiderail** (connection to end post is separating)
