# West Montrose Covered Bridge

## Preservation Plan

Submitted to The Regional Municipality of Waterloo  
by IBI Group

April 2014

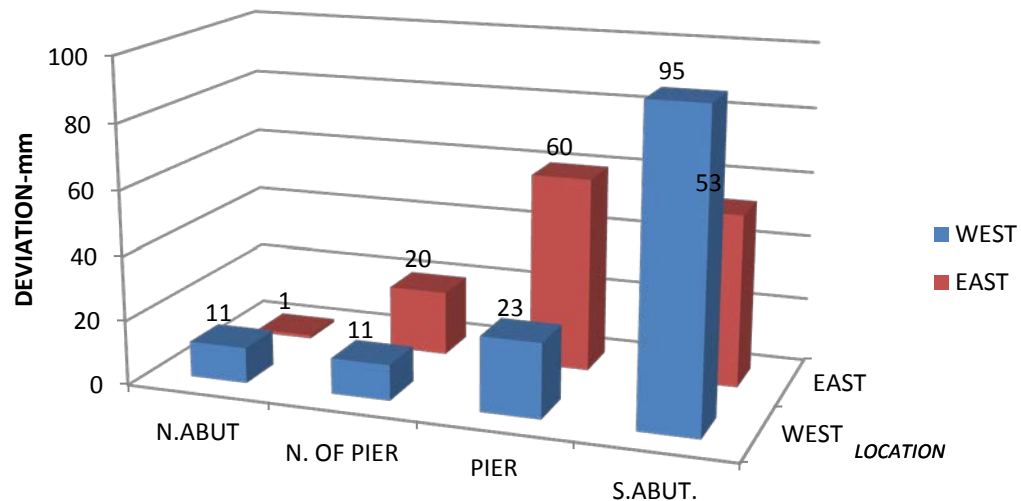
**Figure 1 Horizontal Deflection of Bailey Truss's Top Chord**

In addition any horizontal deflection of Bailey truss top chord with respect to the bottom chord (i.e. out of plumb of the truss) was measured at these locations. The results varied from a low value of 1 mm to a high 60 mm (Fig.1). Almost all showed the top chord movement to be in the easterly direction.

- Bailey trusses are generally in good condition; however, high out of plane deviation toward east especially (up to 95 mm for South west top chord as mentioned earlier) affects the general stability of truss and should be addressed in next maintenance work.

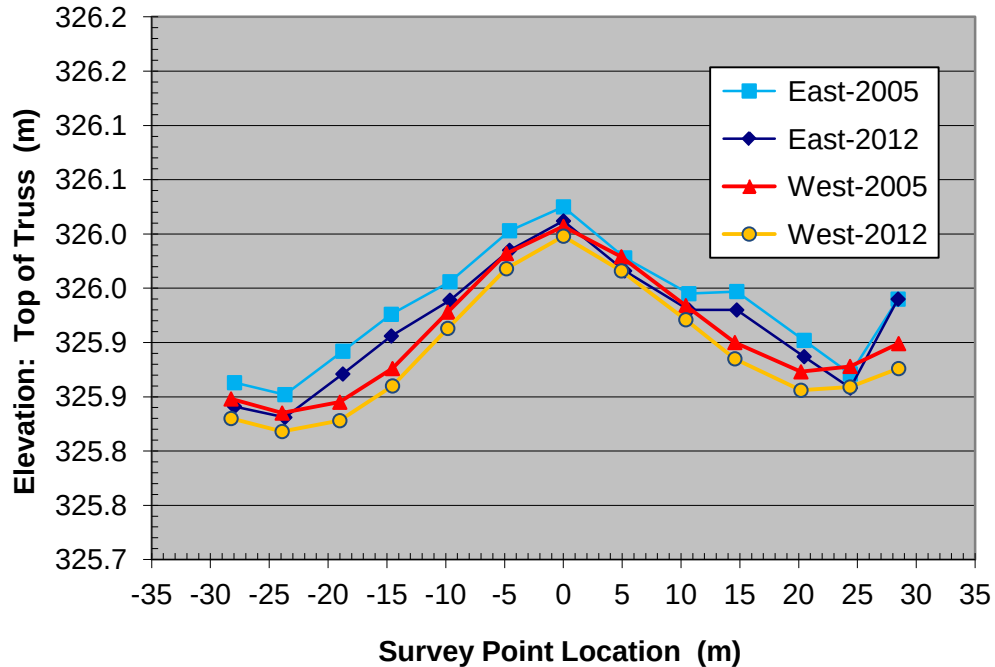
Figure 2 West and East Bailey Trusses Deflection in 2005 and 2012

The vertical deflection curve of the West Bailey truss is uniform and considered reasonable. However discontinuities were noted in the deflection curve of the east Bailey truss. Therefore the east bailey was exposed at the apparent discontinuity and inspected for any pin/weld failure. No significant problems were detected in the Bailey truss assembly.

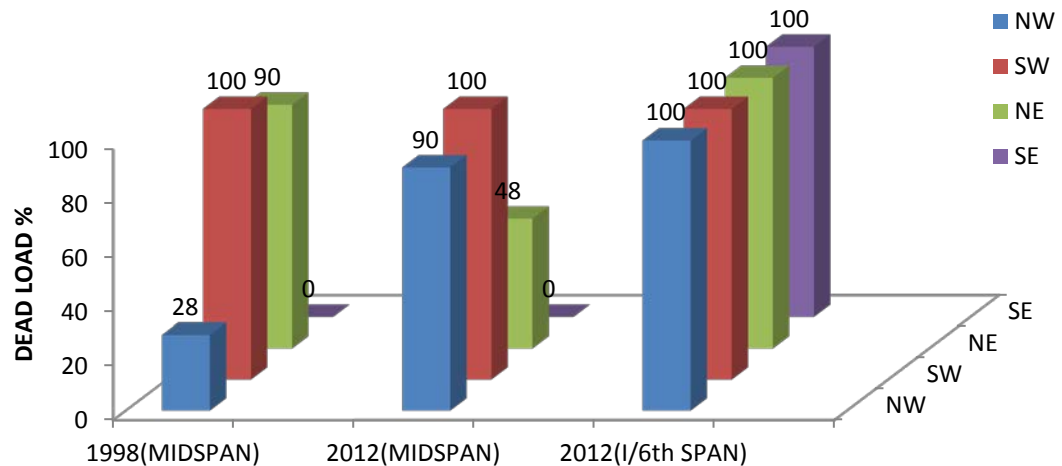
**Figure. 3 Bailey Truss Dead Load Carrying Percentages 1998 and 2012**

Based upon the theoretical deflection curves for the Bailey Trusses compared to observed vertical deflections it is concluded that the west Bailey Truss system is now carrying the total dead load of the structure with little contribution from the original west timber truss systems. The east load distribution is less distinct due to apparent anomalies in the deflection curves. Deflections should be monitored on a regular basis until the anomalies have been rationalised. The current observations were also compared with the assessments carried out in 1998. It is noted that overall deflections have increased, which is indicative of a load shedding from the timber trusses to the Bailey systems

Note -1/6 span point represents location of apparent discontinuity in east truss

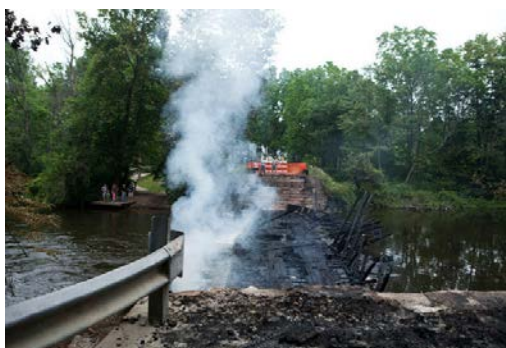
Pictured here are the remains of the White's Road Bridge, Michigan's oldest covered bridge, following arson set fire in July of this year. At least two other US bridges were lost this year due to fire. Similar losses have occurred in both Quebec and New Brunswick.

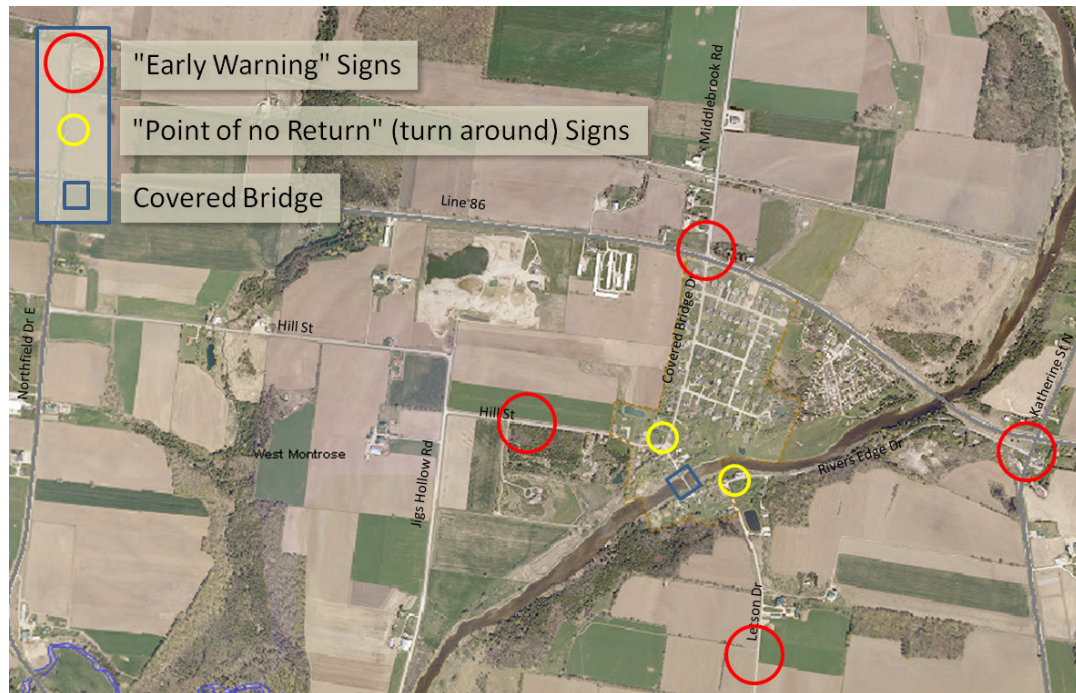
The vehicle operator has limited options when reaching the regulatory signs. It has been agreed that advance warning signs be improved to clearly identify the constraints ahead in sufficient time for the operators to take an alternative route. In addition it has been agreed to add advisory signs to identify "point of no return" (turn around signs). Conceptual overviews of the proposed/required improvements are shown below.

The signage details for the foregoing improvements are currently being developed for implementation in the near future.

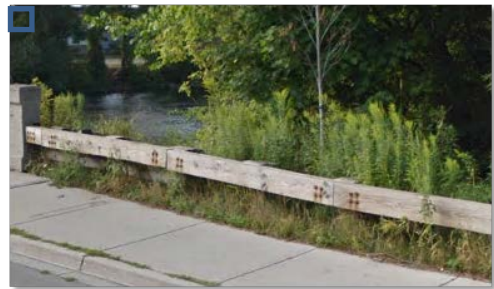
The cable system is considered insufficient protection on the approaches and should be replaced by a code compliant barrier system. Such a system would also provide a more significant fall protection for the public and reduce the region's exposure to risk. An appropriate timber system was utilized by the Region at the Mill Race bridge improvements in Cambridge.
