February 6, 2019

File: 11680

**THE SHORES PHASE 1 DEVELOPMENT, SECHELT, B.C.  
GEOTECHNICAL COMMENTS ON SINKHOLE RISK MANAGEMENT**

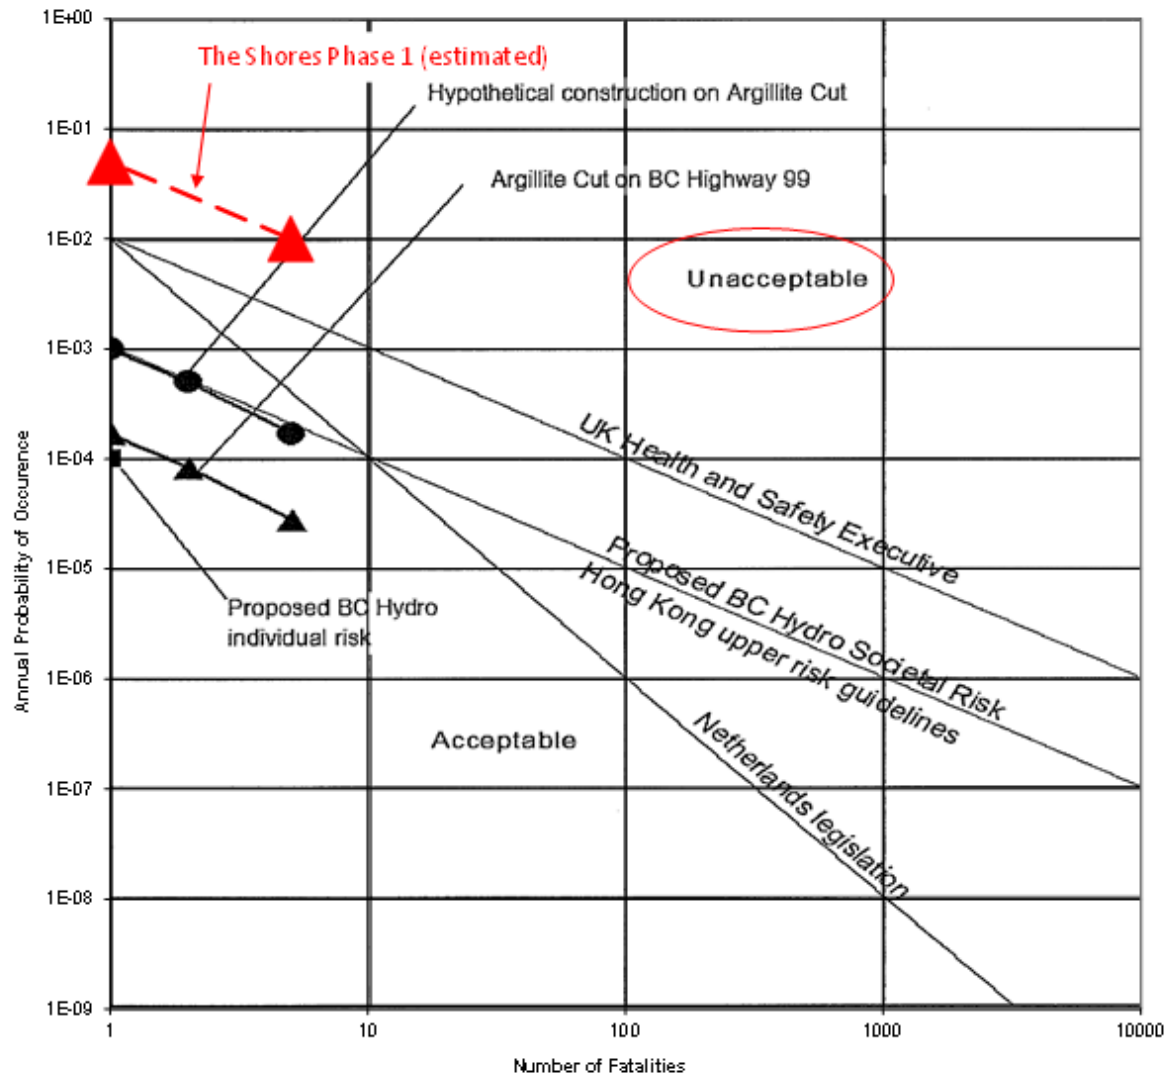
Figure 3. Societal Acceptance of Risk Comparison

This recommendation is supported by a comparison of the estimated risk with criteria for acceptable societal risk in various jurisdictions including public entities in BC. We estimate that the annual probability of sinkhole collapse is 1 which is supported by the recent history of the site. The probability of a fatality associated with a sinkhole collapse is difficult to quantify. Assuming an annual probability of a fatality associated with a collapse is between 1 in 20 and 1 in 100, this results in an estimated annual probability of a sinkhole collapse resulting in a fatality of between 1 in 20 (5 E-2 per annum) and 1 in 100 (1 E-2 per annum). For discussion purposes, the number of fatalities resulting from a single sinkhole collapse could be assumed to be between 1 and 5 (e.g. a full vehicle); however other scenarios are possible. These values are plotted in Figure 3 and fall within the Unacceptable Risk zone.

In consideration of the above, we recommend that the District no longer allow occupancy of the public and private properties and buildings within the Phase 1 site. The high hazard of sinkhole collapse in combination with the consequences of potential injury or death result in a high, and in our opinion, unacceptable level of risk to the public. We confirm we provided this recommendation to the District on February 1, 2019.

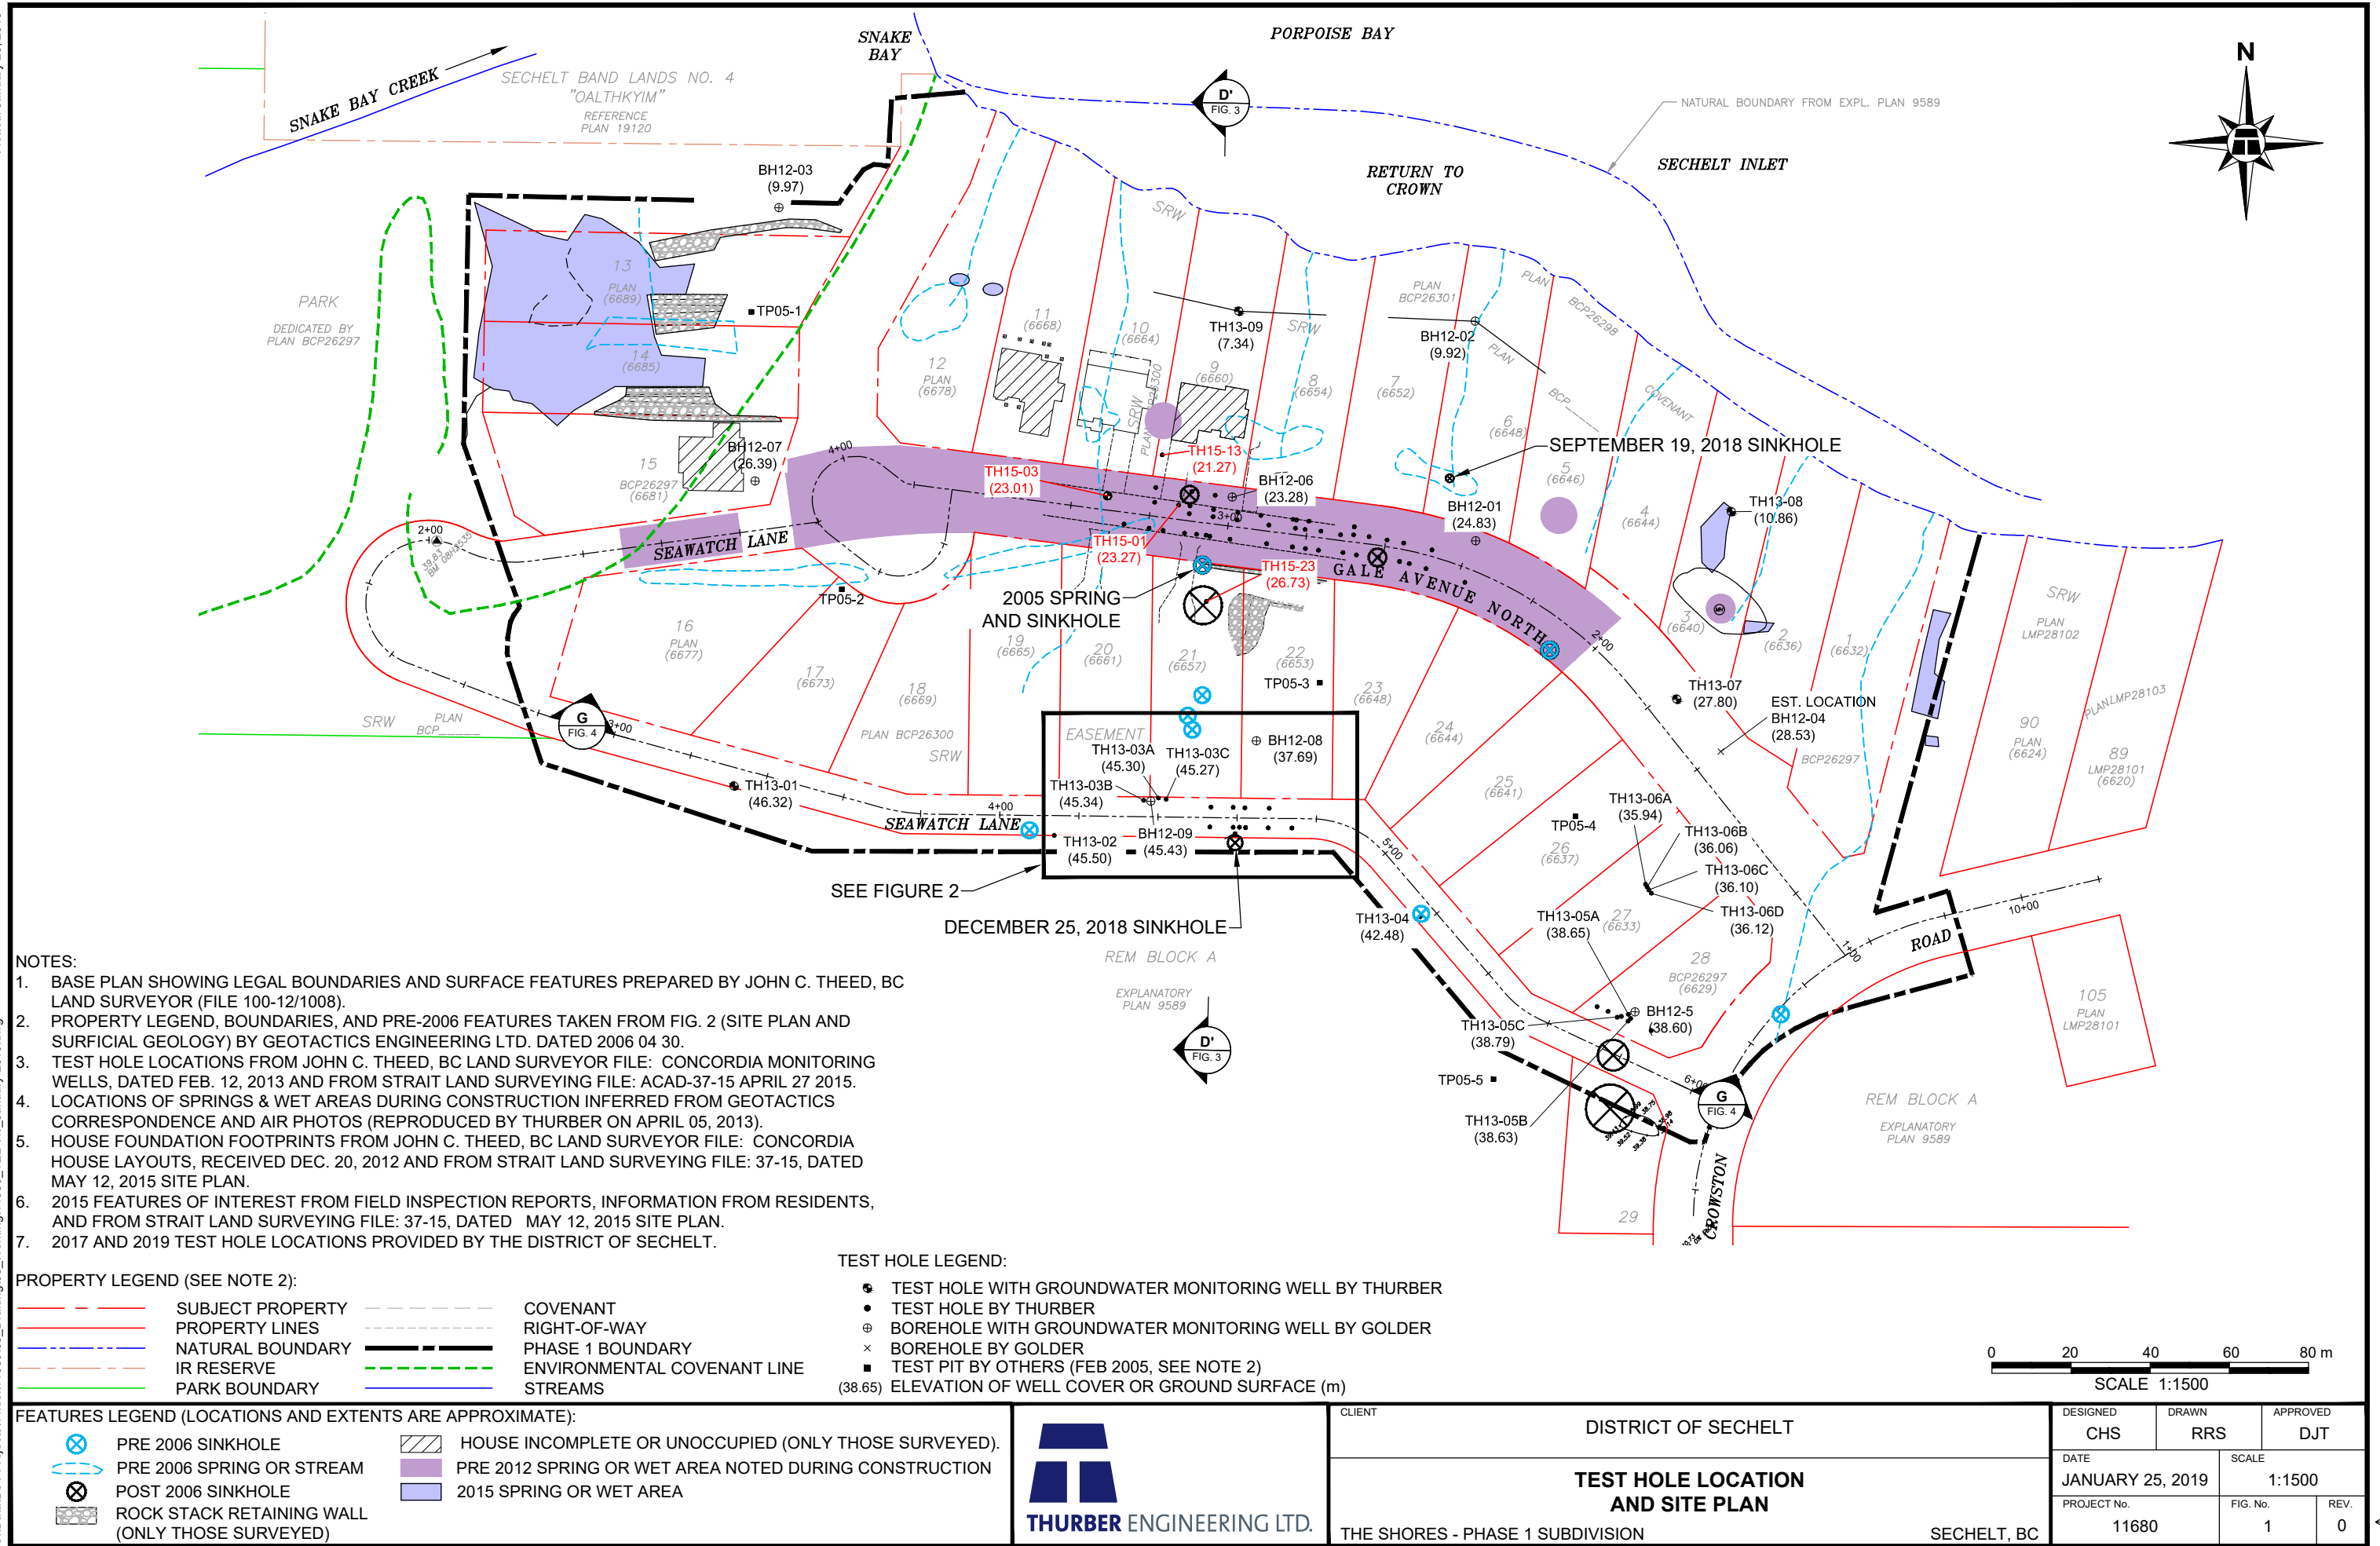
Figure 4. Sinkhole Management Area  
Thurber File: 11680

Figure 4 presents our recommendations for the boundary of the Sinkhole Management Area based on the currently available information and understanding of the sinkhole hazards. This boundary includes a precautionary geotechnical setback from known sinkhole areas because the extents of the subsurface erosion have not been confirmed on the neighbouring properties.

It is possible that this boundary does not include the full area currently affected by the sinkhole development process or that the subsurface erosion could spread beyond this boundary in the future. The limits of the boundary may need to be extended in the future. The low-density zoning of the existing rural developments south of the Sinkhole Management Area boundary should be maintained to avoid increasing risk exposure.

Further to the recommendations of our July 11, 2017 memorandum, land use and water management restrictions should be implemented within the Sinkhole Management Area to reduce the infiltration of stormwater into the ground to pre-development levels. We suggest that the restrictions include:

- Deforestation and clearing of vegetation should be prohibited. Revegetation of areas already cleared should be implemented to the extent possible.
- All existing and proposed ponds and stormwater ditches including the east Crowston Road ditch should be lined at the base and sidewalls. Ponds should be decanted into the stormwater system to reduce their storage volume and to mitigate overtopping potential.
- Rock pits or other measures intended to promote the infiltration of stormwater should not be used.
- Discharge of water onto the ground surface including irrigation should be prohibited.

The properties within the Sinkhole Management Area should not be developed with occupied structures without a detailed investigation and assessment of the potential for subsurface erosion and sinkholes at those sites. The assessment must determine how far the subsurface erosion
