CCTV inspection report

Customer: DISTRICT OF SECHELT

Project: SEAWATCH

Road: GALE AVE NORTH, L-100 ROADWAY, L-200 LANEWAY

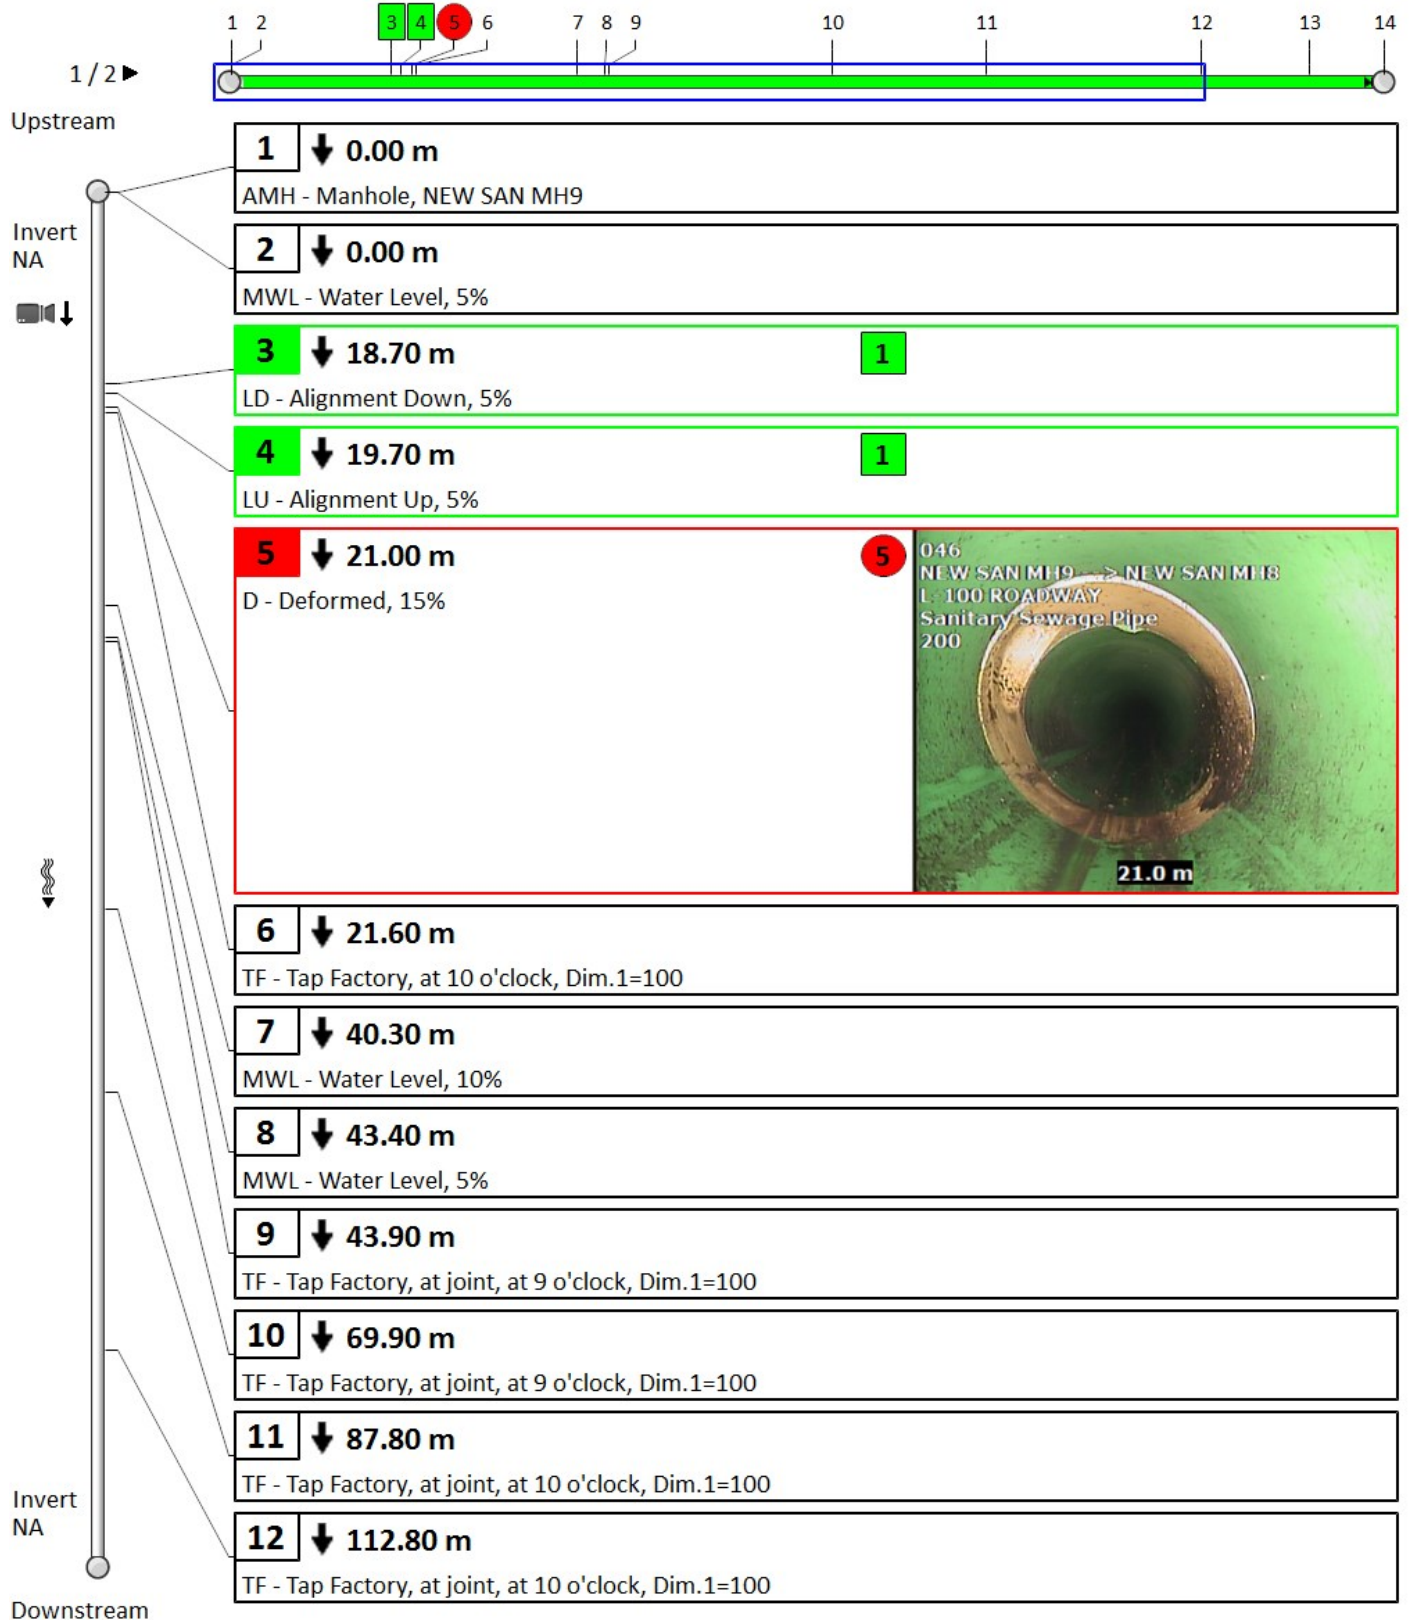
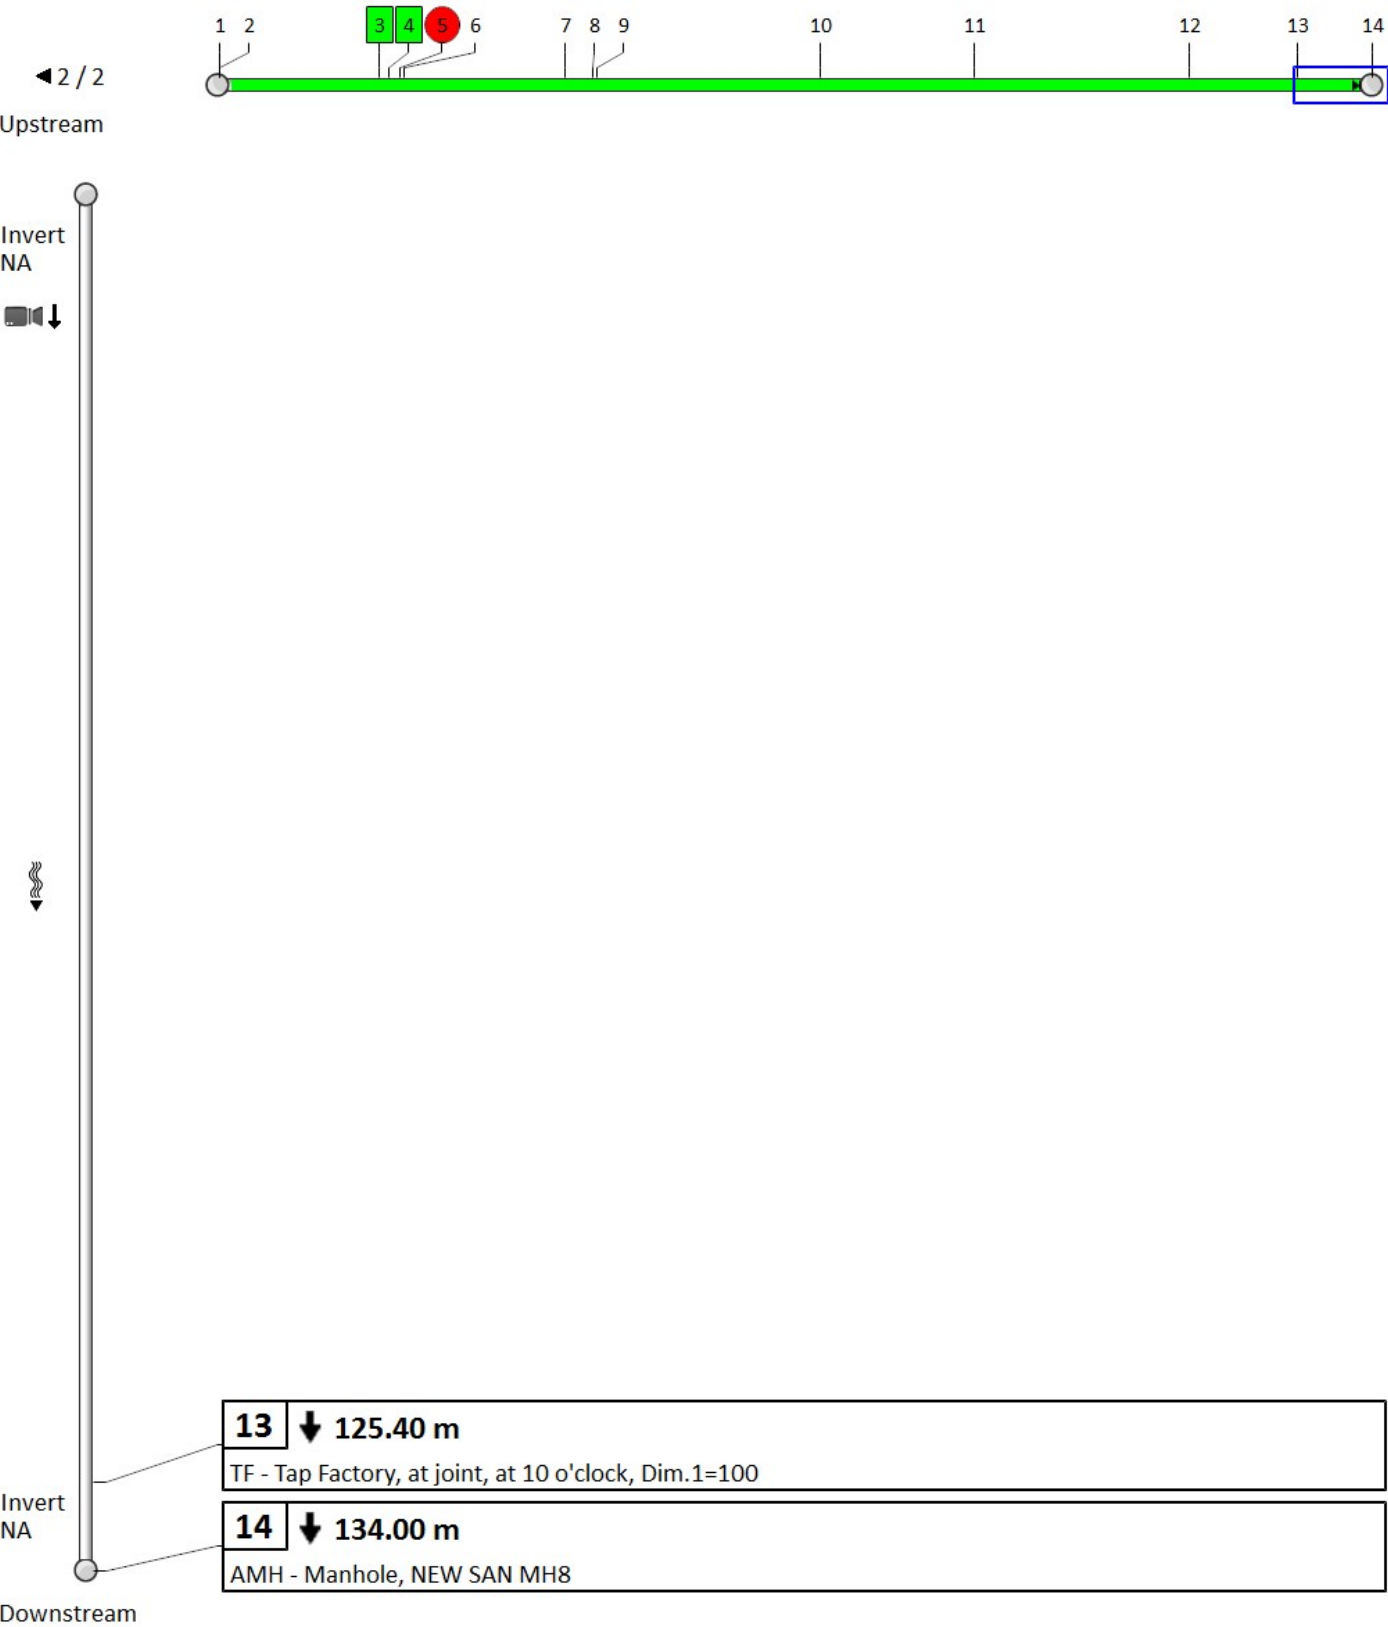
Pipe: 046  
 Direction of flow: NEW SAN MH9 --> NEW SAN MH8  
 Direction of inspection: NEW SAN MH9 --> NEW SAN MH8  
 Direction: Direction of flow

Peak: 5  
 Quick rating: 5100  
 Score: 5  
 Index: 5.0

Peak: 1  
 Quick rating: 1200  
 Score: 2  
 Index: 1.0

Peak: 5  
 Quick rating: 5112  
 Score: 7  
 Index: 2.3

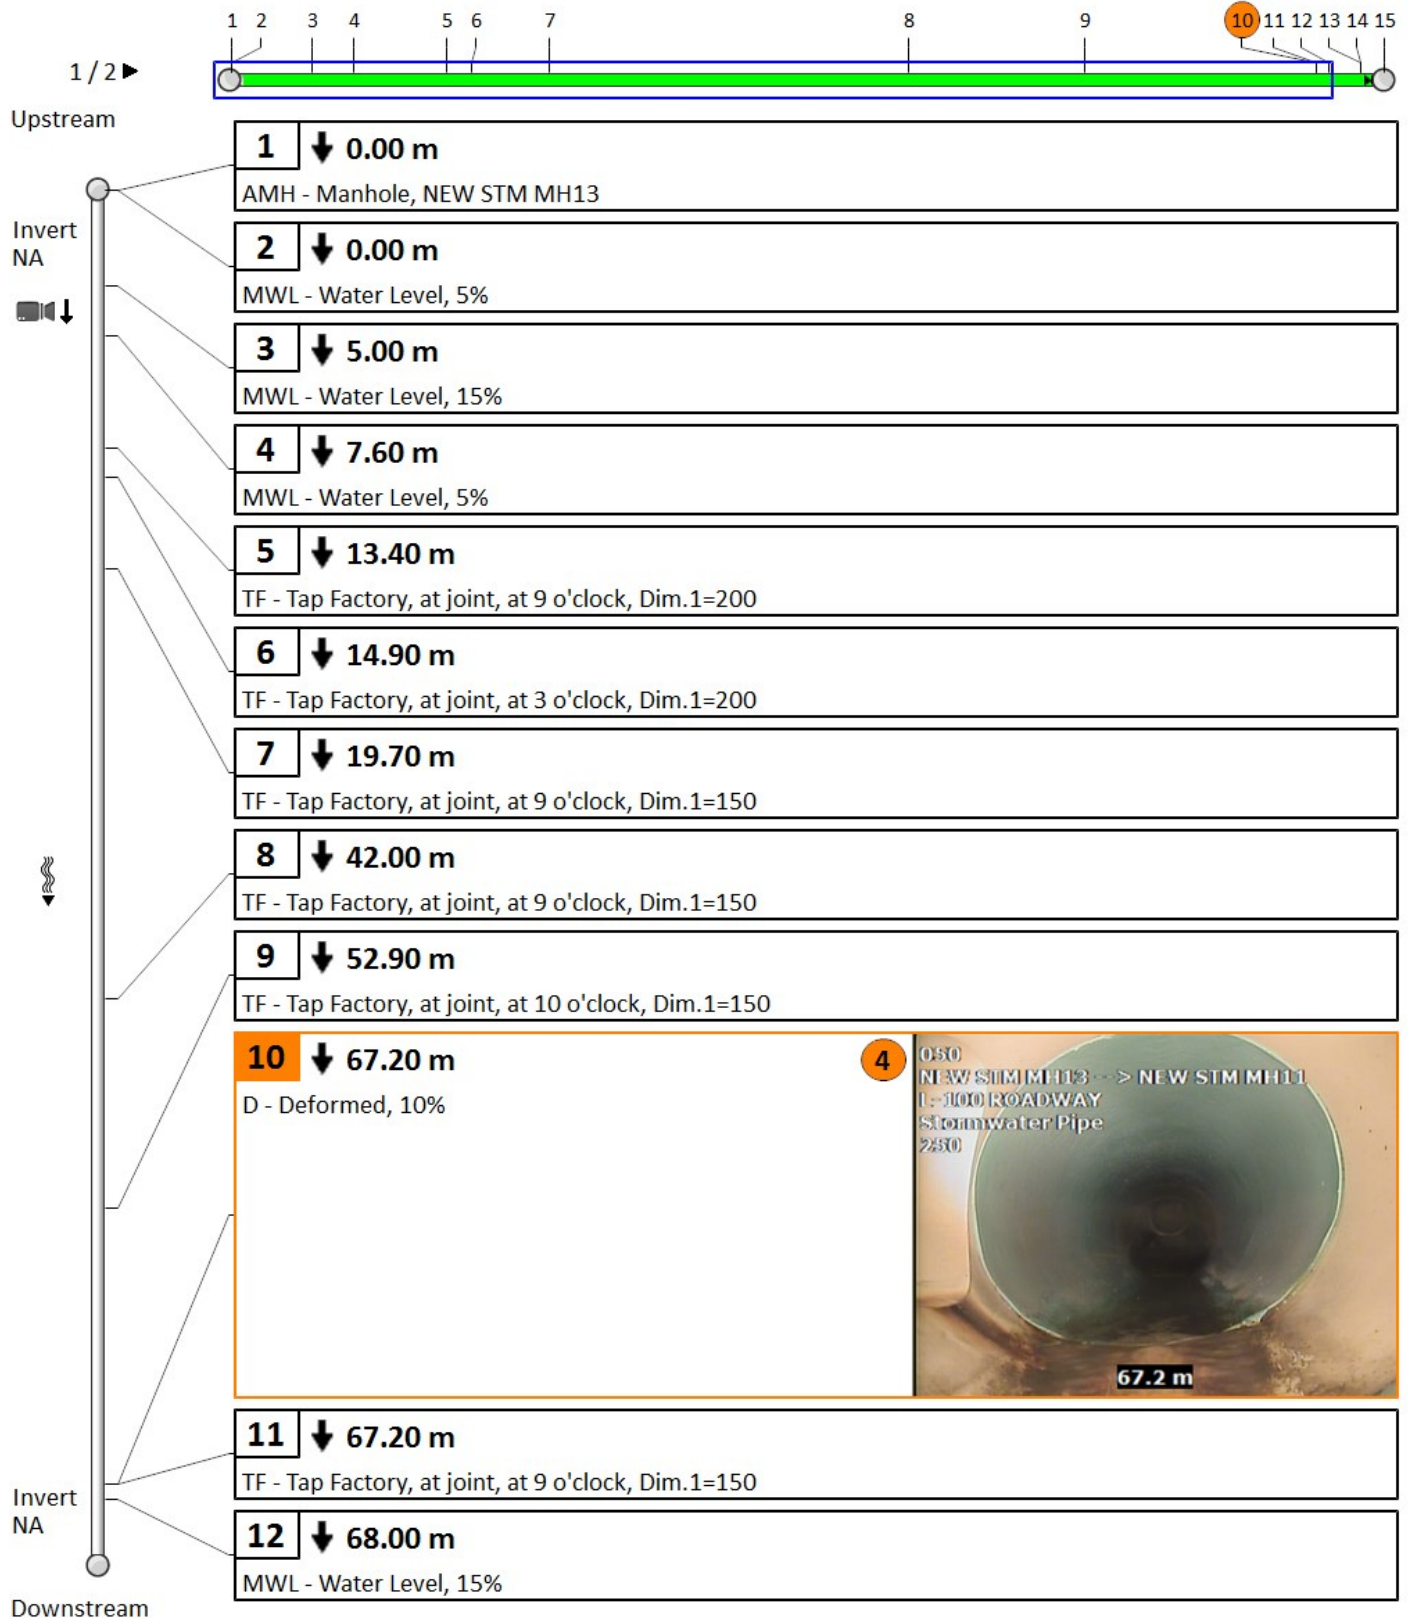
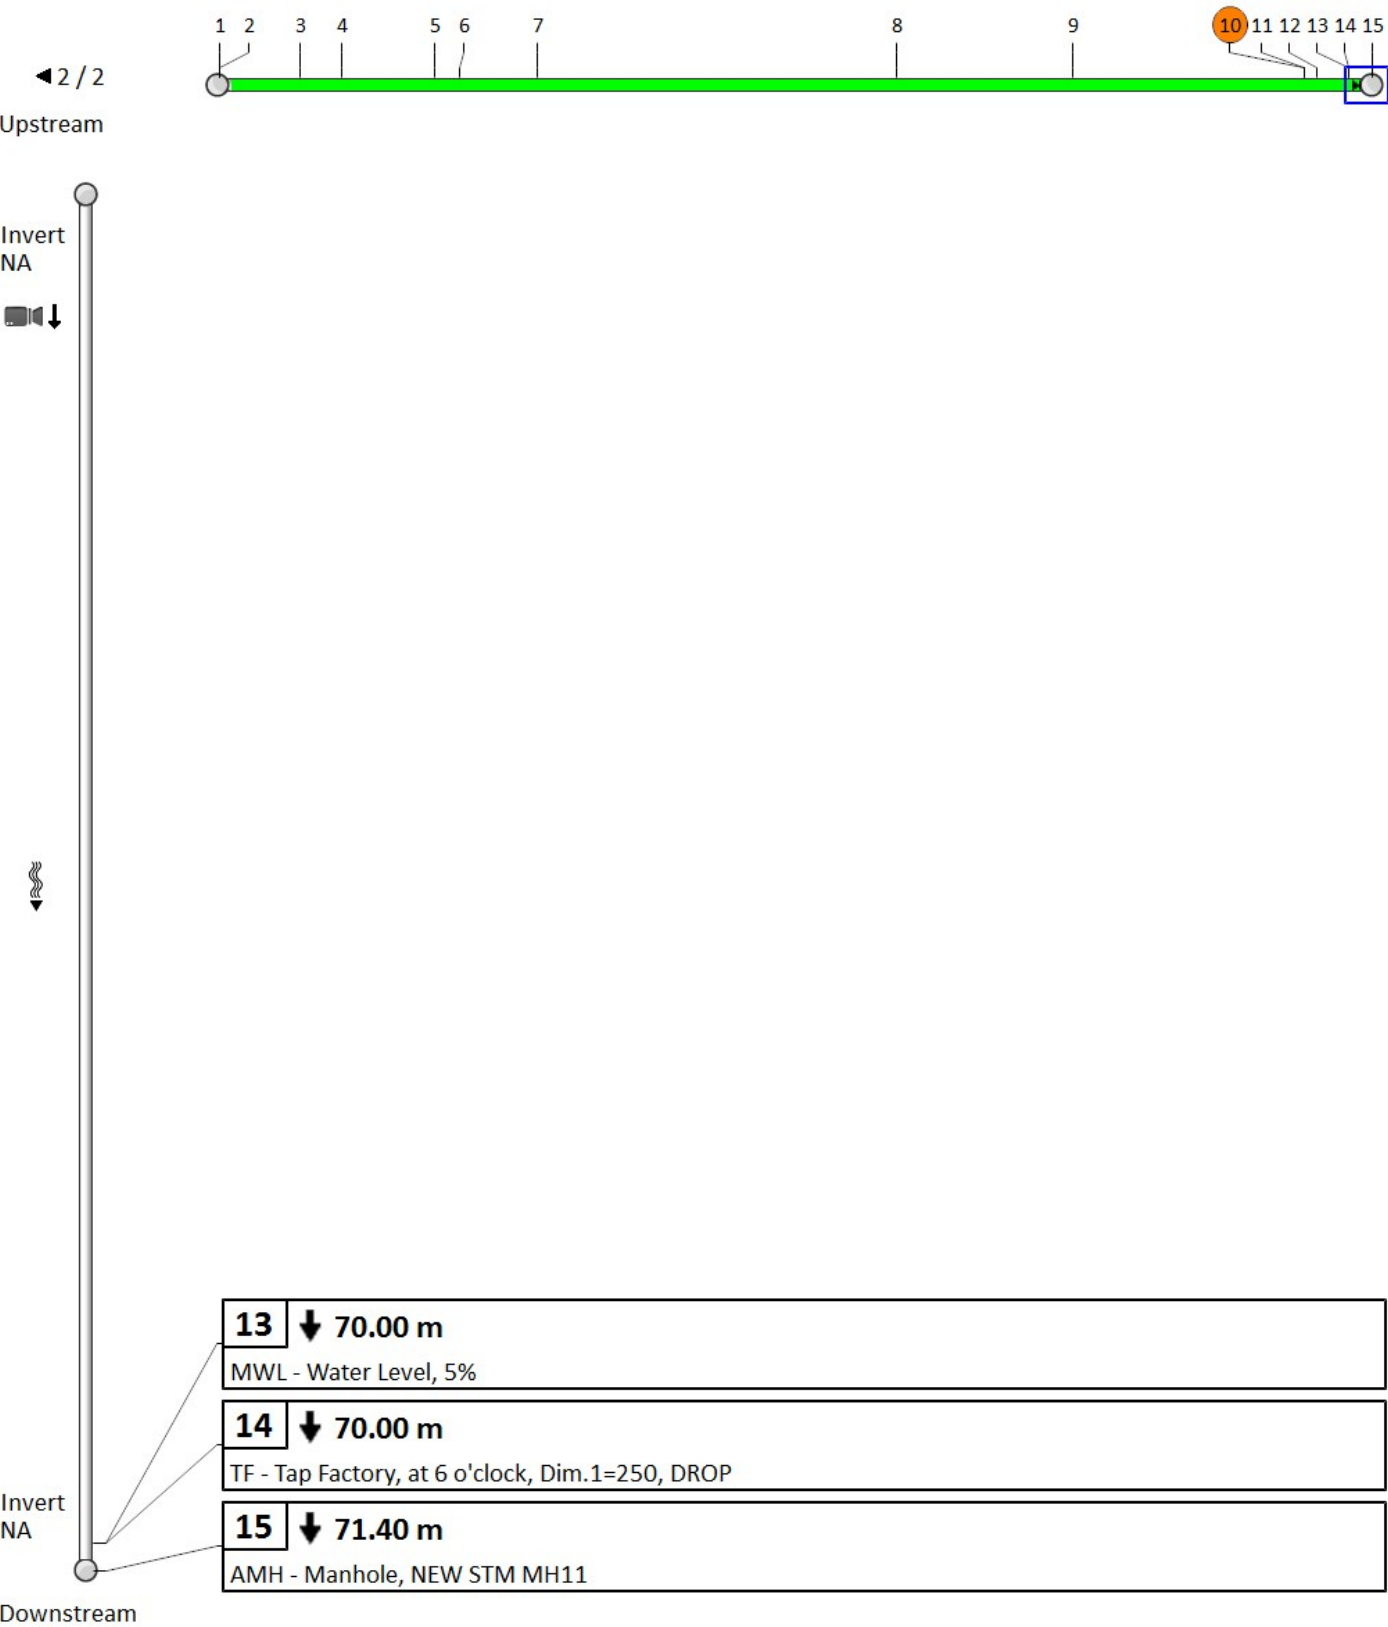
Pipe: 050  
 Direction of flow: NEW STM MH13 --> NEW STM MH11  
 Direction of inspection: NEW STM MH13 --> NEW STM MH11  
 Direction: Direction of flow

| Score | Quick | Index | Pipe | Start/End | Direction | Road | Page |
|---|---|---|---|---|---|---|---|
| 4 | 4100 | 4.0 | 050 | NEW STM MH13 --> NEW STM MH11 | Direction of flow | L-100 ROADWAY | <a href="#">18</a> |
