**KERR WOOD LEIDAL**  
consulting engineers

# Lot 9/10 Stormwater Replacement

Final Report  
November 2018  
KWL Project No. 551.026-300

District of Sechelt

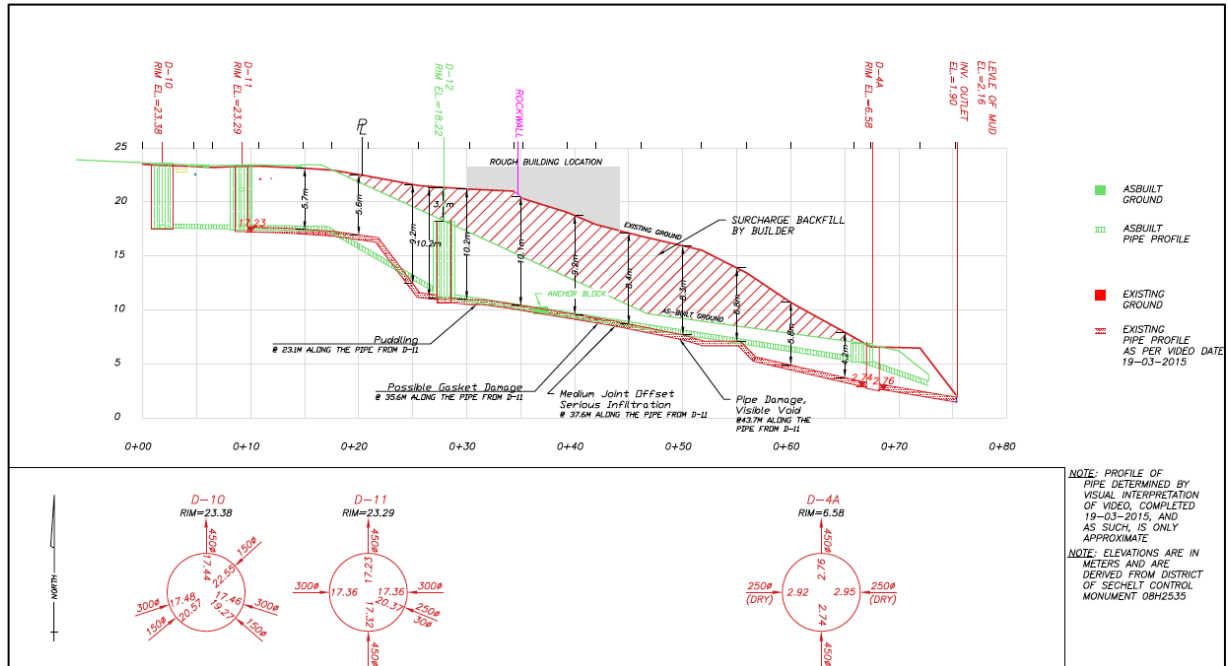
**Figure 3-4: As Built and Existing Profile Views of the Storm Outfall Between Lots 9 and 10 (reproduced from Thurber)**

A subsequent investigation in 2015 confirmed that there is approximately 10 m of cover present in some areas, and one of the manholes (D-12 in Figure 3-4) has been entirely covered. In addition, the

measured storm outfall pipe profile varies considerably from the “as built” information. Some areas are “surcharged” by up to 7 m of fill, and the differences in profile and soil depth are shown in red on Figure 3-4.

Thurber conducted an extensive investigation of site conditions, and in their 2015 report, found that large 12-36 inch rock had been placed above the outfall between Lots 9 and 10 as a working pad for equipment. This, together with excessively high fill levels along the pipeline route were a potential cause of the apparent pipe bending and buckling.

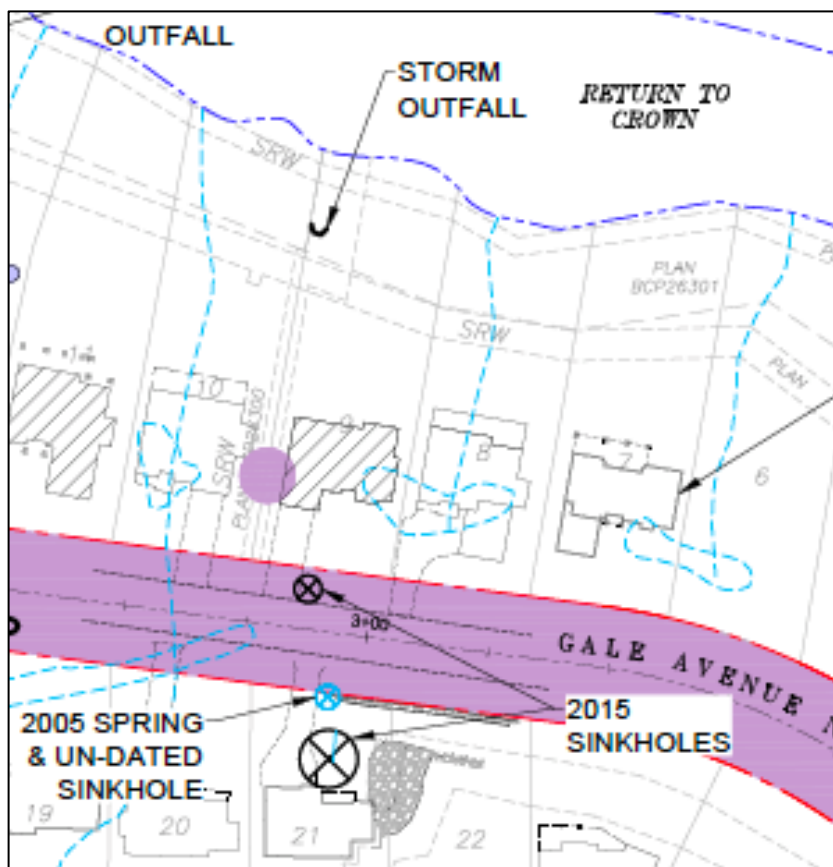
These observations suggest that the stormwater pipe is not currently performing as designed and does not properly convey stormwater and groundwater to Porpoise Bay. It is apparent that there is significant infiltration that brings sediment and fines into the pipeline downstream of manhole D-11. This is most likely causing piping in the soils surrounding the pipe, and could be contributing to the formation of sinkholes in the area. Sinkholes are observed on Lot 21 (across the street from the outfall), and in the front yard of Lot 9 (next to the upstream end of outfall), as depicted in Figure 3-5. Loss of soil via subsurface erosion, piping, and entry into the pipeline should be considered as a contributing factor to subsequent pipe collapse.

Figure 3-5: Sinkholes in the Vicinity of the Stormwater Outfall (reproduced from Thurber)

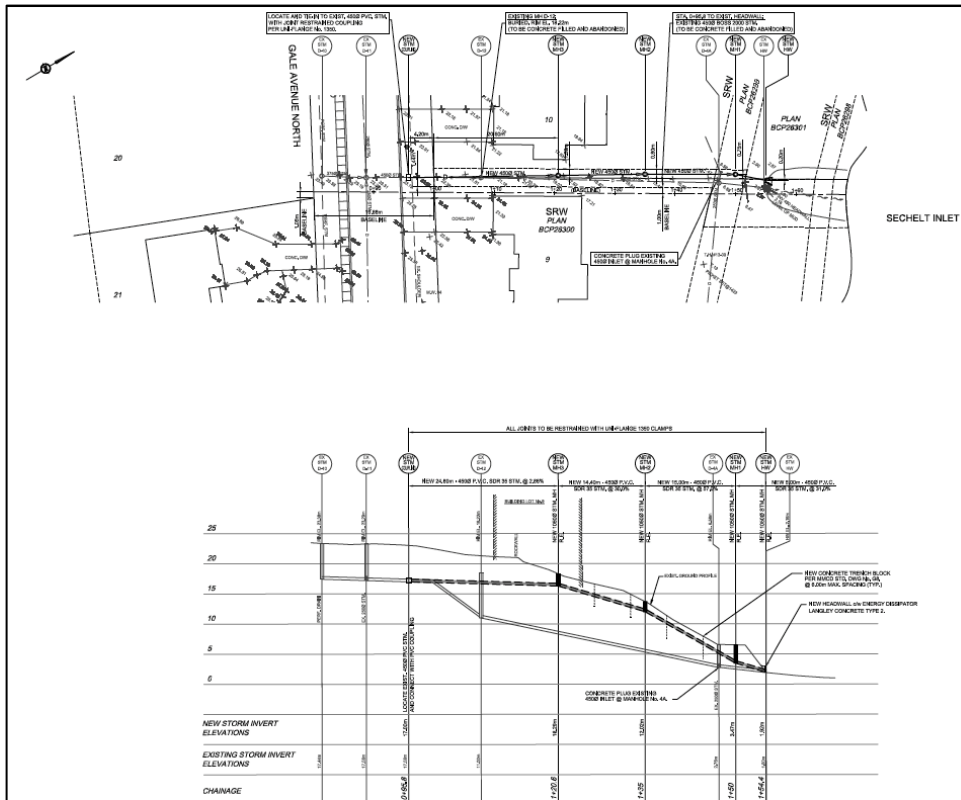
**Figure 5-1: Shallow Storm Outfall Remediation Strategy (as proposed by WEB/Golder)**

Of significance, the profile shows a sharp change in profile to the north of MH 12 at approximate chainage 0+17. This would normally require a manhole to accommodate the change in slope. Since none is shown, the profile information should be considered as suspect.

Option 1 does not address subsurface conditions, and groundwater flows will continue to flow through existing pathways surrounding the pipe. It should be anticipated that the sinkhole forming processes will continue, although at a reduced rate.

- Constructing approximately 60 m of 450 mm dia. SDR 35 PVC replacement storm sewer complete with restraint couplings. The new storm sewer would extend from this tie-in to the existing outfall at a depth between 1 and 6 m from existing ground surface than the existing storm sewer.

- Tie-in to a replacement Type 2 headwall complete with energy dissipator, as supplied by Langley Concrete.
- Finally, the entire existing storm sewer downstream of the tie-in location, together with manholes D-12, and D-4A would be plugged with concrete, as recommended, and as specified by Golder in their April 2, 2015 memorandum.

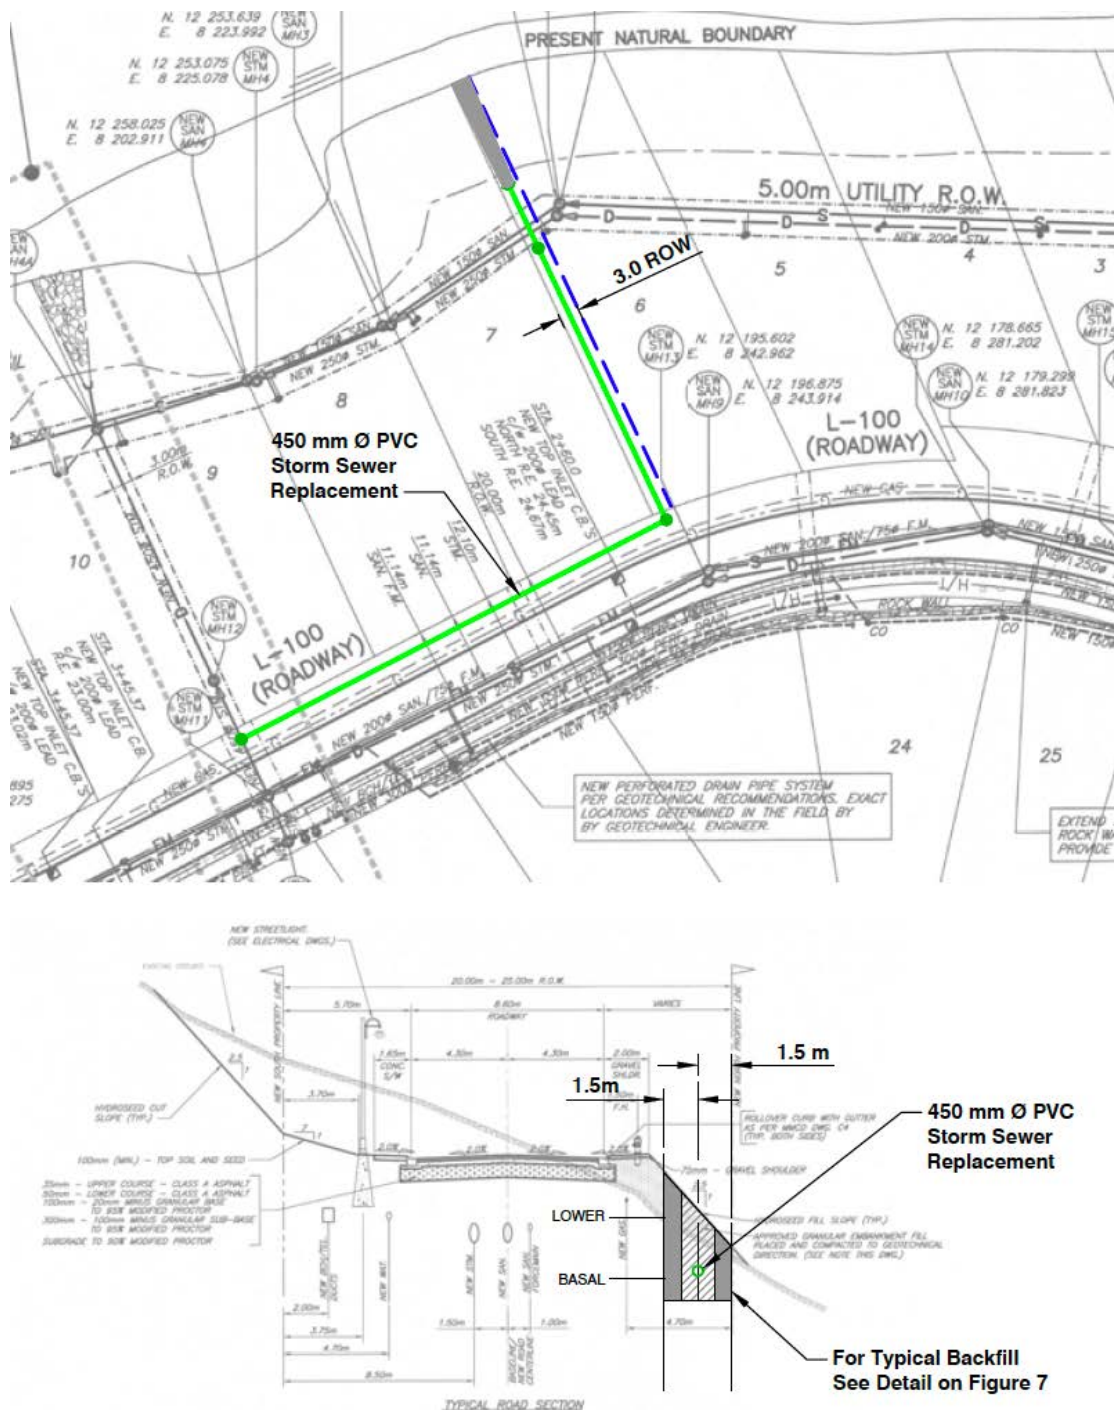
Figure 5-3: Routing Option – Plan and Detail

Option 3 uses a new route that provides an opportunity to permanently control groundwater passage through Lots 9, 8, and 7. Groundwater would be intercepted by the cut-off trench containing the storm sewer, thereby potentially arresting or significantly slowing down the sinkhole forming processes for these lots. This could be expanded to other adjacent lots, and possibly to other areas within the subdivision. In addition, the routing passes through the sinkhole on the south side of Lot 9, and provides an opportunity to make significant repairs as part of the trench backfilling process. It should be noted that while the groundwater cut-off trench will potentially reduce some of the sinkhole forming processes on the north side of the road, it is unknown what effects it may have on the adjacent road. Construction of Option 3 should not be construed as a reason to re-open the road in this vicinity without referring to assessment by a geotechnical engineer.

currently, to be replaced with 1 m/75 m slope in the opposite direction). The remaining 75 m would follow the wider right-of-way to a new outfall. This option would include replacement of two manholes along Gale Avenue North, as well as constructing three new manholes along the ROW, and modification of MH11.

Of significance, the remainder of the pipelines and manholes within the existing right-of-way between Lots 9 and 10 would need to be grouted as per Option 1. This would leave the two “illegal” drain connections disconnected from MH 12. Accordingly, the lines would need to be extended to their respective north boundary stormwater service tie-in locations.

Based on the above discussion, Option 3, despite its higher cost, appears to be the option that satisfies all the selected criteria, has a lot of flexibility in design, and has the potential to provide longer term mitigation to reduce the rate of sinkhole formation at the south boundaries of Lots 9, 8, and 7. Accordingly, Option 3 is recommended as the preferred option to move to the pre-design stage.
