**THURBER ENGINEERING LTD.**

File: 14-214-2

**THE SHORES SUBDIVISION - PHASE 1  
GEOTECHNICAL ASSESSMENT**

As requested, Thurber Engineering Ltd. (TEL) has completed a review of the sinkhole formed on June 1, 2012 and previously reported sinkholes, slope instability, springs and erosion within The Shores subdivision. This letter documents our observations and provides our comments and recommendations.

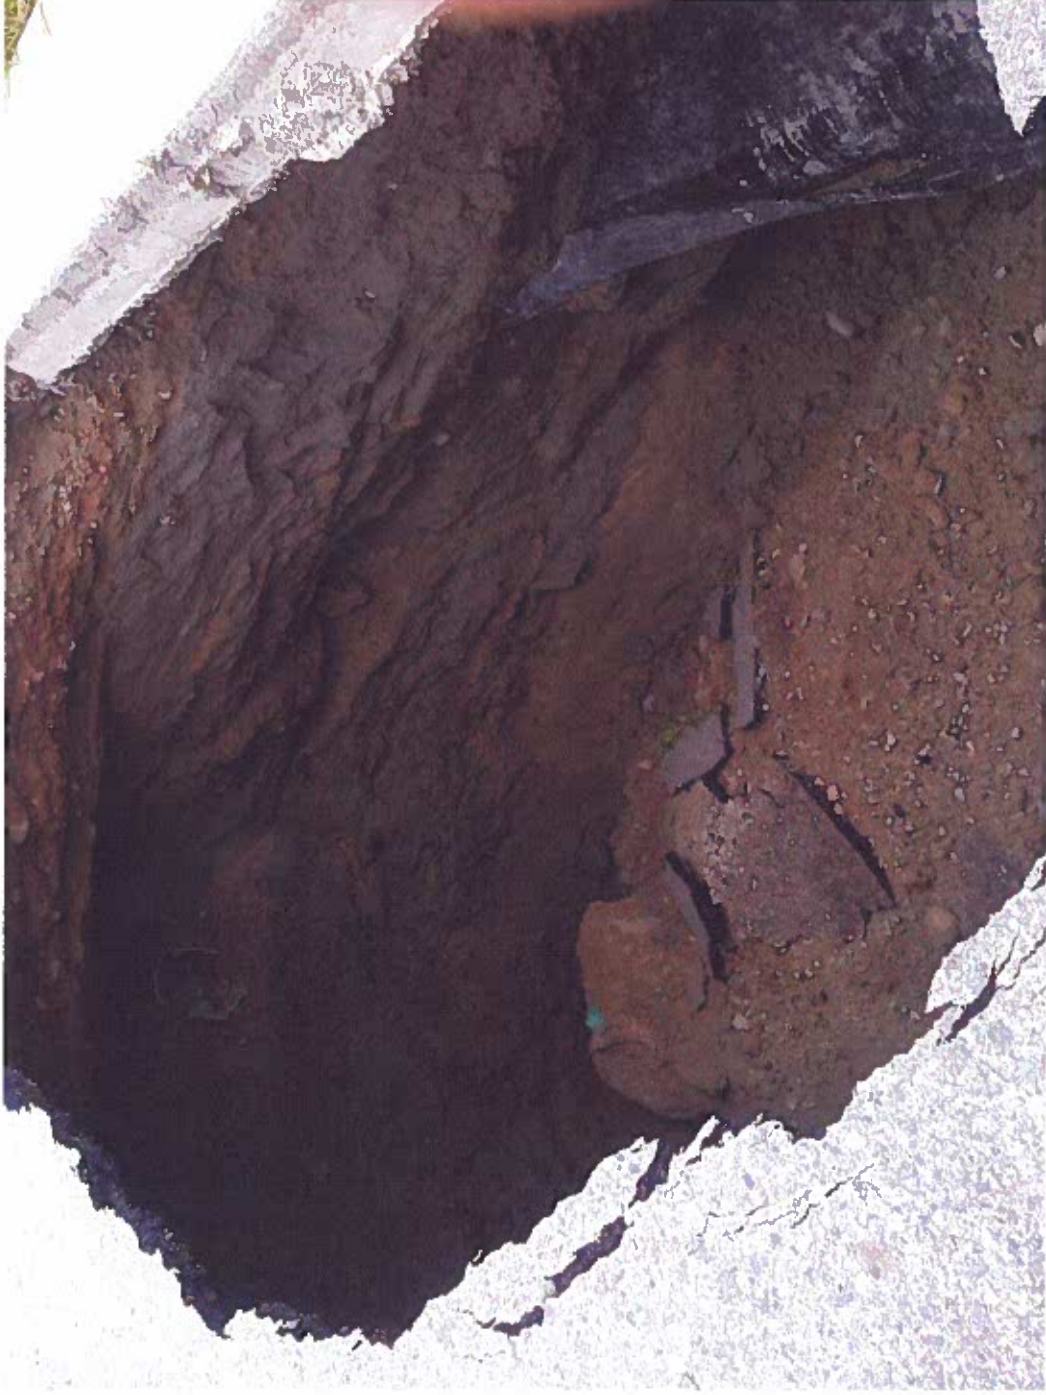
Photo 1. Sinkhole enlarged below asphalt, fabric surround of interceptor drain (near right bottom corner) and broken sanitary sewer (near top centre).

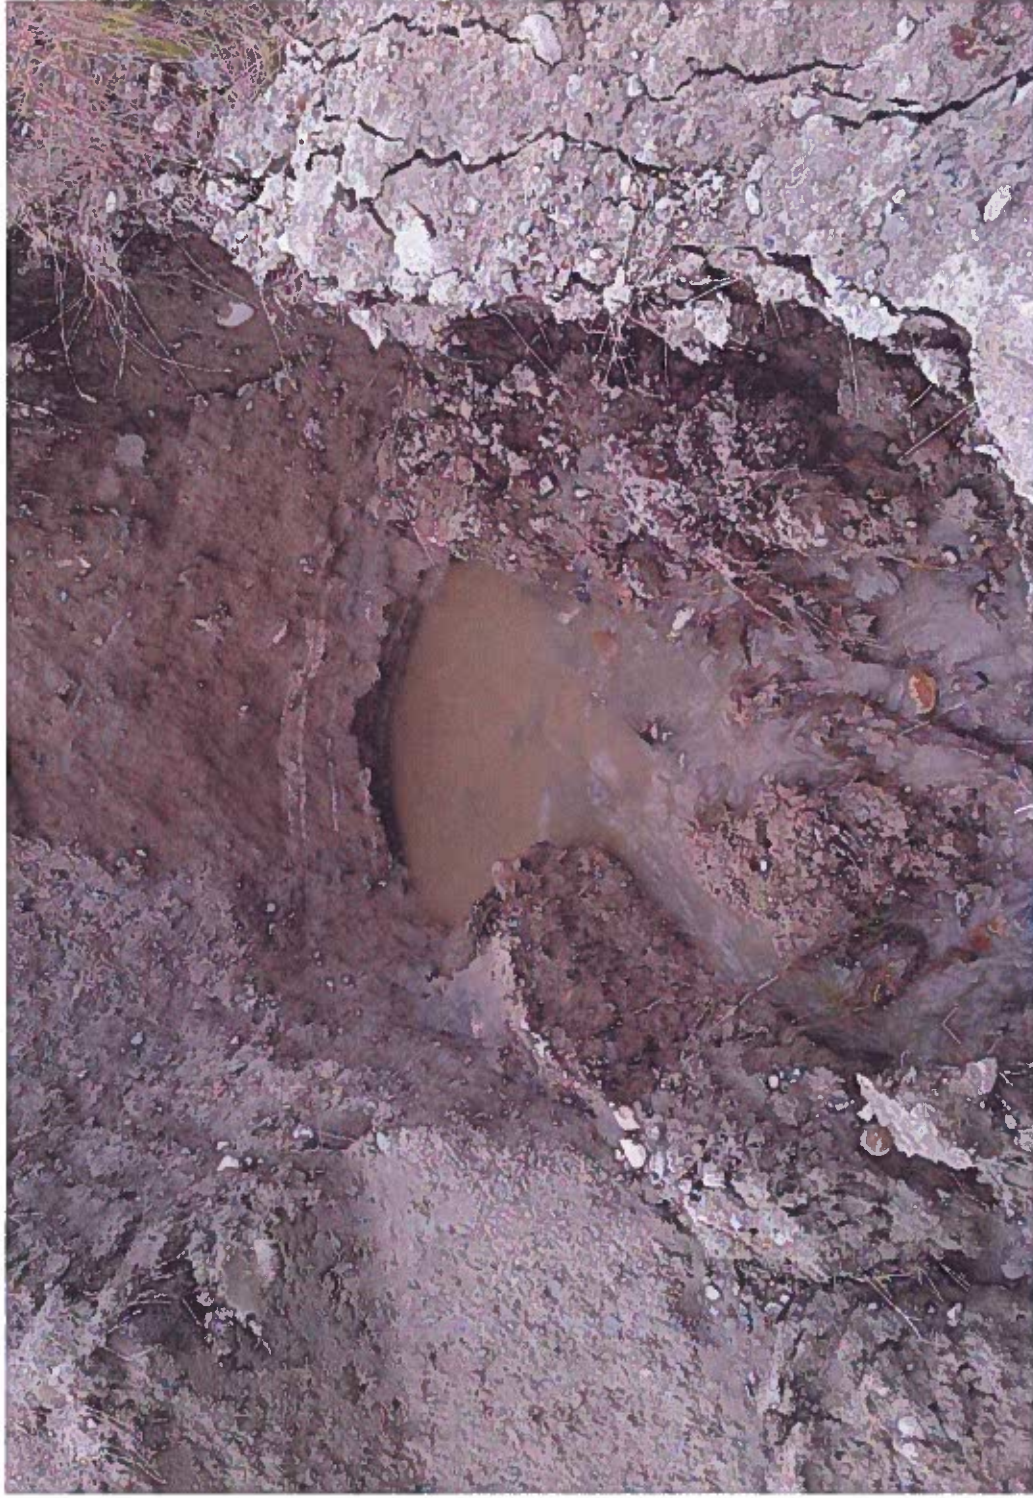
Photo 2. Spring on Lot 2 prior to backfilling with crushed gravel.

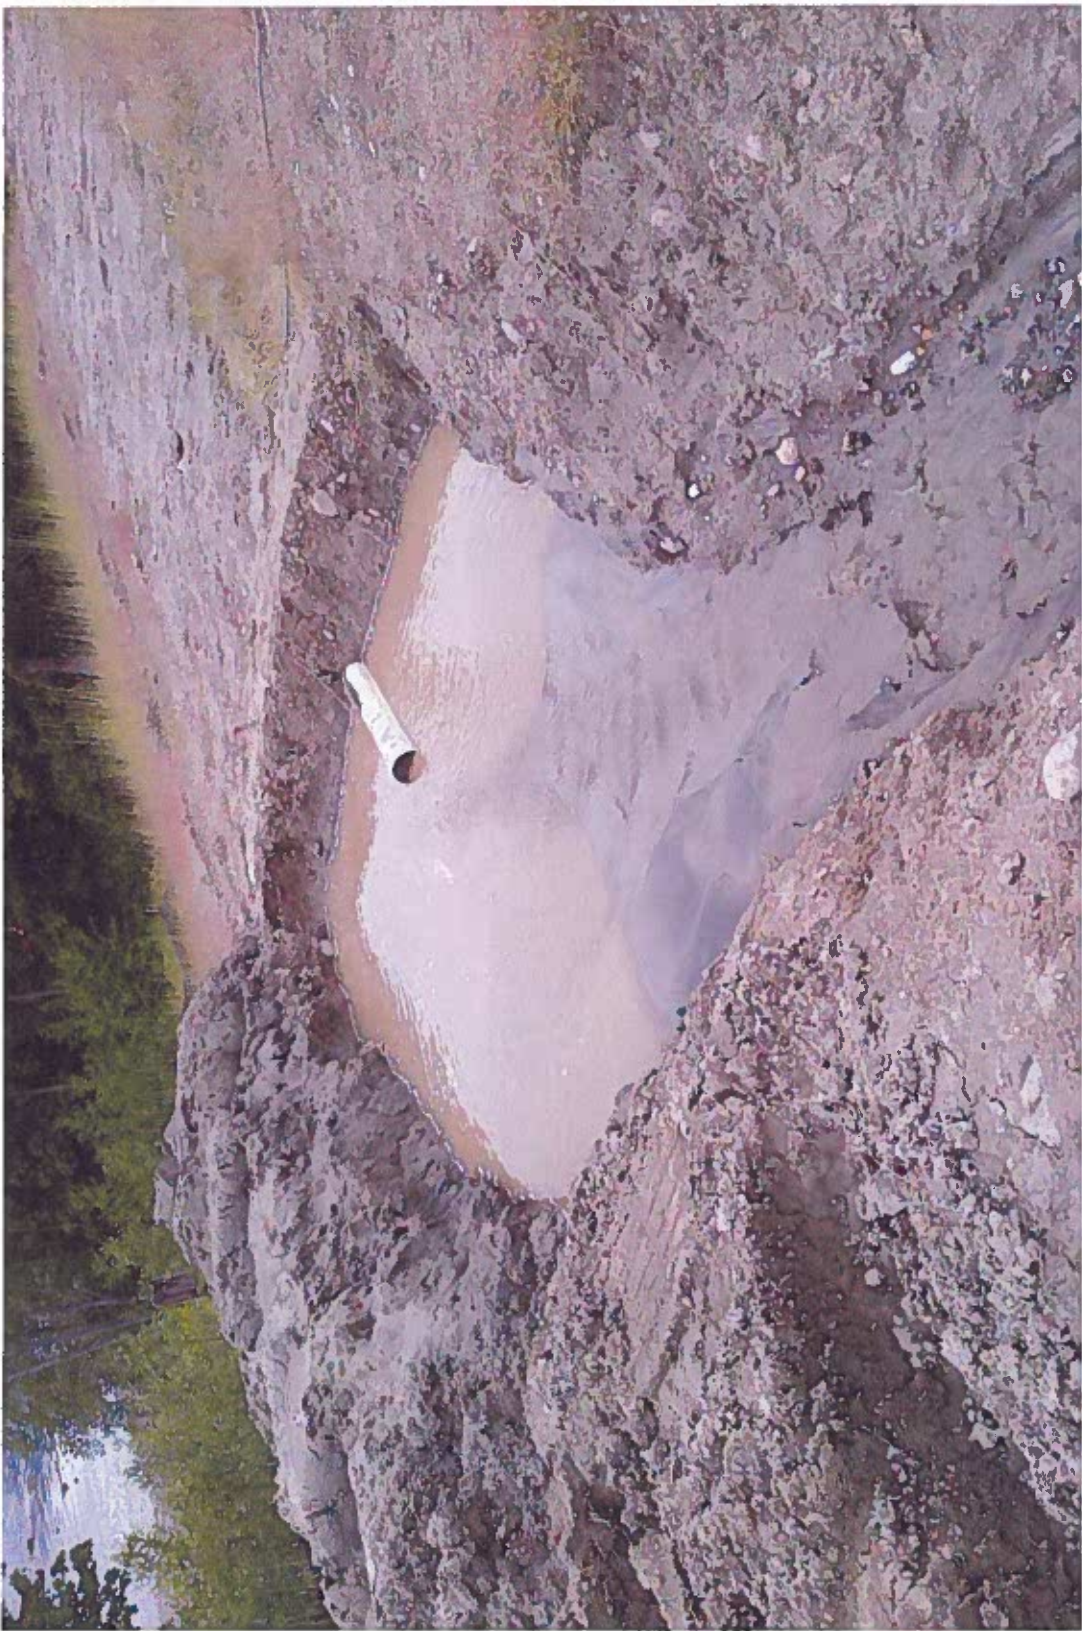
Photo 3. First of the stilling basins on June 2.

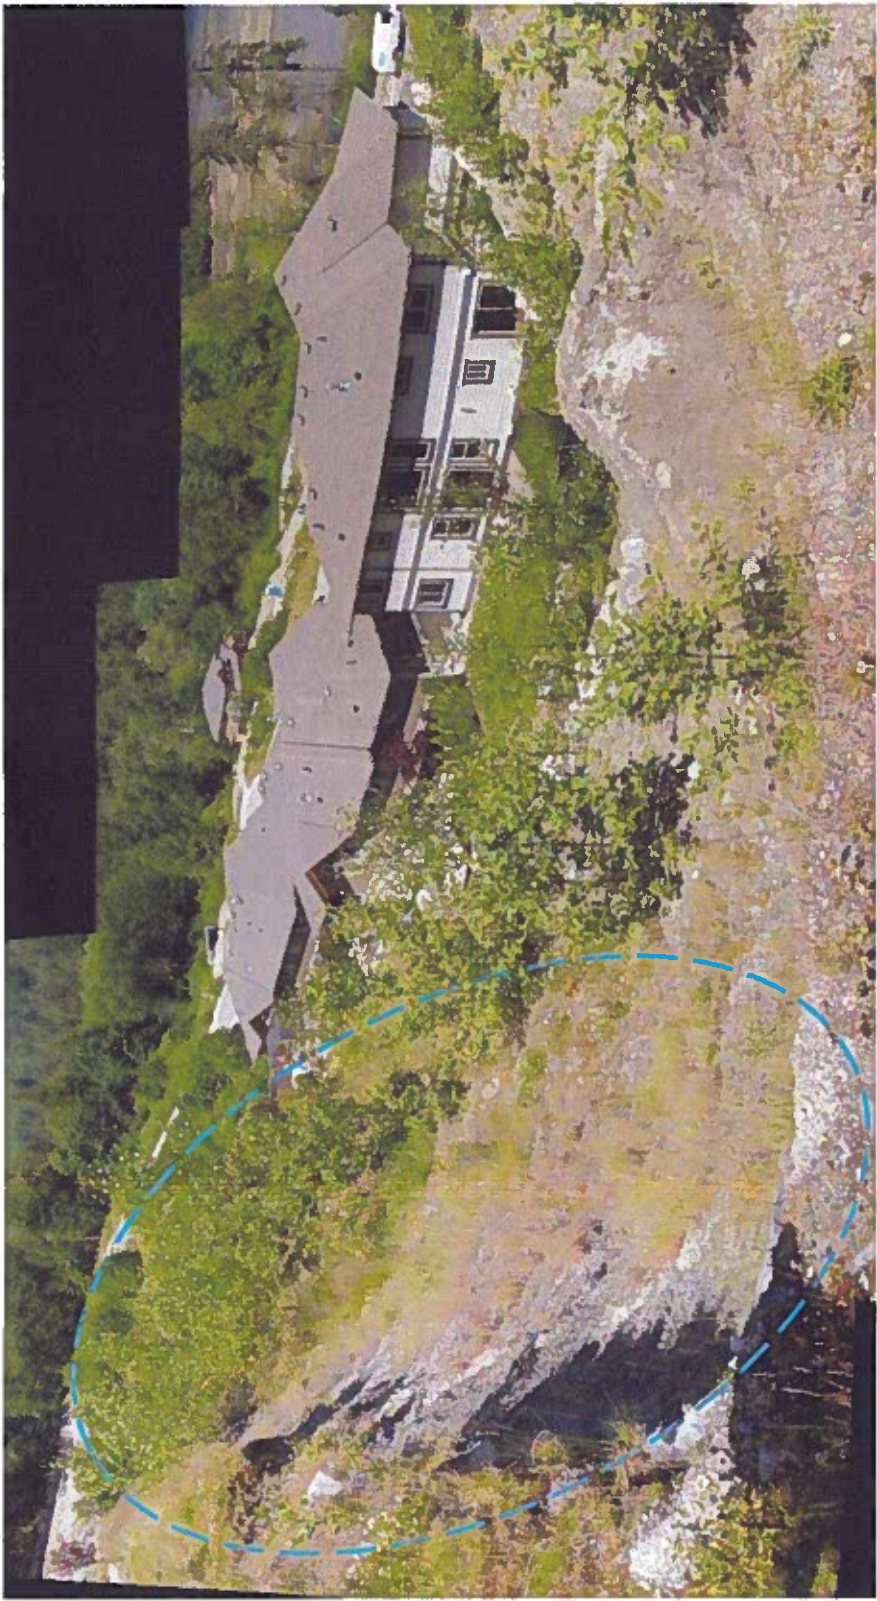
Photo 4. Head of scarp-like feature at southeast corner of Lot 21 (left hand side of photo).

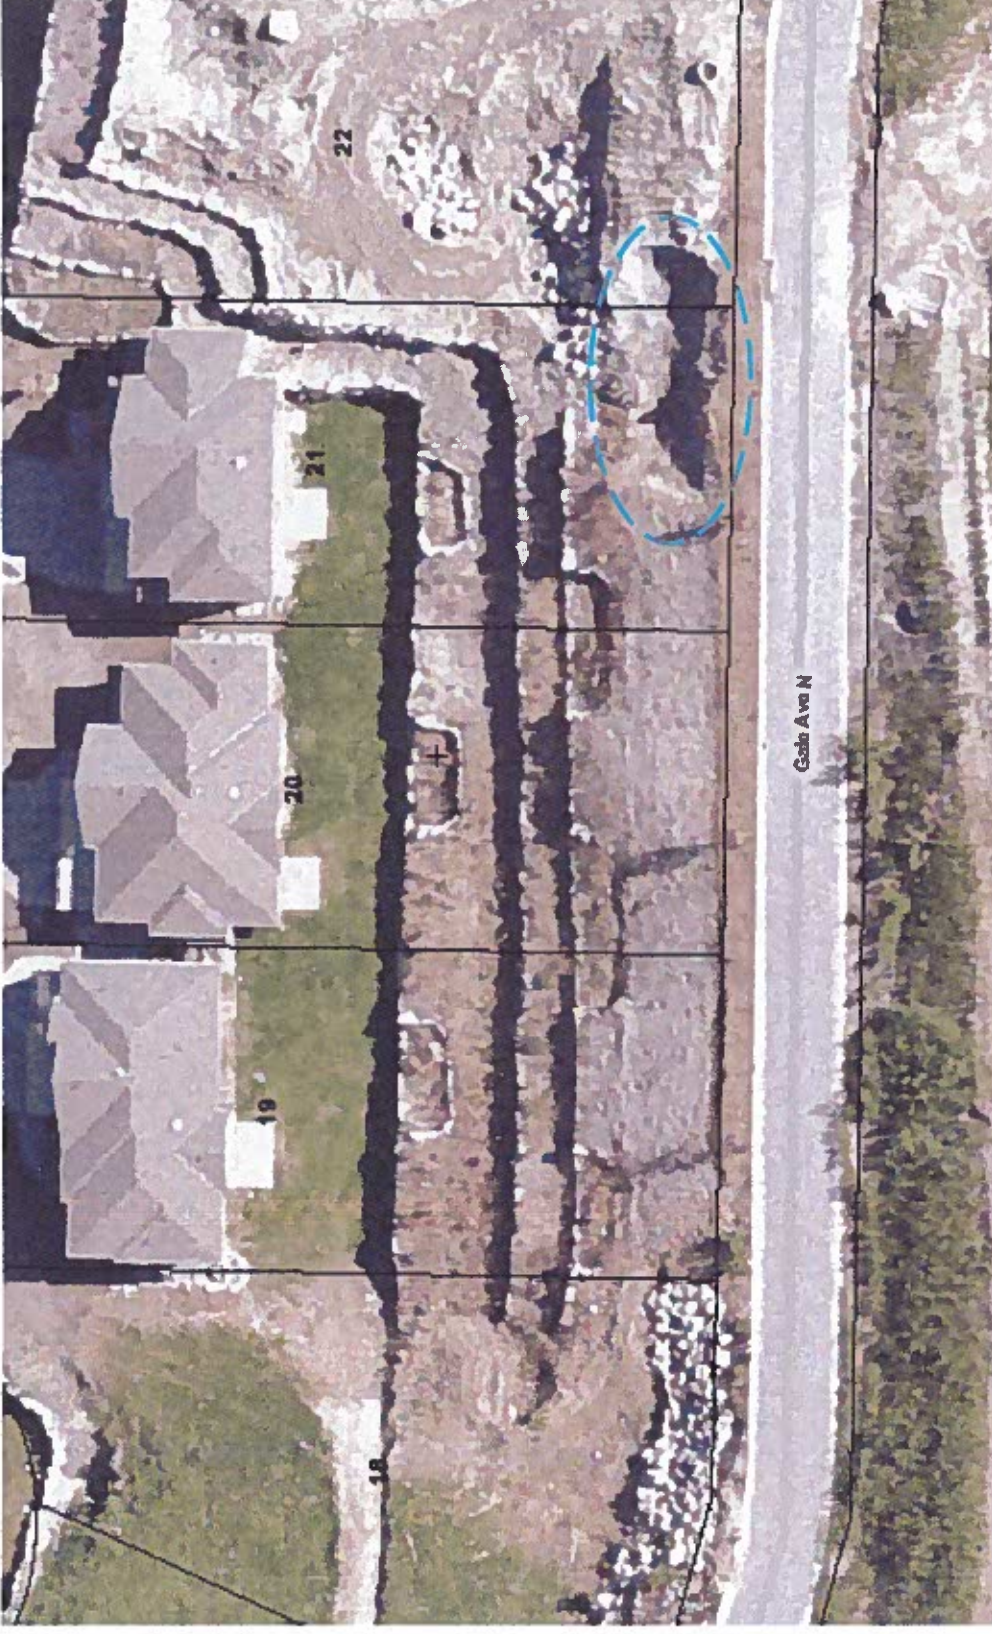
Photo 5. Rock stack walls at south end of Lots 19 to 21. Note scarp-like feature in southeast corner of Lot 21 (blue long dash line).  
Extract from SCRD OPIS.

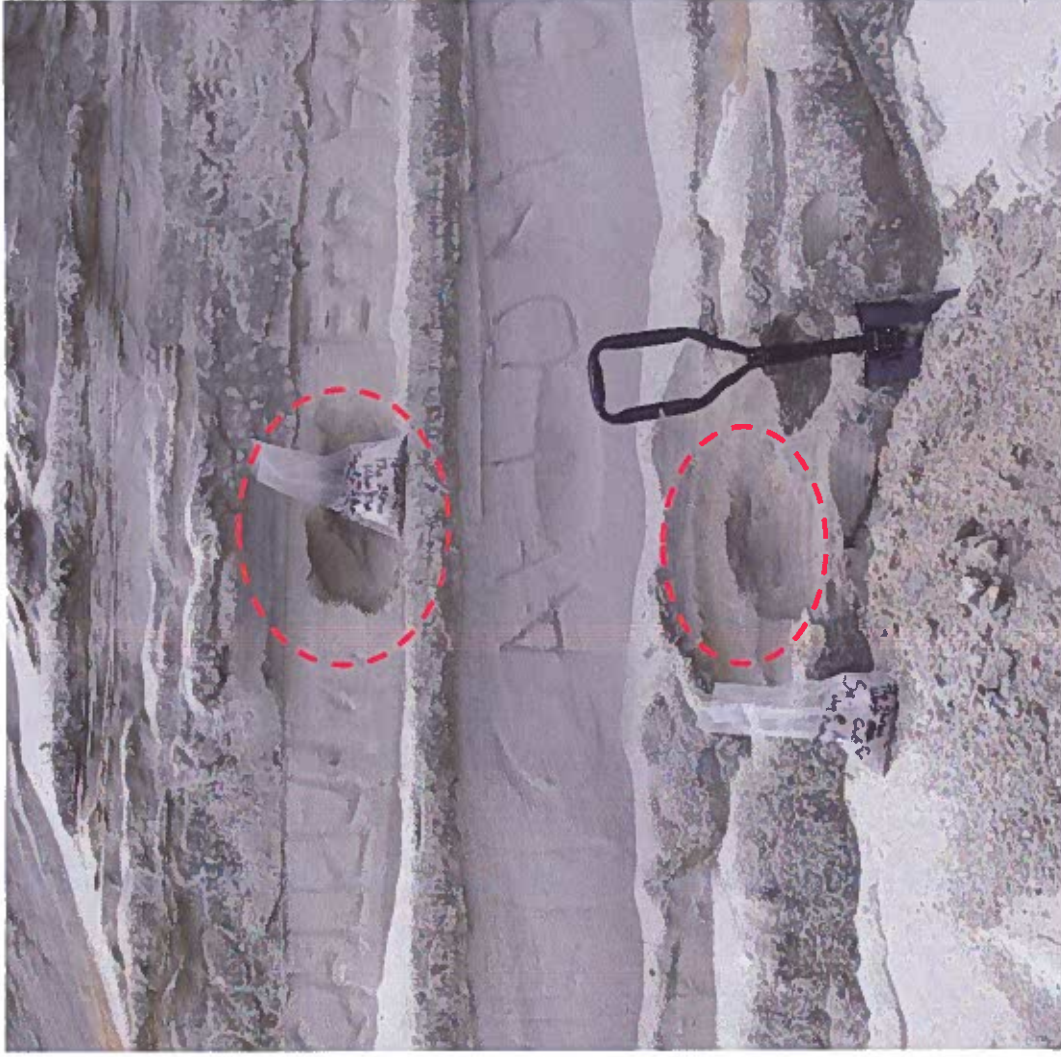
At the southwest corner of the site, the existing cut slopes are benched. Several of the cut slopes are near vertical as shown in Photos 6, 7, 8 and 9. No seepage was observed on the soil exposures. No warning signs or hoarding are present.

Photo 6. Sand exposure in cut slope at west end of site. Collection location of samples Sa-3 (bottom) and Sa-4 (top)

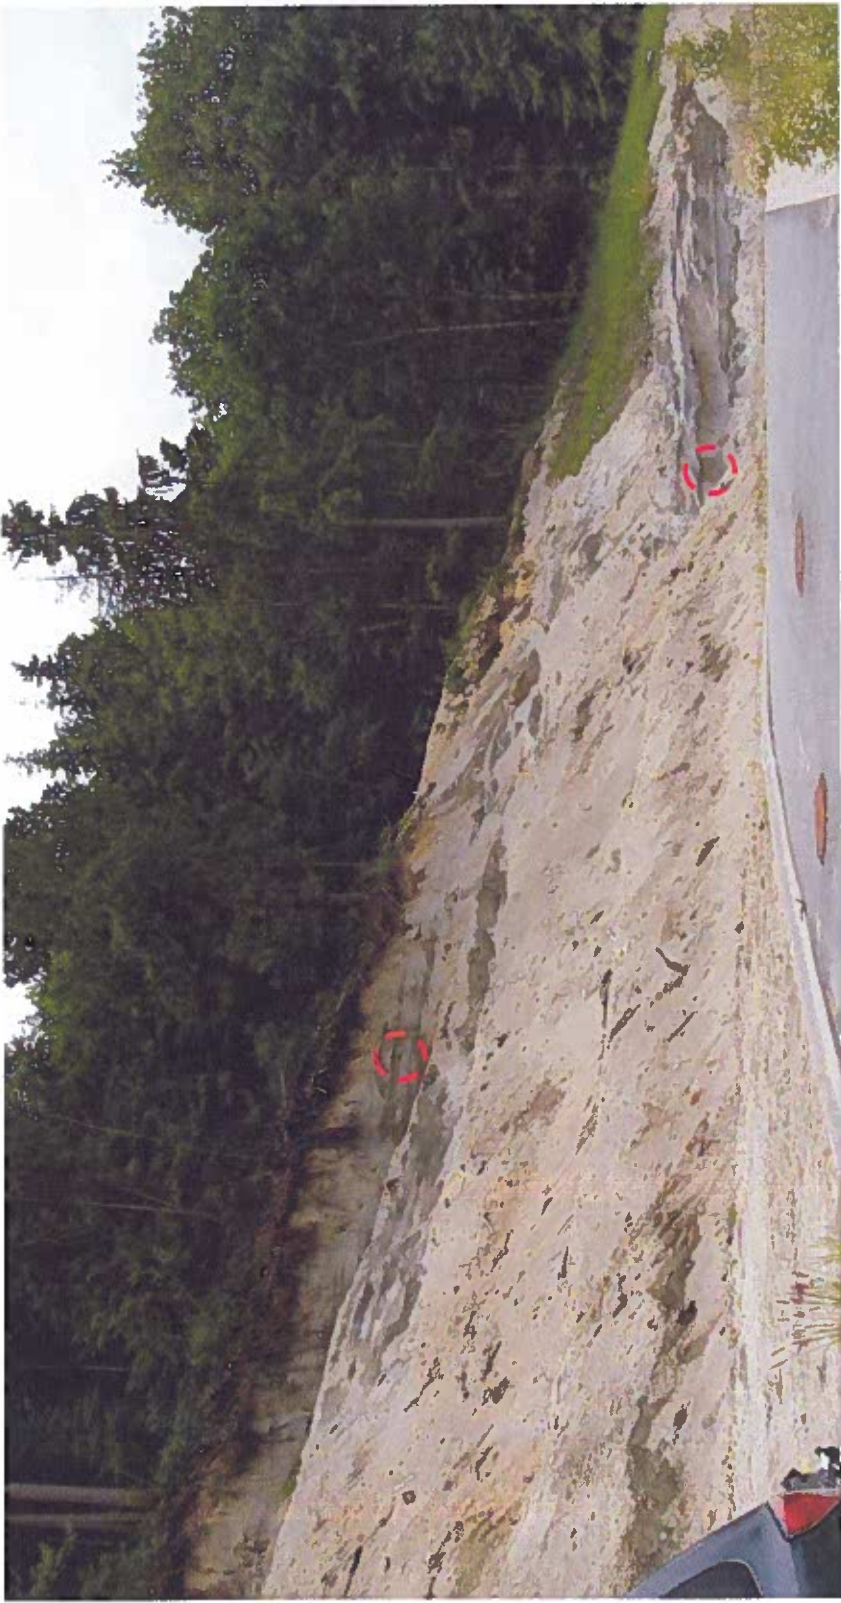
Photo 7. Cut slope at west end of site. Collection location of sample Sa-5 in upper left and Sa-3 and Sa-4 in lower left.

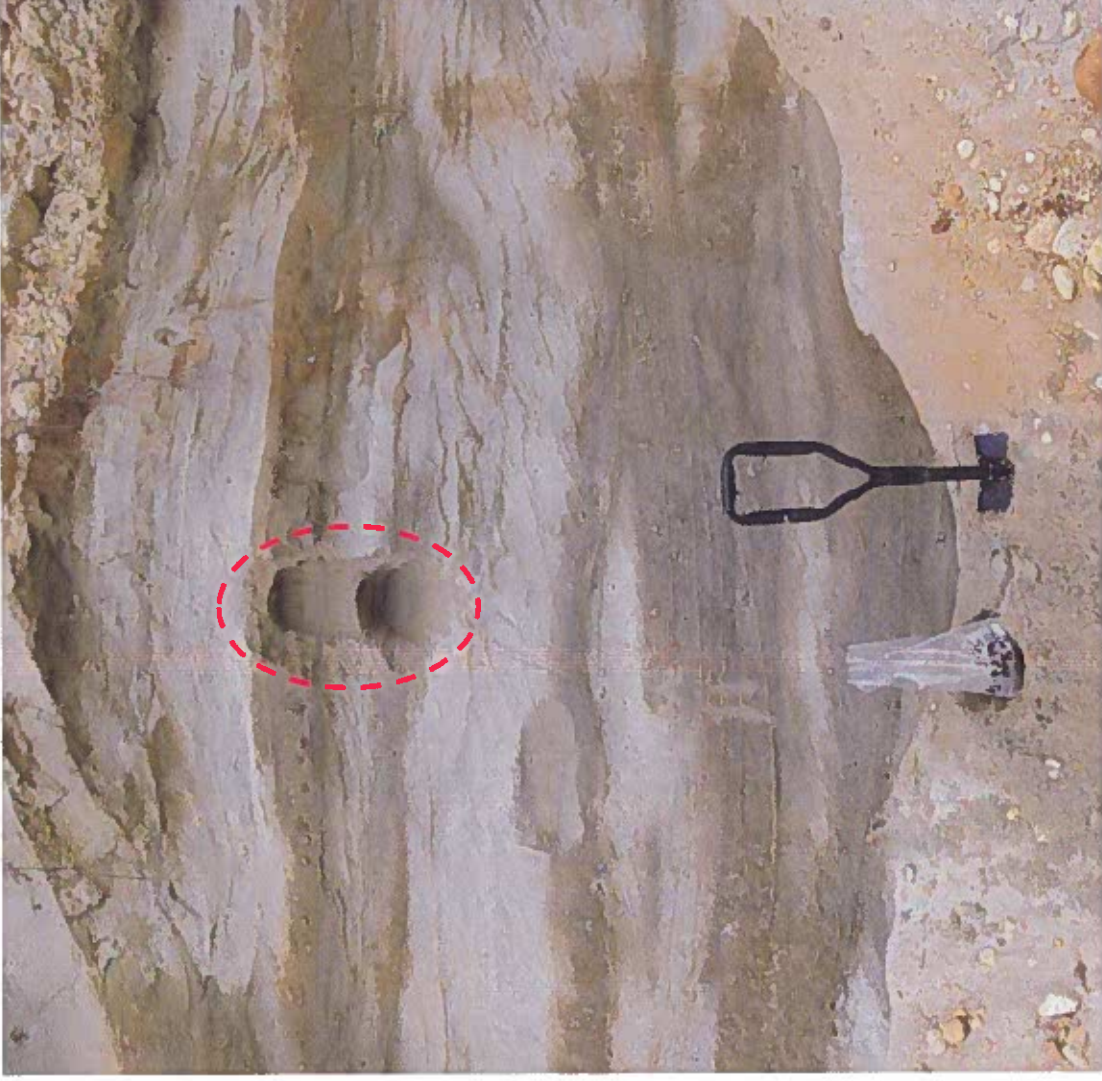
Photo 8. Sand exposure in cut slope opposite Sta. 2+50 (L-200) and sample Sa-5 collection location.

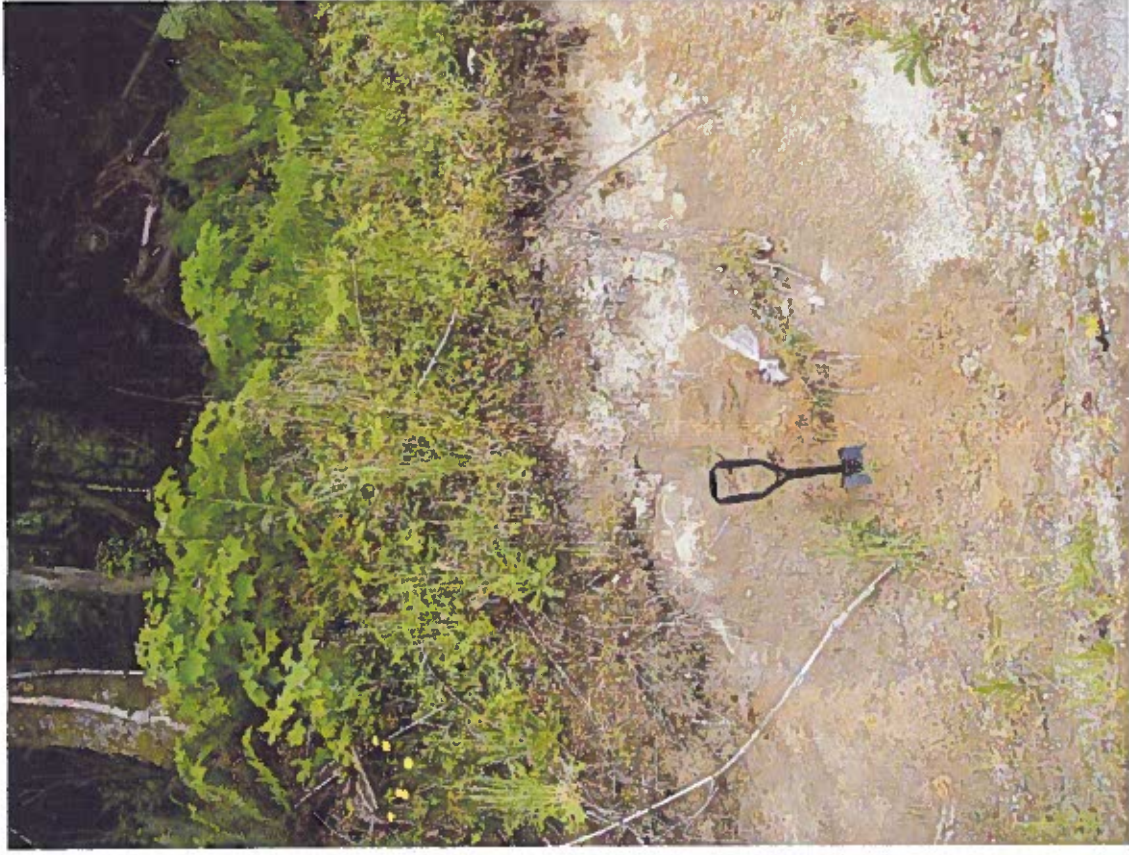
Photo 9. Soil exposure in cut slope opposite Lot 17 (Sta. 3+40, L-200) and sample Sa-6 collection location.

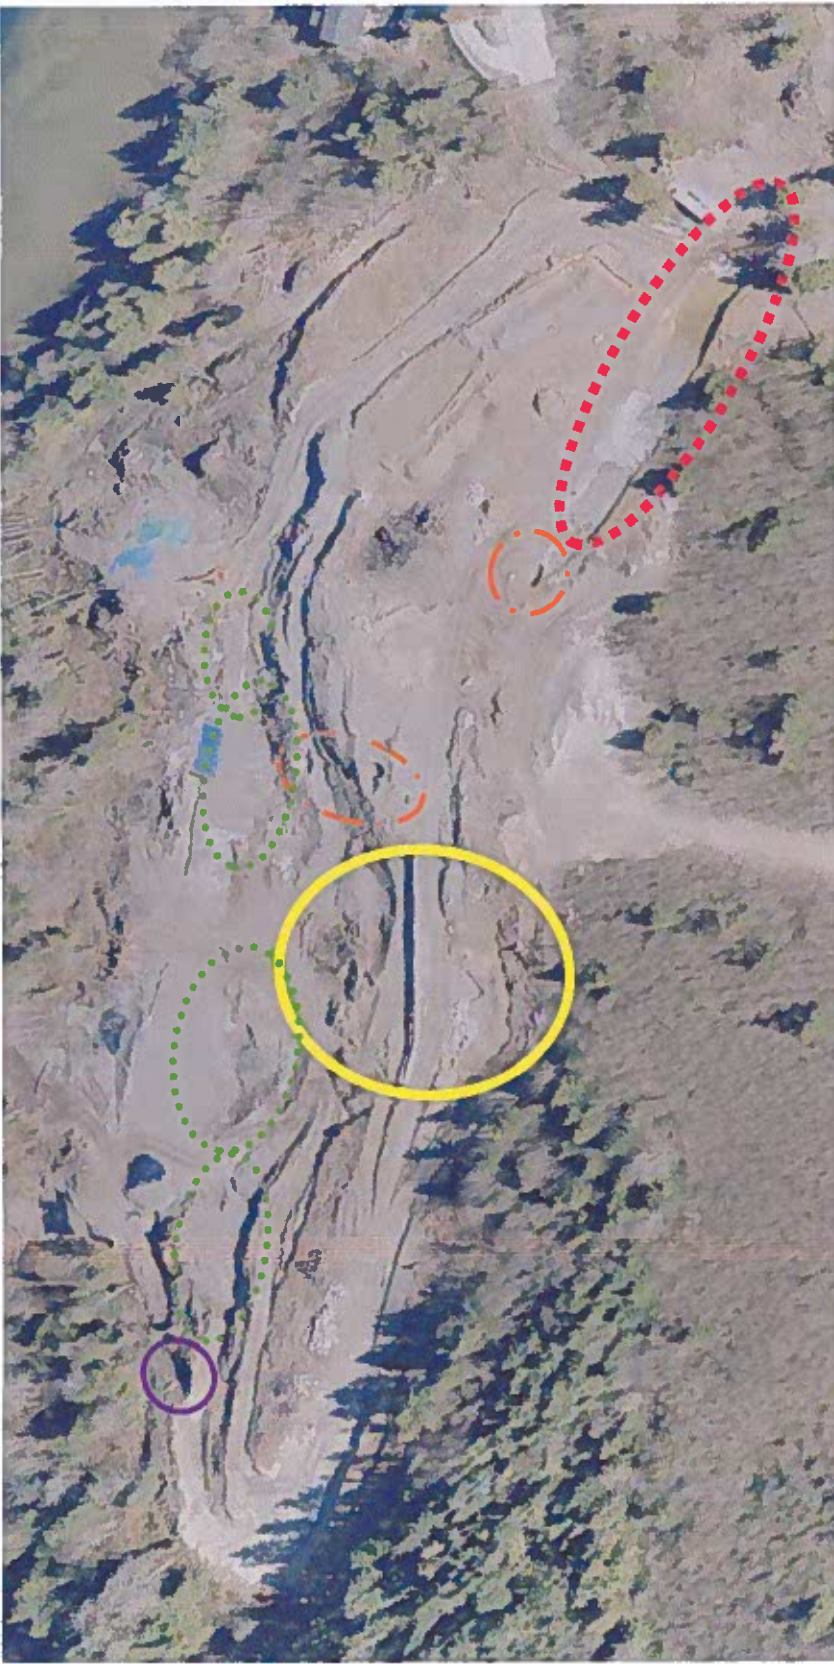
Photo 10. Infilled central gully (wide yellow line), multiple sinkhole-like features (orange dot-dash lines), recent instability (purple line), springs and/or erosion features (green dotted line) and sedimentation basin (dark red short dashed line). March 27, 2006 digital image (SRS 7264-59) provided by IMT.

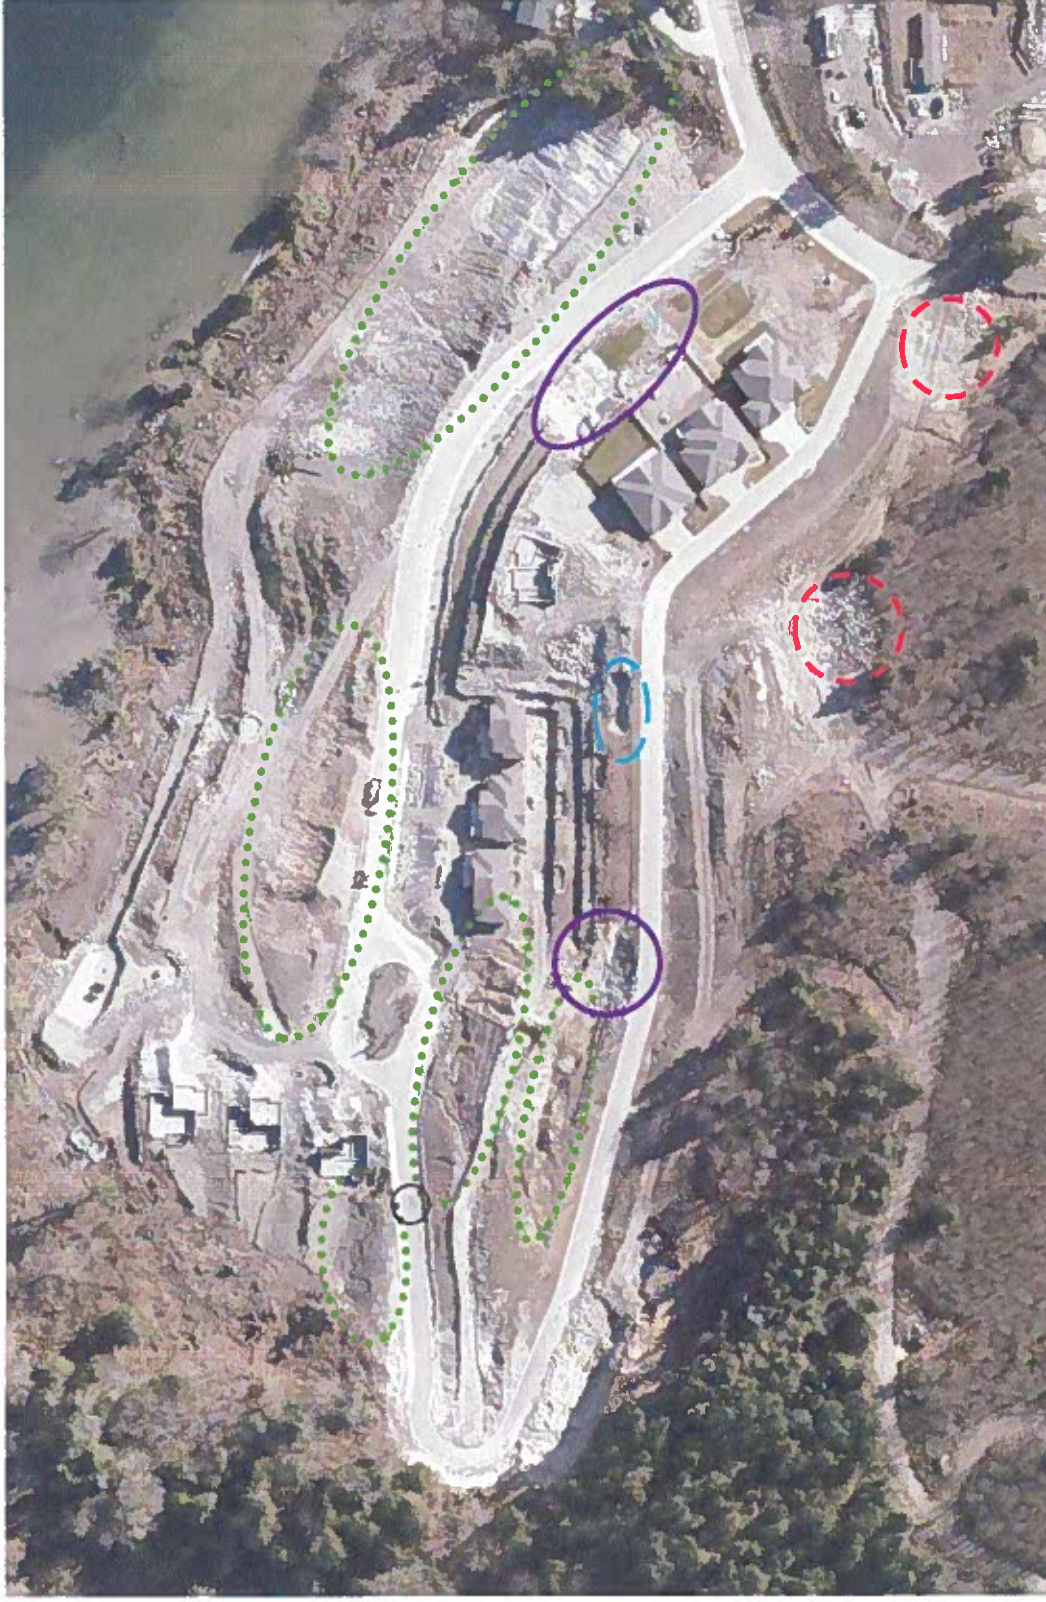
A portion of the March 2009 image provided by DOS is reproduced on Photo 11. The photo shows house foundations on Lots 13 to 15, largely completed houses on Lots 19 to 21, and completed houses on Lots 25 to 27. The scarp-like feature at the southeast corner of Lot 21 is clearly visible in the image. Scarp-like features and/or signs of recent instability are visible at the south end of Lot 18 and the north end of Lots 25 and 26. Numerous erosion features including rills (surficial erosion patterns), localized gullying and springs are visible at several locations including Lots 1 to 5/6, 9 to 12, 15, 16 to 18 and to the south of the Phase 1 development. Significant ground disturbance is visible south of the Sta. 5+80, L-200 sinkhole on the proposed Lot 29 (Phase 2) and behind Lots 23 to 26 as shown on the photo. A relatively small asphalt patch is visible adjacent to Lot 15.

Photo 11. March 2009 image showing signs of recent instability (solid purple lines), springs and/or erosion features (green dotted lines) and significant ground disturbance (red dashed lines). Note that the scarp-like feature is visible at the southeast corner of Lot 21 (blue long dashed line). A small patch in the asphalt surfacing is visible adjacent to Lot 15. Image provided by DOS.

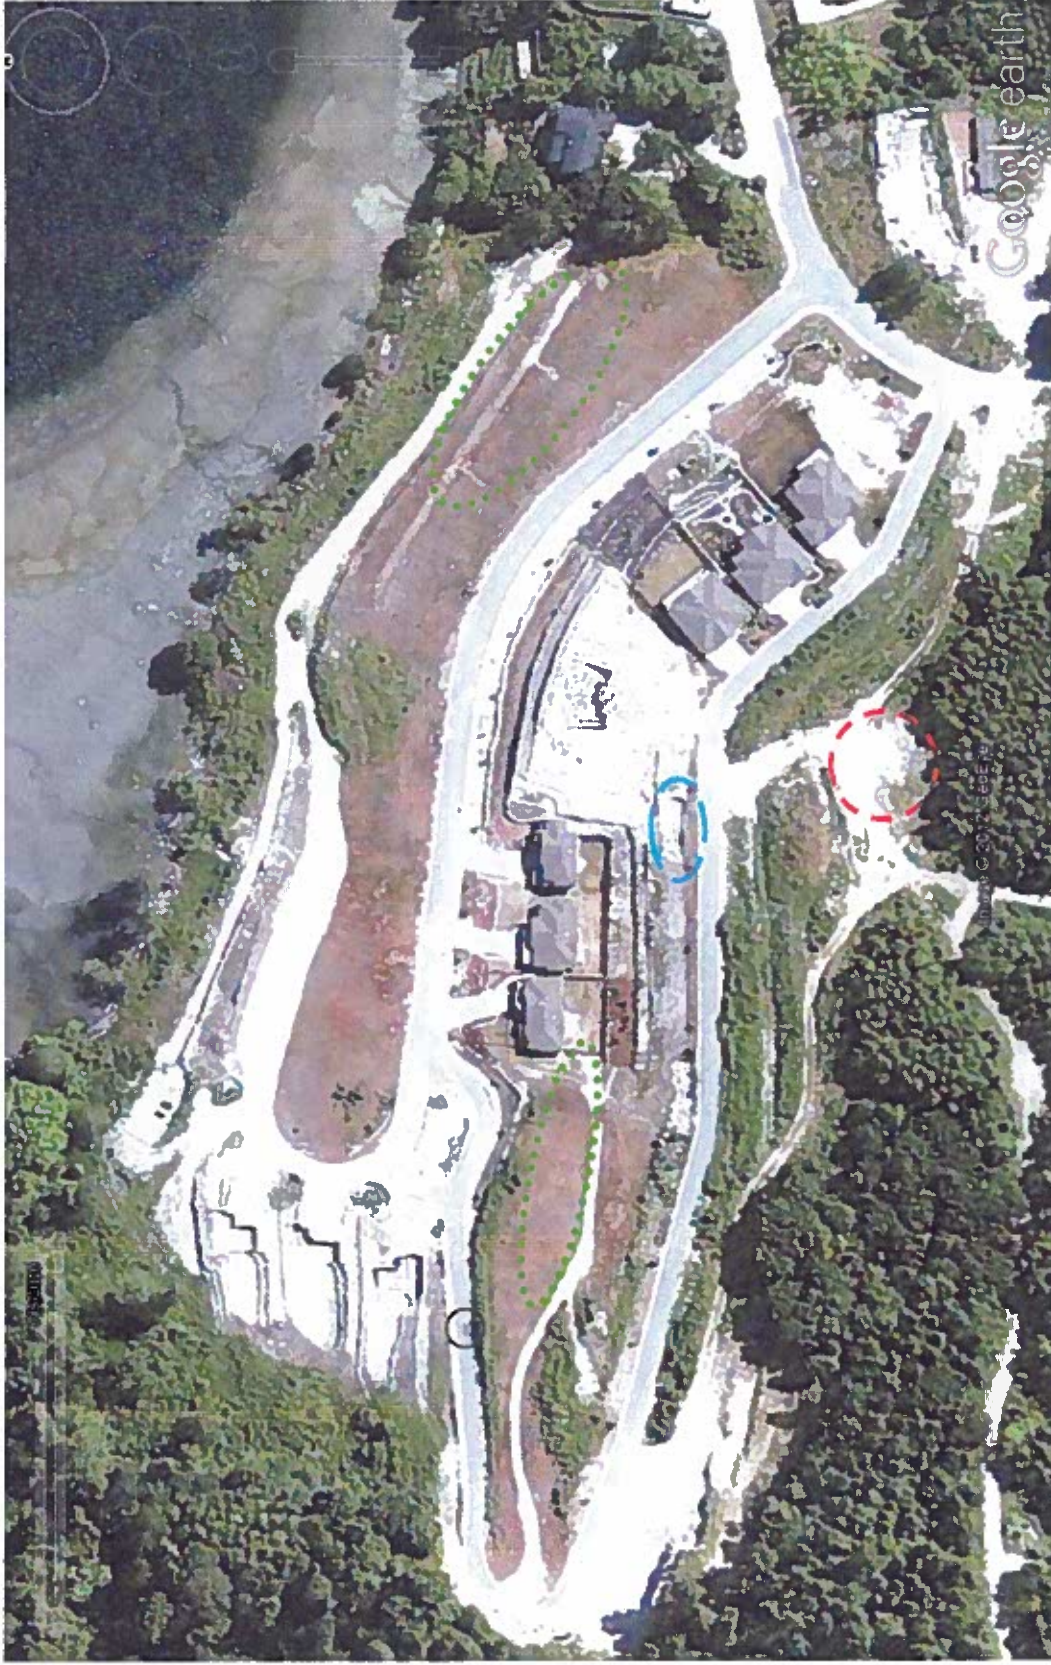
The 2010 Google Earth image shows houses on Lots 19 to 21 and Lots 25 to 27 (Photo 12). House foundations are visible on Lots 13 to 15 and Lot 23. Springs or erosion features are visible near the toe of the fill on Lots 2 and 4. The asphalt patch adjacent to Lot 15 is visible as is the ground disturbance behind Lots 23 to 26. The scarp-like feature on Lot 21 is visible.

Photo 12. 2010 Google Earth image showing springs on Lots 2 and 4 (green dotted lines), ground disturbance (red dashed lines) and asphalt patch adjacent to Lot 15 (thin black line). Note that the scarp-like feature is visible at the southeast corner of Lot 21 (blue long dashed line).

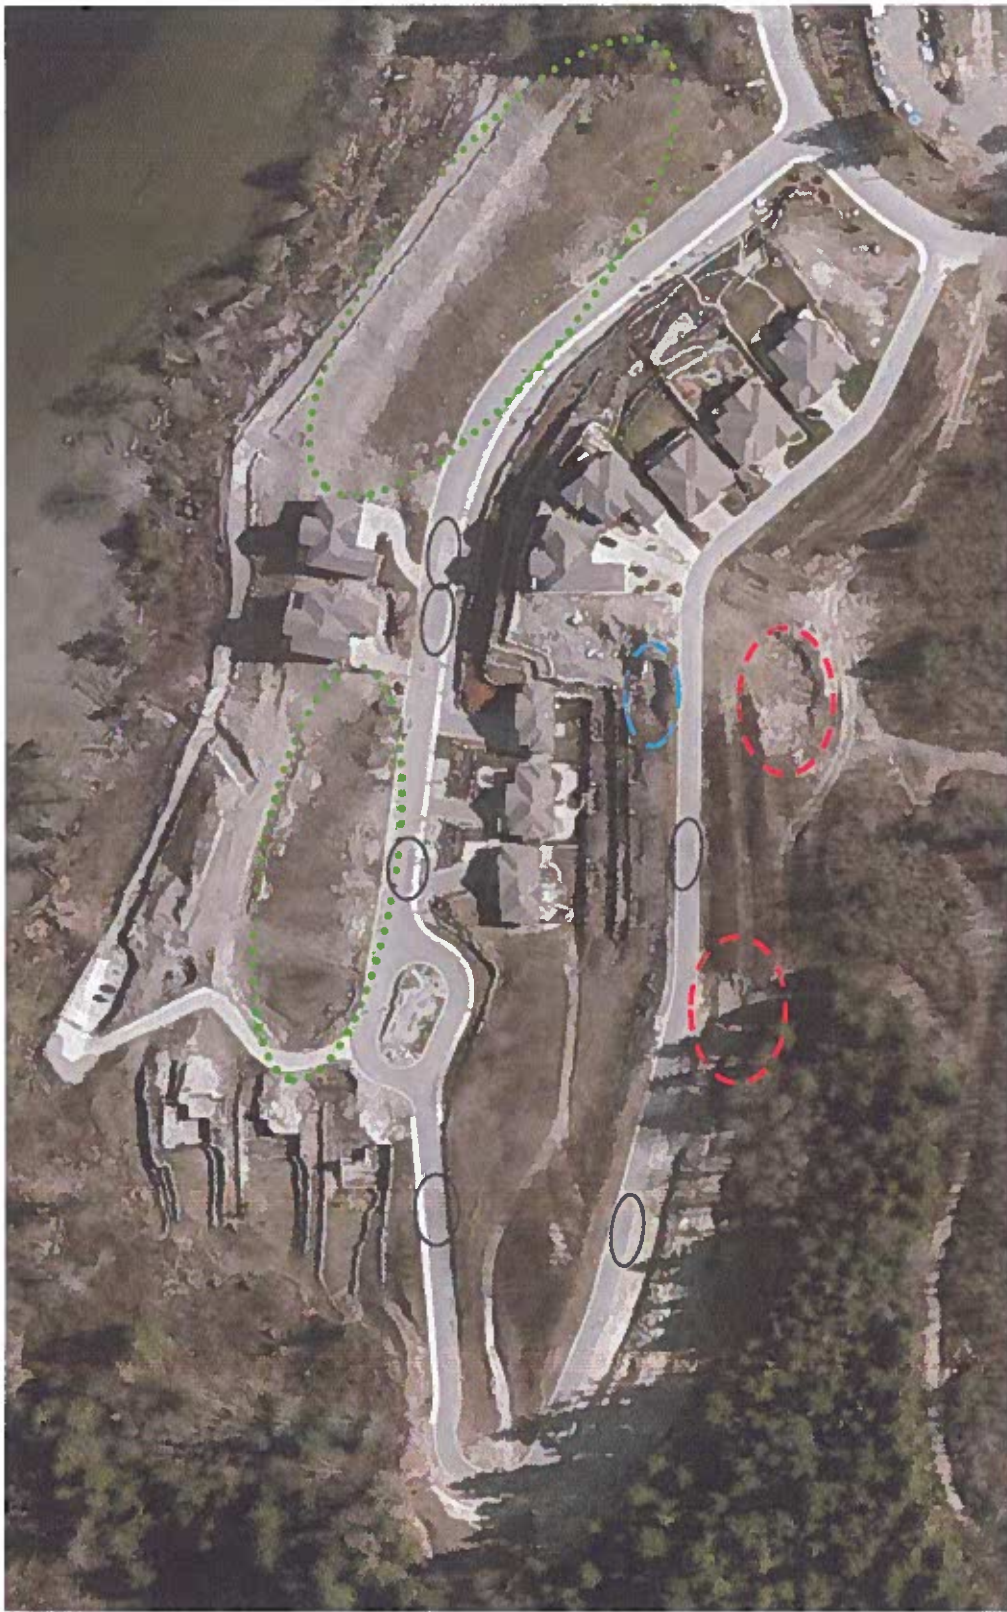
A portion of the March 2012 image provided by DOS is reproduced as Photo 13. The photo shows largely completed houses on Lots 7 and 8, the same house foundations on Lots 13 to 15 as seen on the 2009 image, completed houses on Lots 19 to 21 and Lots 23 to 27. The

scarp-like feature at the southeast corner of Lot 21 is still clearly visible in the image. While no signs of recent instability are visible and vegetation has taken hold on most of the undeveloped lots, erosion features including rills, localized gullying and springs are visible at several locations including the fill slope on Lots 1 to 6 and on Lots 9 to 12 as shown. Ground disturbance is visible south of Lot 18 and behind Lots 23 to 26 as shown. Also visible are the majority of the asphalt patches and repairs shown on Theed's drawing dated June 12, 2012. Of particular interest is the patch adjacent to Lot 15 which appears to have quadrupled in size since the 2009 image was taken.

Photo 13. March 2012 image showing springs and/or erosion features (green dotted lines) and significant ground disturbance (red dashed lines). Note that the scarp-like feature is visible at the southeast corner of Lot 21 (blue long dashed line). The asphalt patch adjacent to Lot 15 appears to have increased in size relative to the 2009 image and other patches visible (thin black line). Image provided by DOS.
