CCTV inspection report

Customer: DISTRICT OF SECHELT

Project: SEAWATCH

Inspection Date: 12/07/2017, 13/07/2017

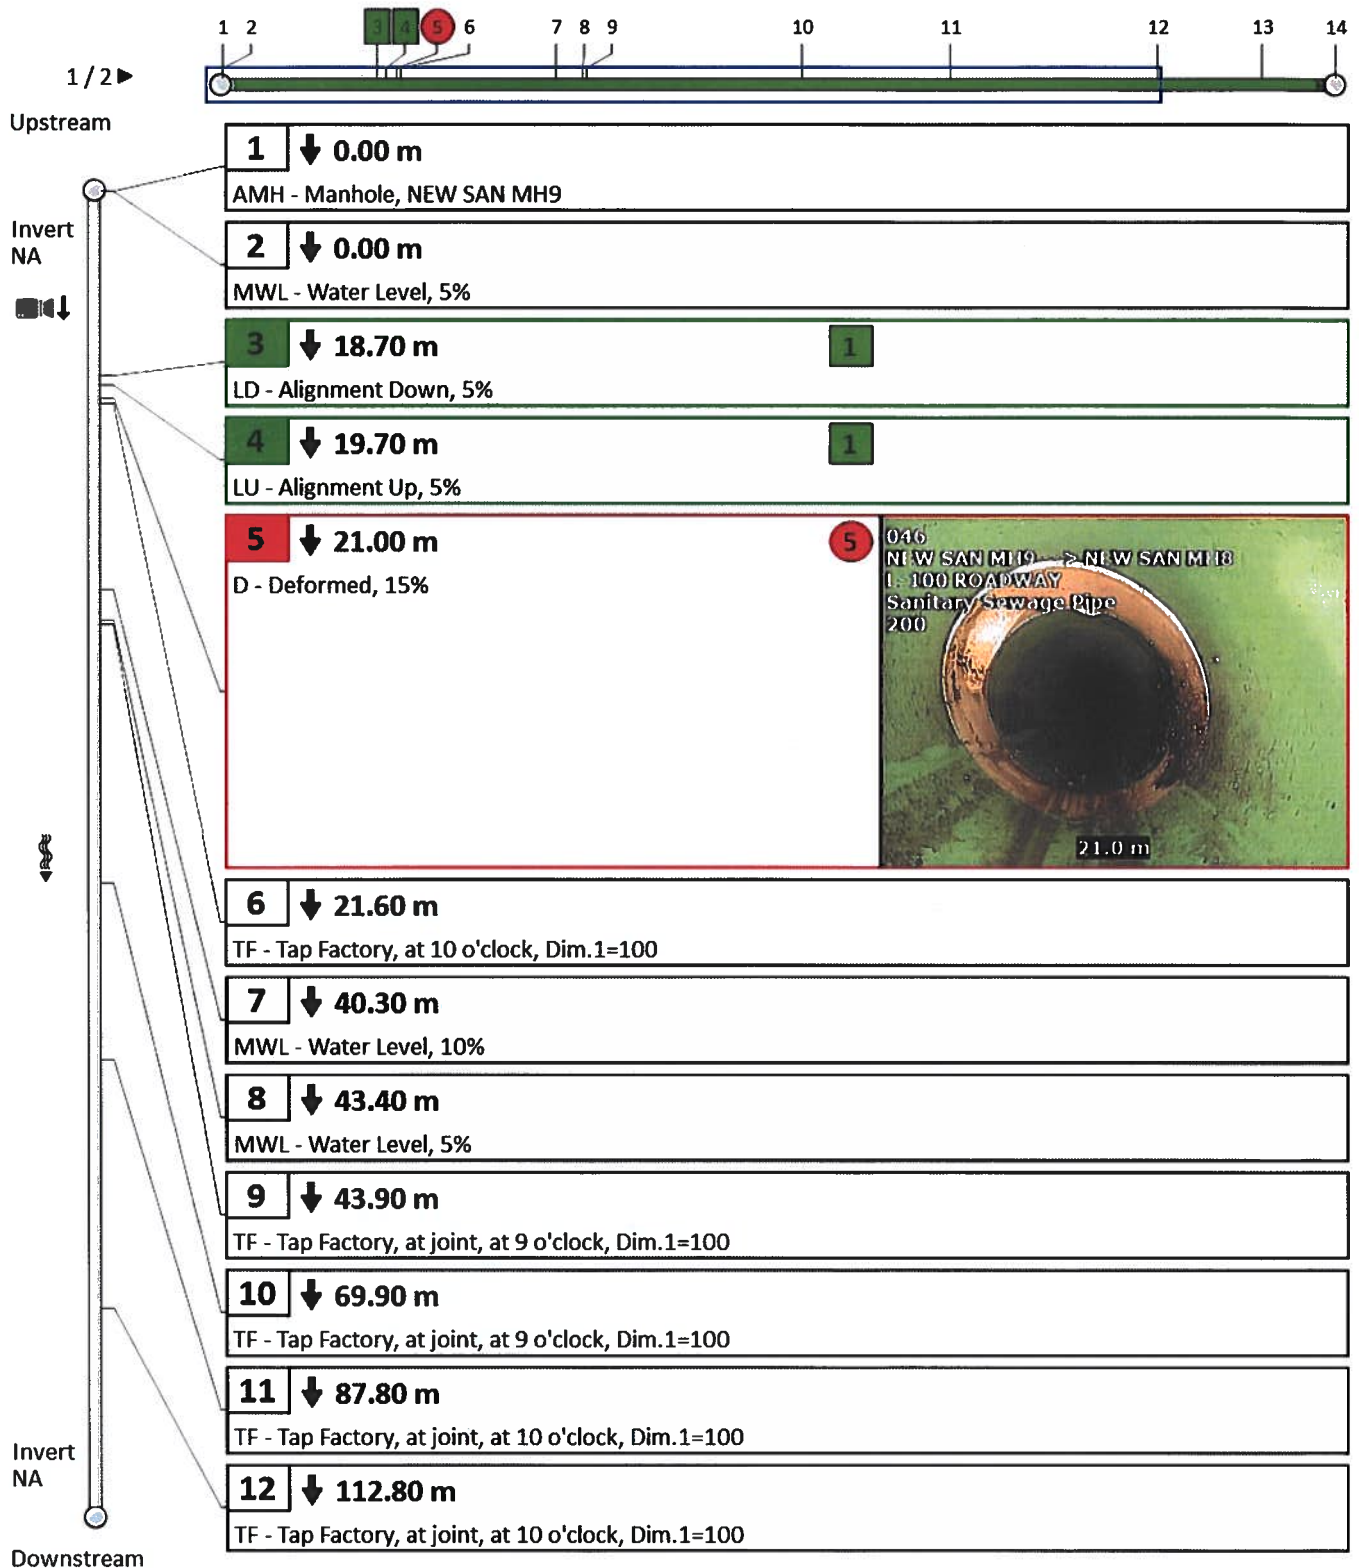
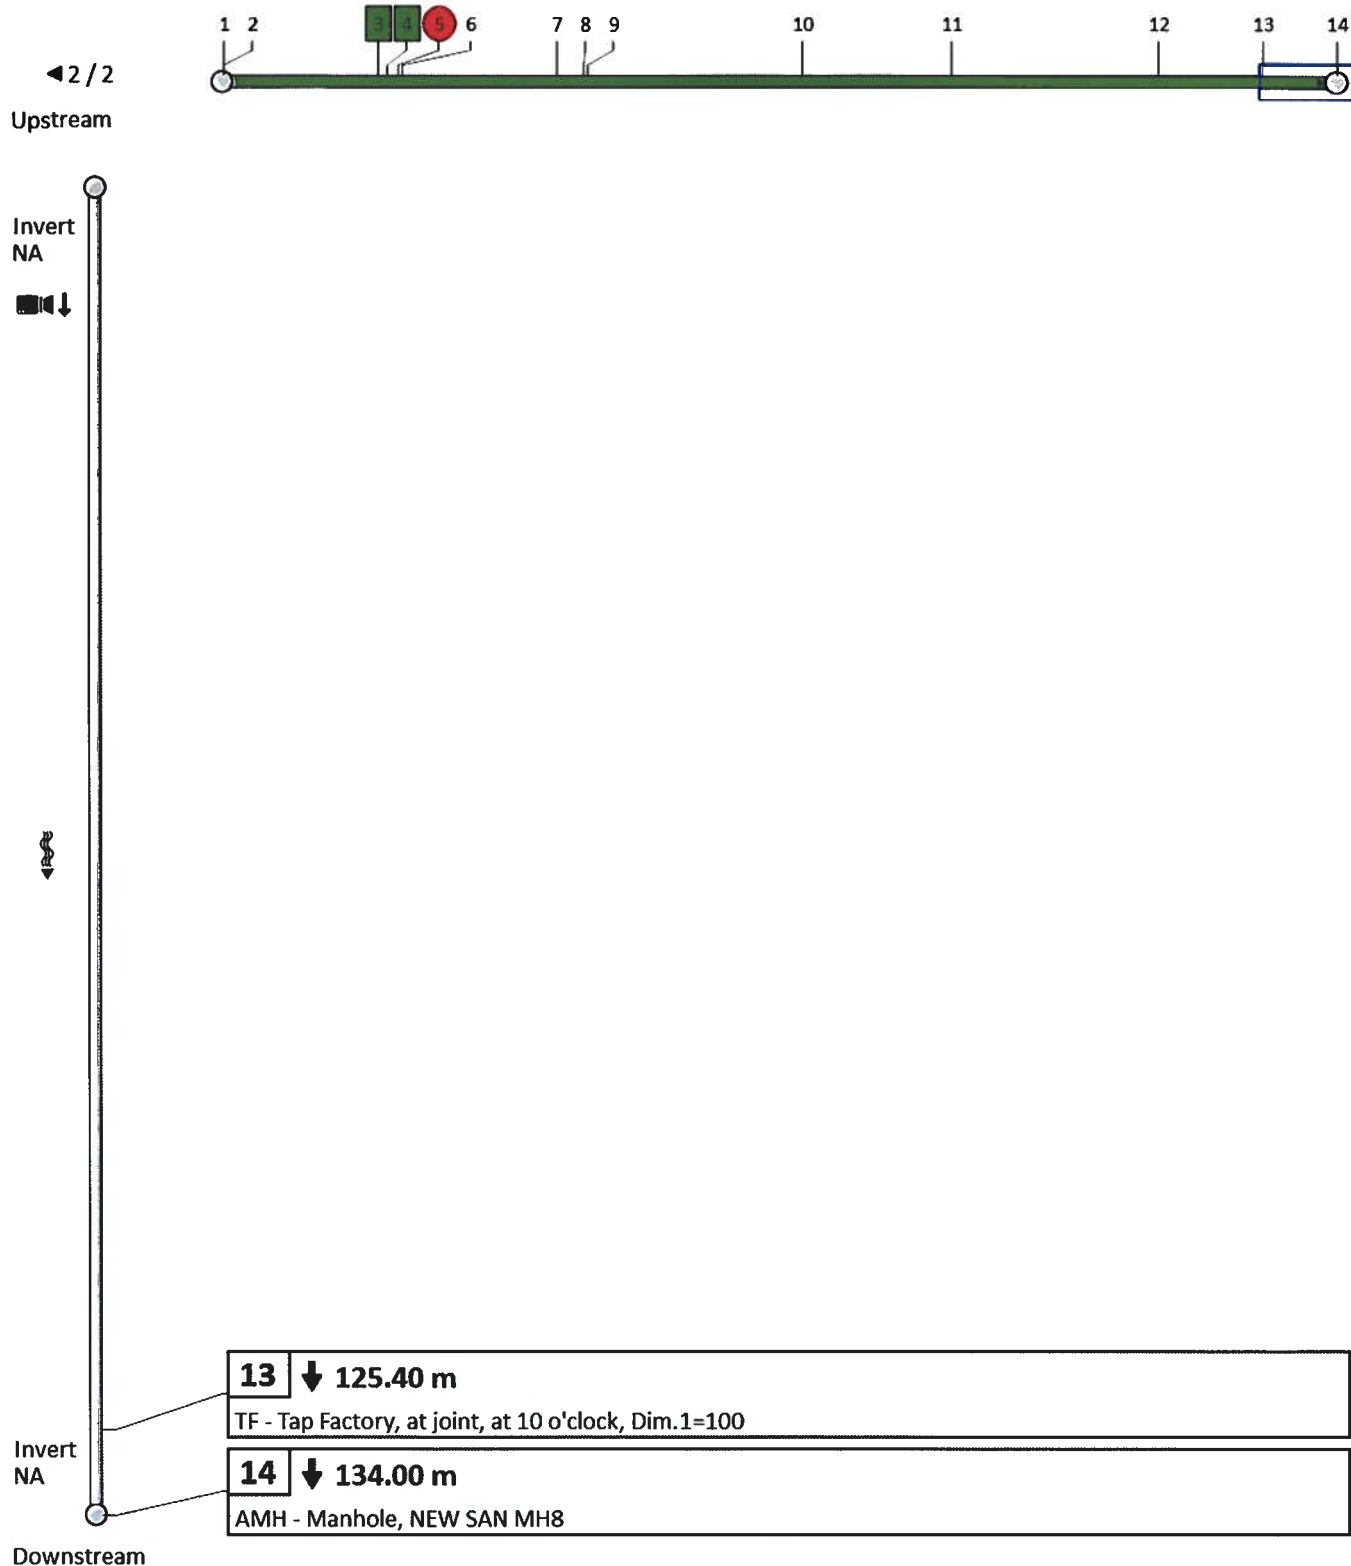
Pipe: 046  
Direction of flow: NEW SAN MH9 --> NEW SAN MH8  
Direction of inspection: NEW SAN MH9 --> NEW SAN MH8  
Direction: Direction of flow

Peak: 5  
Quick rating: 5100  
Score: 5  
Index: 5.0

Peak: 1  
Quick rating: 1200  
Score: 2  
Index: 1.0
