Project Number CO - 03

**Re: Addendum to Geotechnical Assessment, Phase 1, The Shores Subdivision  
Sechelt, B.C.**

**Re: Geotechnical Assessment, Phase 1, The Shores Subdivision**  
**Sechelt, B.C.**

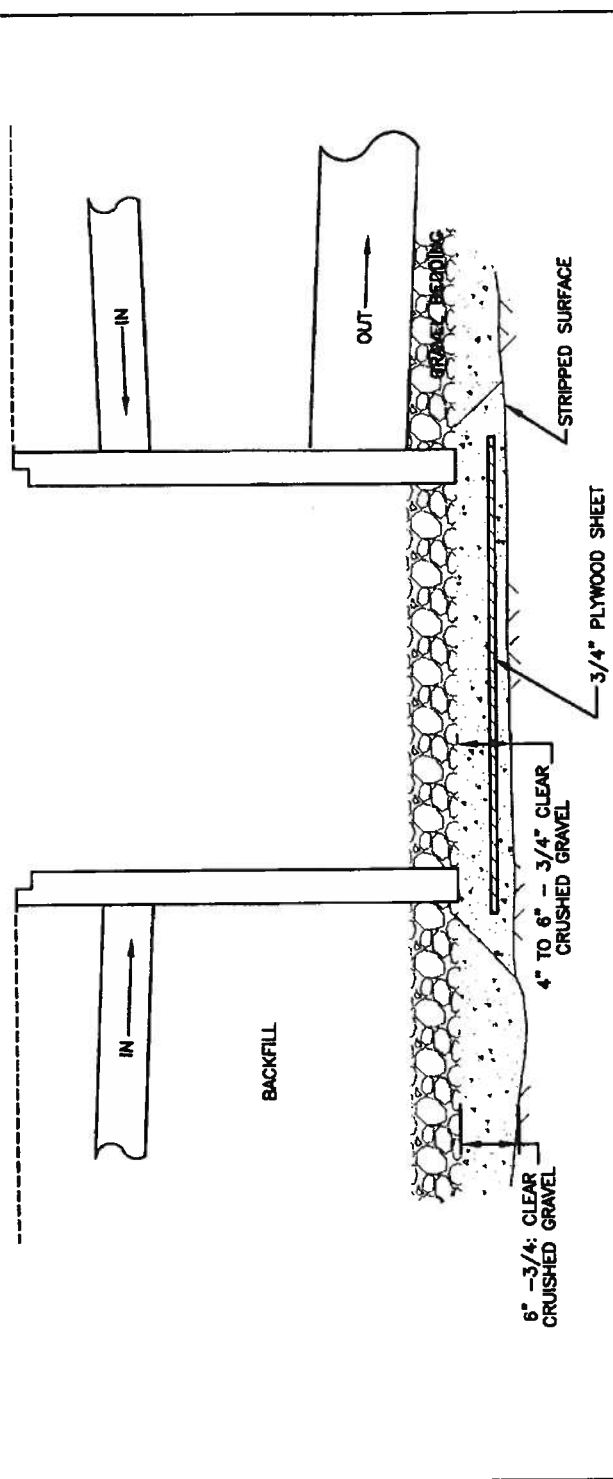
| | | | | | CO-03 | FIGURE NO. FIGURE 5 |

Where manholes are installed as part of the interceptor drain systems, the subgrade soils are susceptible to rapid softening and degradation of strength when exposed. It is recommended that, as soon as foundation grade for a manhole is exposed, a sheet of  $\frac{3}{4}$ -inch plywood be placed on the subgrade surface followed by 4 to 6 inches of  $\frac{3}{4}$ -inch clear crushed gravel as bedding for the concrete barrel of the manhole. Additional  $\frac{3}{4}$ -inch clear crushed gravel should be placed inside and outside the manhole barrel. It is also recommended that to minimize damage to the subgrade surface, the surface around the manhole be exposed in small sections with each section being covered with at least 6 inches of gravel before the next section is exposed. Figure 5 shows the recommended detail for manhole installation.

Where water-softened conditions spread faster than the softened material can be removed, particularly along the outflow pipe trench from the manhole, it is recommended that a 2-foot layer of 12-inch minus rock be placed as a stabilizing base for the pipe bedding and trench backfill.
