Project Number CO - 03

**Re: Geotechnical Assessment, Phase 1, The Shores Subdivision  
Sechelt, B.C.**

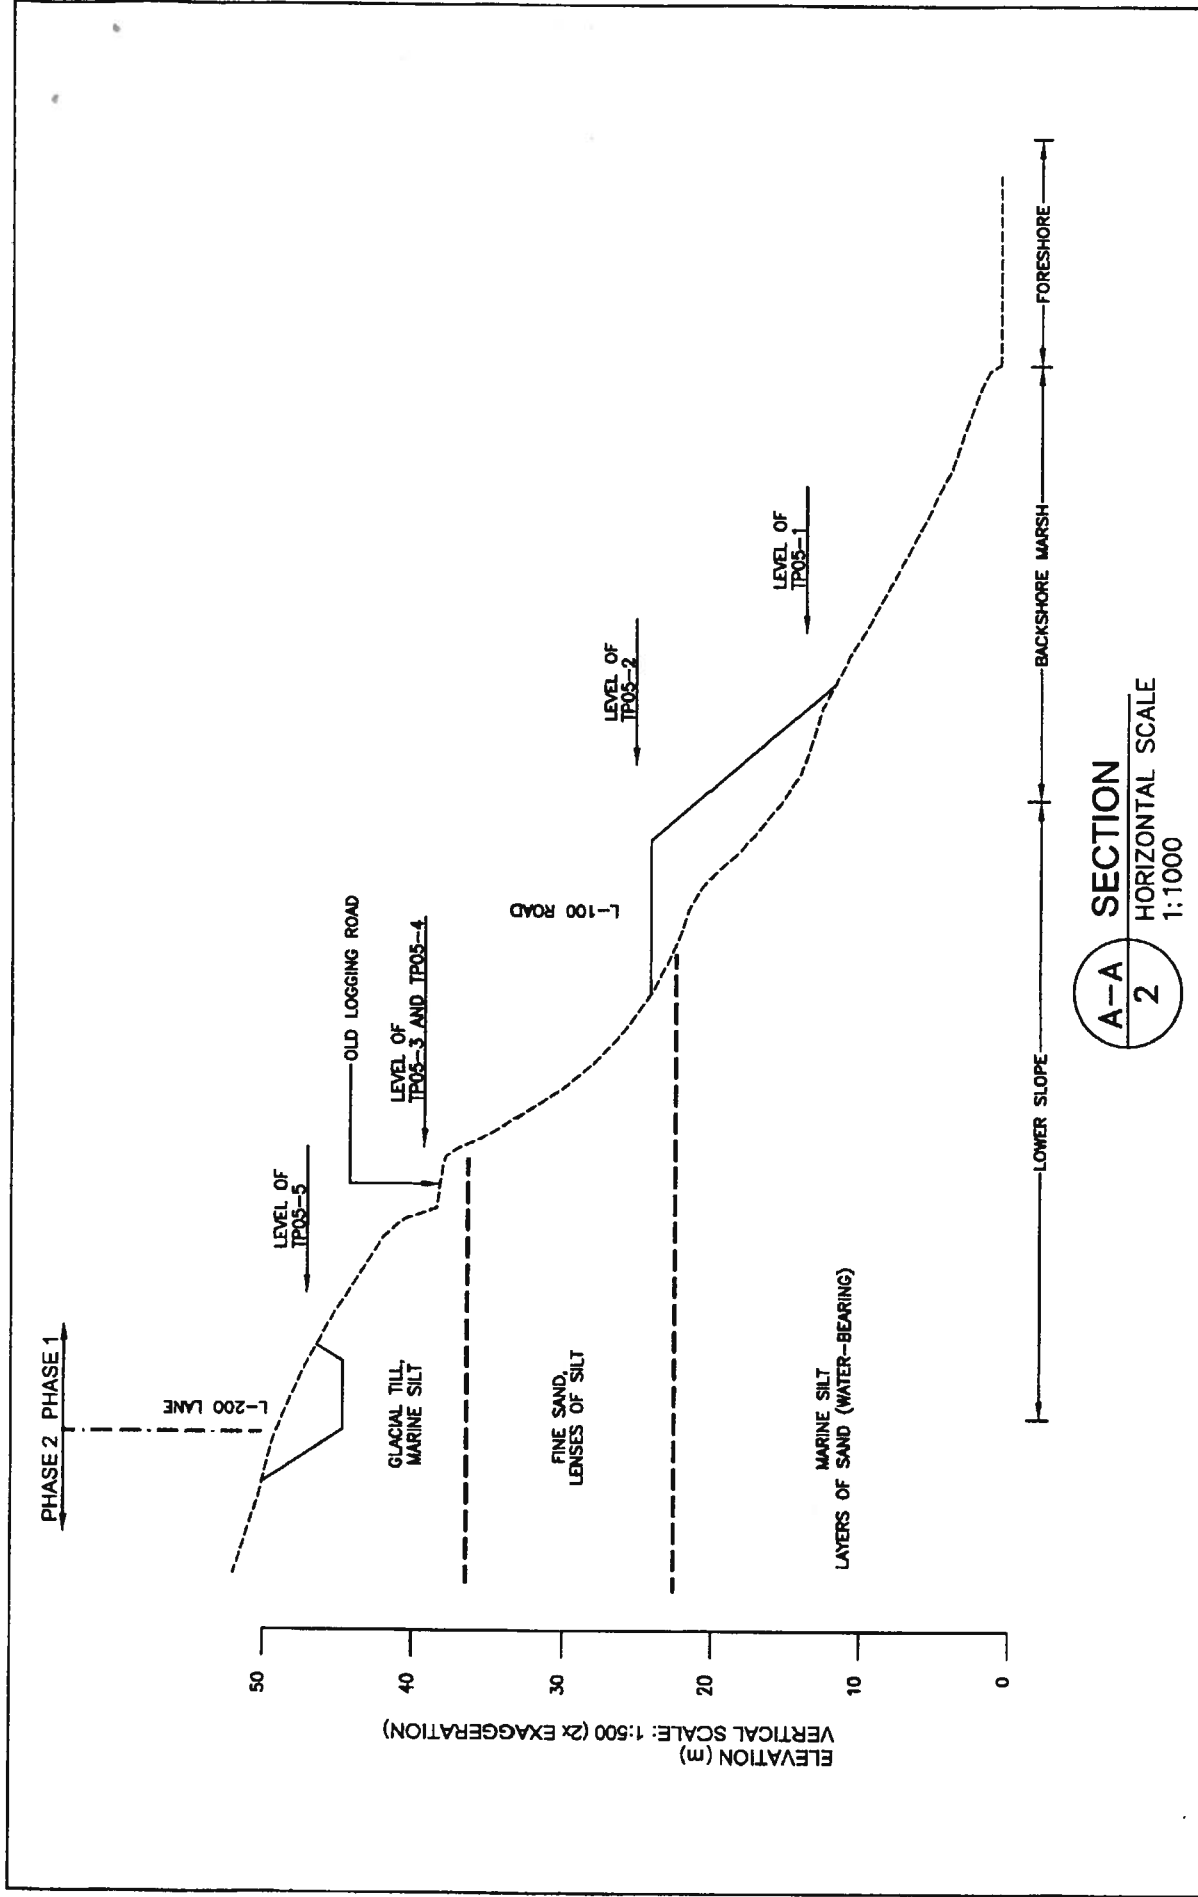
| | TITLE | | SLOPE PROFILE A-A' | | | |

Back analysis of a section of the slope that had experienced instability using the selected soil parameters resulted in a calculated Factor of Safety of 1.01. This formed the basis for assessing the potential for additional slope failures regressing upslope from the initial slide. Adoption of a reduced friction angle for the marine silt was also confirmed to be reasonable, with a Factor of Safety of 0.985 being calculated for the back analysis of a possible slip occurring in the vicinity of the old logging road between L-100 and L-200 (see Figure 3).

From the stability analyses, it is concluded that the natural slope, unaffected by existing planes of weakness or sink holes, has an adequate Factor of Safety. When local factors, such as fractures in the soil or solution cavities are considered, the calculated Factors of Safety decrease and the probability of slope failure increases. This case also indicates that a 'retrogressive' mode of failure is probable.

As part of the proposed site development, the area where the instability has occurred will be graded by cut-and-fill techniques to create building pads. The soil in blocks that have slid will be removed and site grading fill, with properly engineered retaining walls, will be placed to buttress the slope.

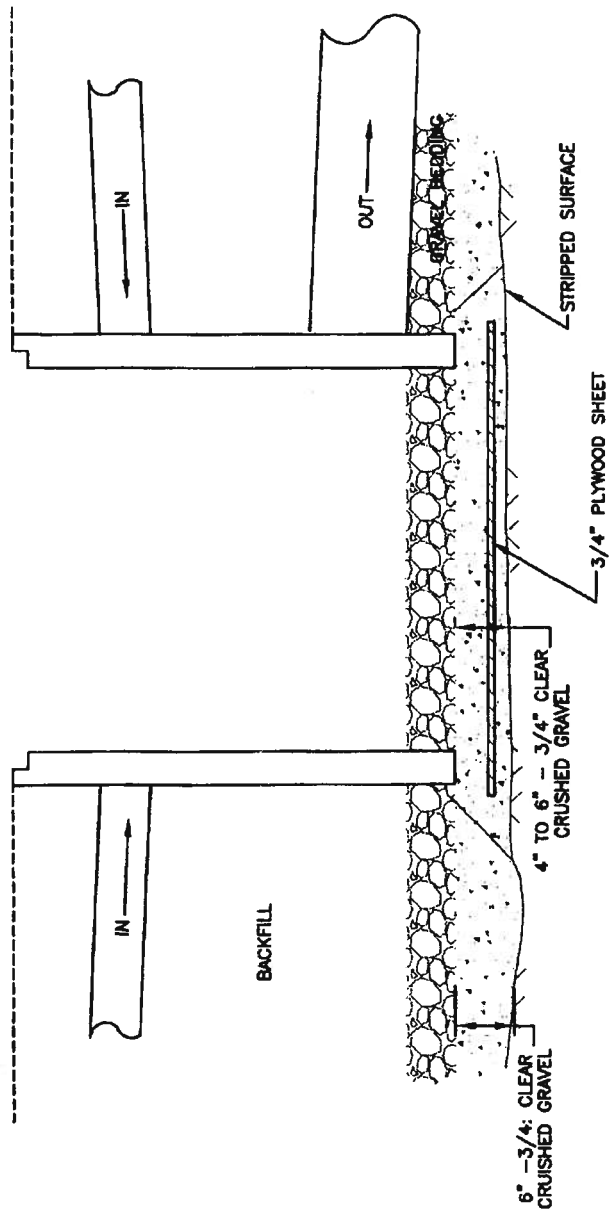
| CLIENT | | CONCORDIA HOMES - THE SHORES | | TITLE | | MANHOLE FOUNDATION PREPARATION | | | |

Where manholes are installed as part of the interceptor drain systems, the subgrade soils are susceptible to rapid softening and degradation of strength when exposed. It is recommended that, as soon as foundation grade for a manhole is exposed, a sheet of  $\frac{3}{4}$ -inch plywood be placed on the subgrade surface followed by 4 to 6 inches of  $\frac{3}{4}$ -inch clear crushed gravel as bedding for the concrete barrel of the manhole. Additional  $\frac{3}{4}$ -inch clear crushed gravel should be placed inside and outside the manhole barrel. It is also recommended that to minimize damage to the subgrade surface, the surface around the manhole be exposed in small sections with each section being covered with at least 6 inches of gravel before the next section is exposed. Figure 5 shows the recommended detail for manhole installation.

Where water-softened conditions spread faster than the softened material can be removed, particularly along the outflow pipe trench from the manhole, it is recommended that a 2-foot layer of 12-inch minus rock be placed as a stabilizing base for the pipe bedding and trench backfill.
