**Phase One Environmental Site  
Assessment – 2656 Concession Road 4,  
Bowmanville, Ontario**

Final Report

September 16, 2024

Project Number:  
122140375

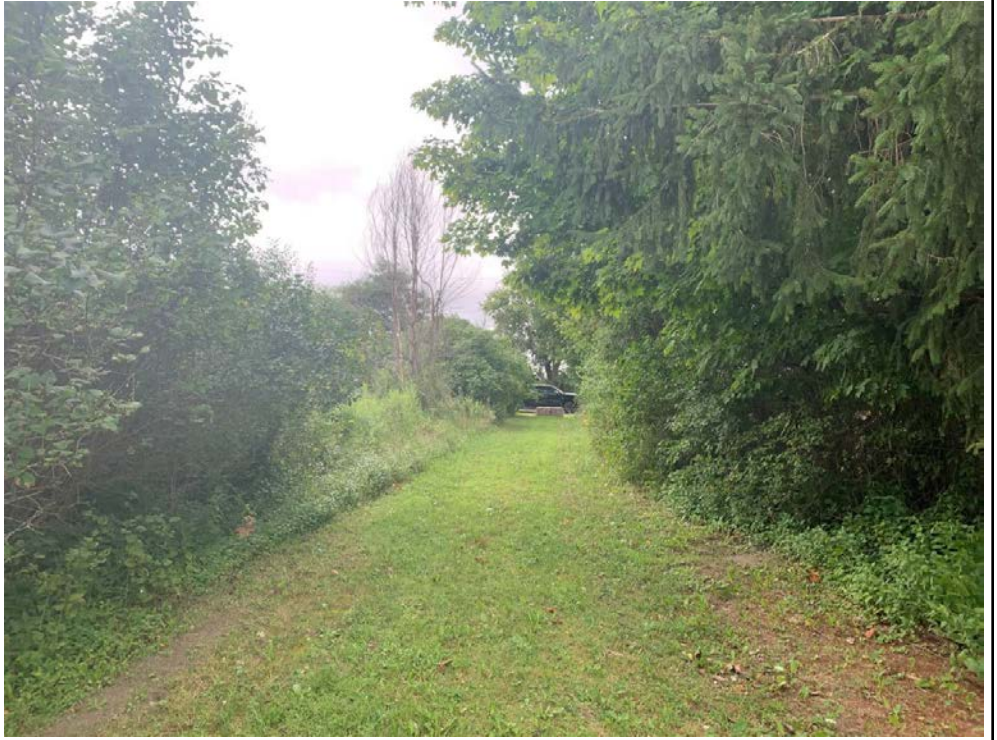
| <b>Photograph ID: 1</b> | | | |

| <b>Comments:</b><br>View of the driveway, facing Concession Road 4 | | | |

A gravel driveway, which appeared to be at a slightly higher elevation than surrounding Phase One Property land, was observed at the Phase One Property during the site visit. Fill material of unknown environmental quality, potentially used to raise the driveway elevation, represents a potential contaminating activity (PCA) contributing to an APEC (APEC #1).

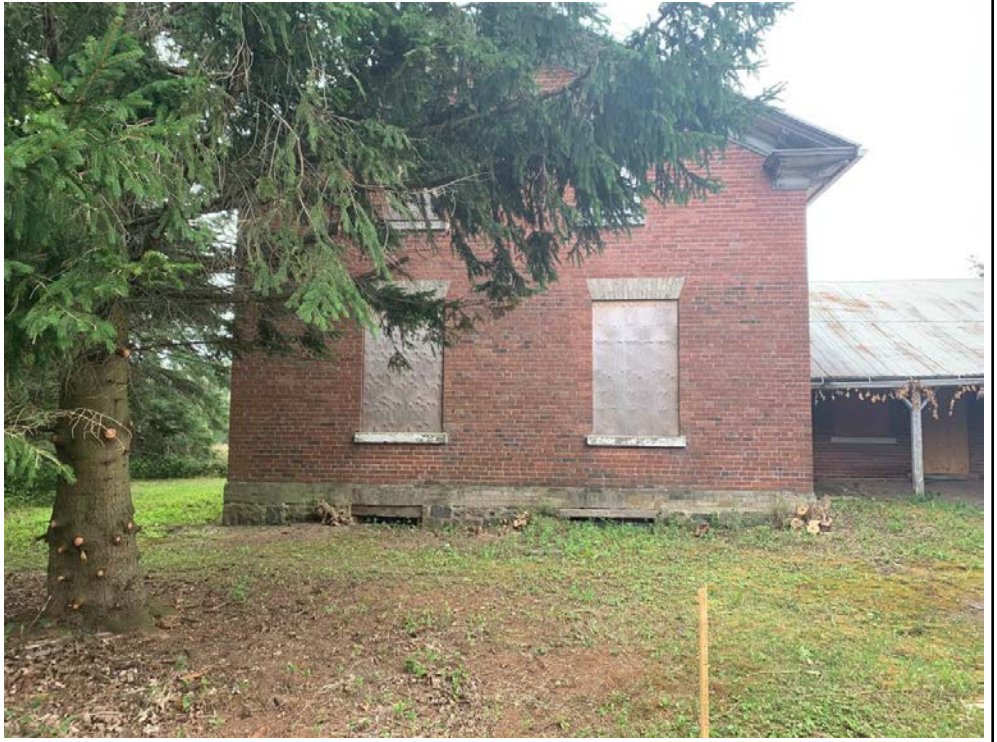
| <b>Photograph ID: 2</b> | | | |

| <b>Photo Location:</b><br>Southwest portion of the Phase One Property | | | |
| <b>Direction:</b><br>Facing west | | | |

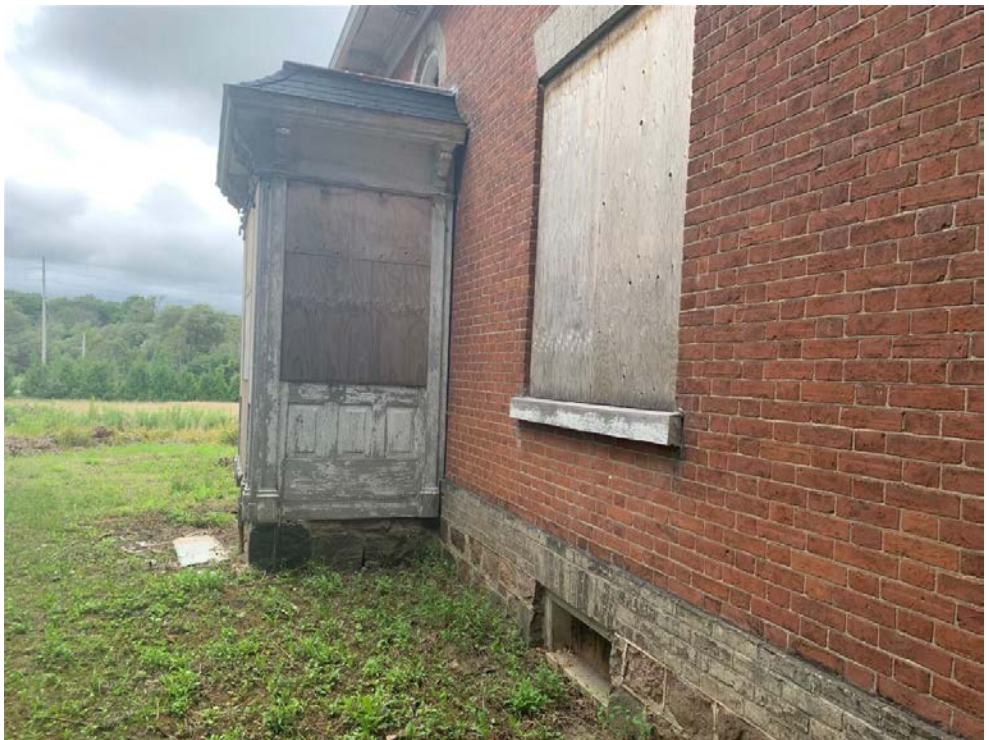
| <b>Photograph ID: 3</b> | | | |

| <b>Comments:</b><br>View of south side of the vacant dwelling | | | |

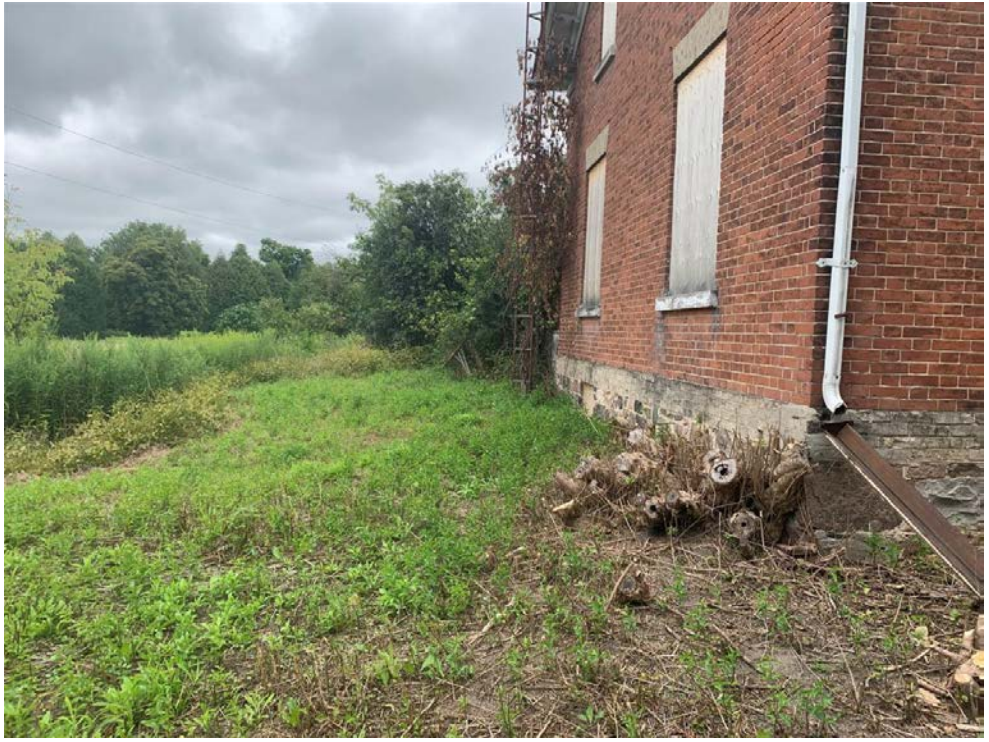
| <b>Photograph ID: 4</b> | | | |

| <b>Photo Location:</b><br>Southwest portion of the Phase One Property | | | |
| <b>Direction:</b><br>Facing north | | | |

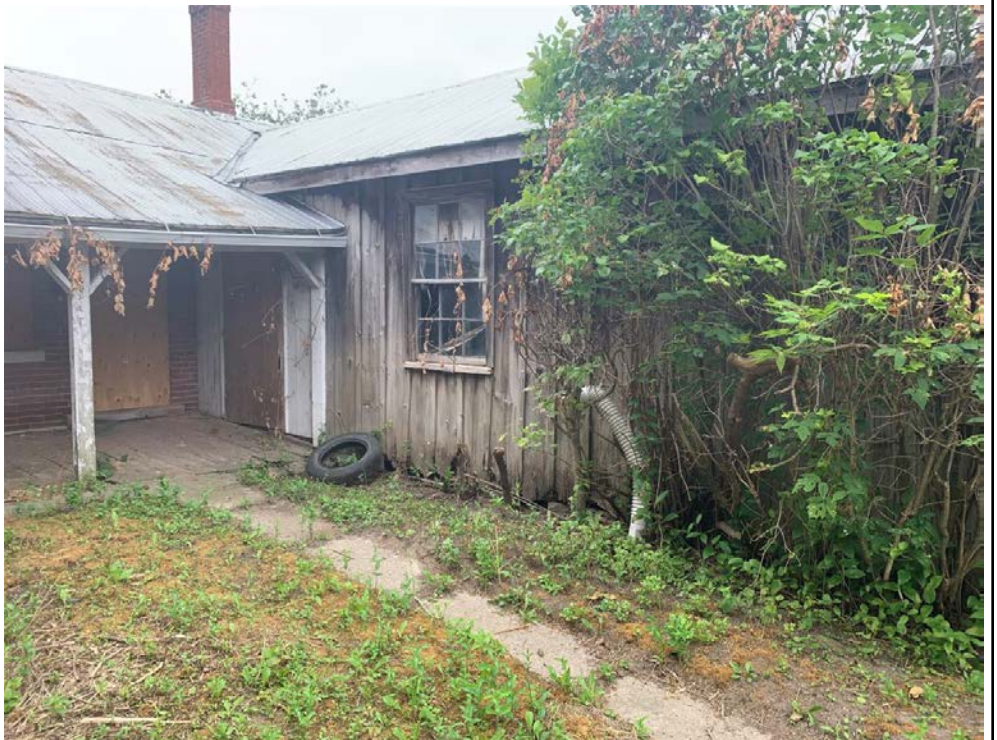
| <b>Photograph ID: 5</b> | | | |

| <b>Comments:</b><br>View of the south side of the vacant garage/shed | | | |

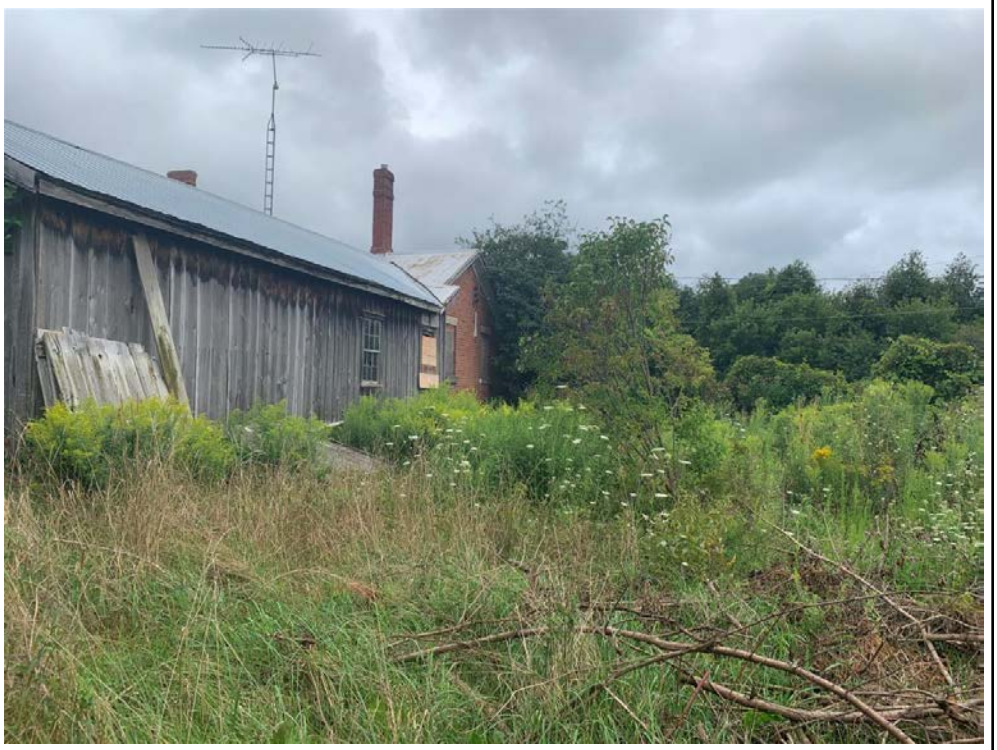
| <b>Photograph ID: 6</b> | | | |

| <b>Photo Location:</b><br>Southwest portion of the Phase One Property | | | |
| <b>Direction:</b><br>Facing southwest | | | |

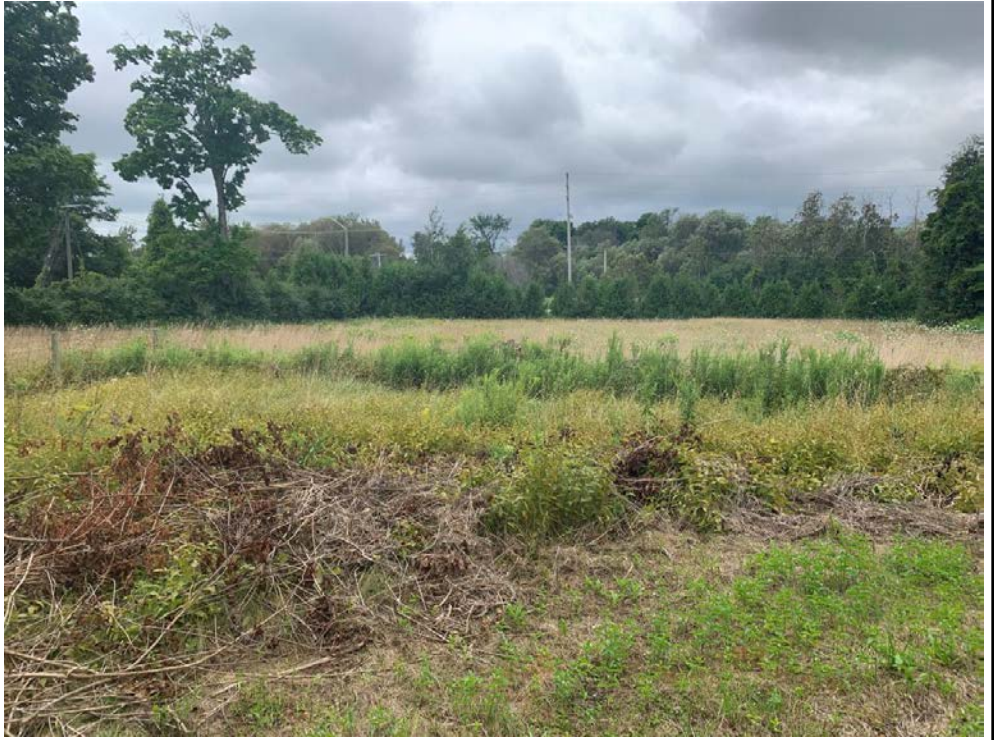
| <b>Photograph ID: 7</b> | | | |

| <b>Comments:</b><br>View of the southwest portion of the Site | | | |

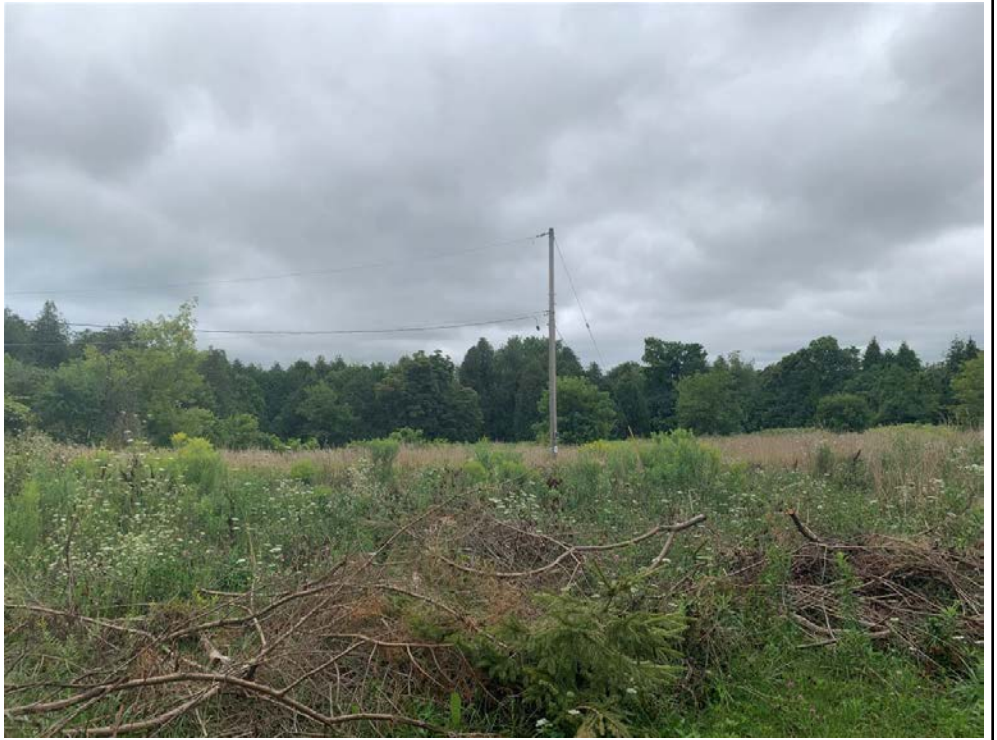
| <b>Photograph ID: 8</b> | | | |

| <b>Photo Location:</b><br>Southwest portion of the Phase One Property | | | |
| <b>Direction:</b><br>Facing north | | | |

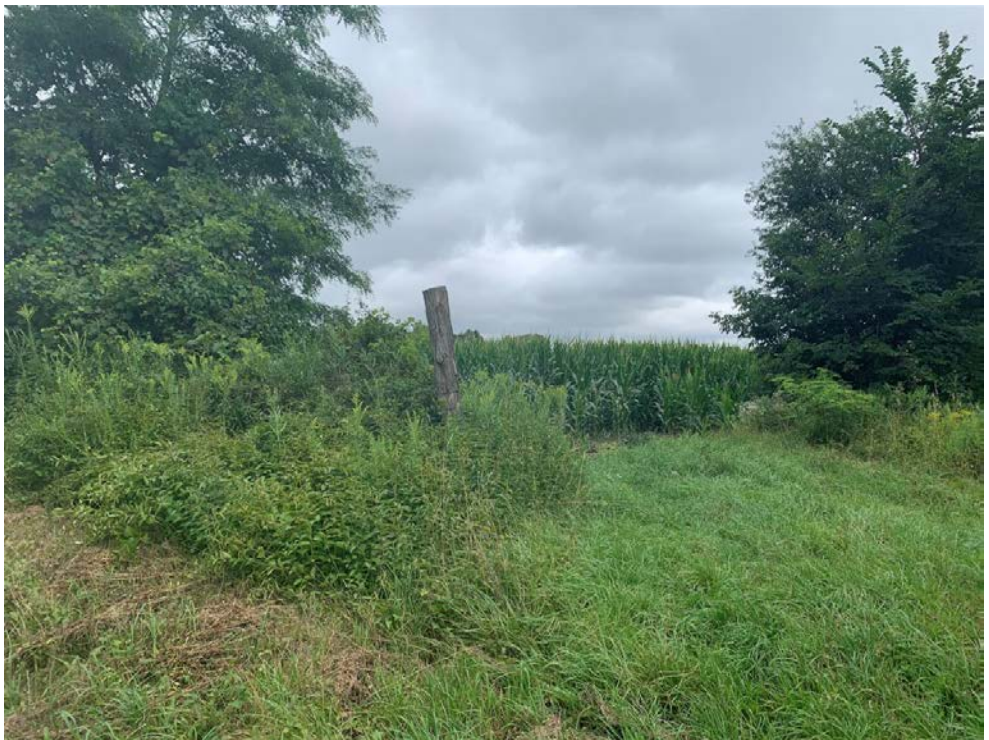
| <b>Photograph ID: 9</b> | | | |

| <b>Comments:</b><br>View of the southeast portion of the Site, including the agricultural portion | | | |

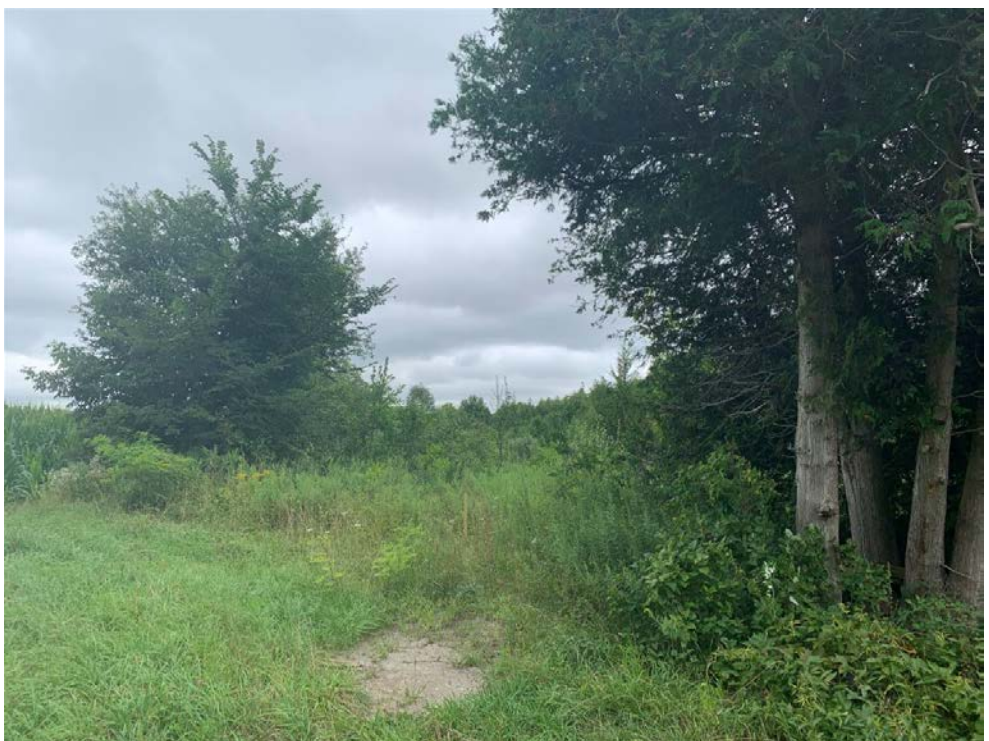
| <b>Photograph ID: 10</b> | | | |

| <b>Photo Location:</b><br>Southeast portion of the Phase One Property | | | |
| <b>Direction:</b><br>Facing north | | | |

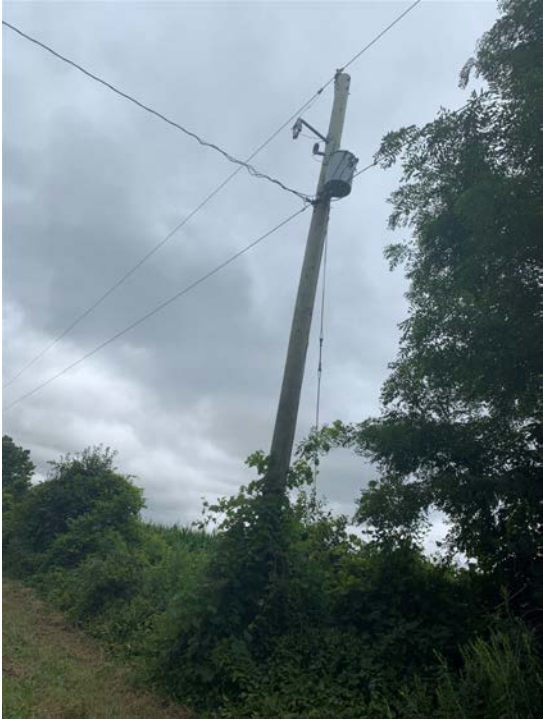
| <b>Photograph ID:</b> 11 | | | |

| <b>Photo Location:</b><br>Southeast portion of the Phase One Property | | | |
| <b>Direction:</b><br>Facing northwest | | | |
