2025 Annual Performance Report  
Stormwater Management System

**ECA Number: 170-S701**

Town of Arnprior  
July 2026

| <b>System Name:</b> Town of Arnprior Stormwater Management System | |

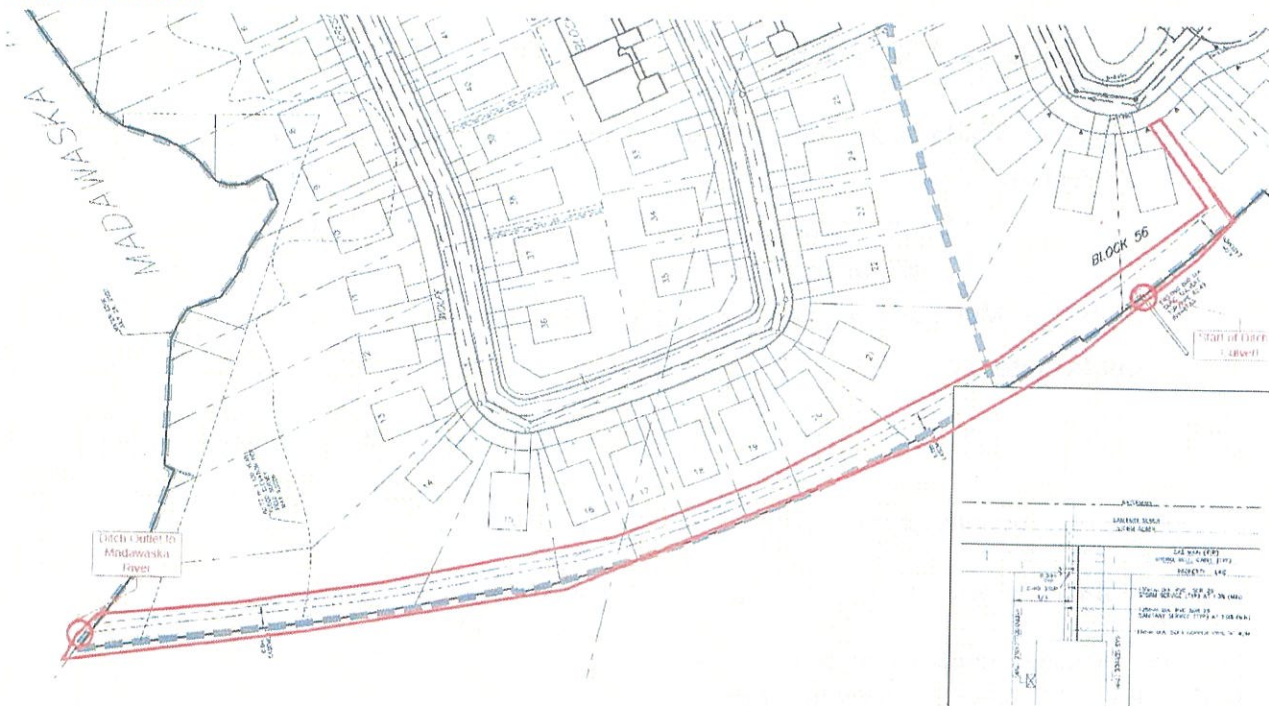
## Appendix 8C- Ditch System Swale Inspection & Maintenance Log

Type of material removed: Brush & estimated quantity: 50 small shrubs
