**HIGH LEVEL BANK STABILITY REVIEW  
PEMBINA RIVER VALLEY  
ENTWISTLE, ALBERTA  
REVISION 1**

**Report  
to  
Parkland County**

Date: November 29, 2017  
File: 18683

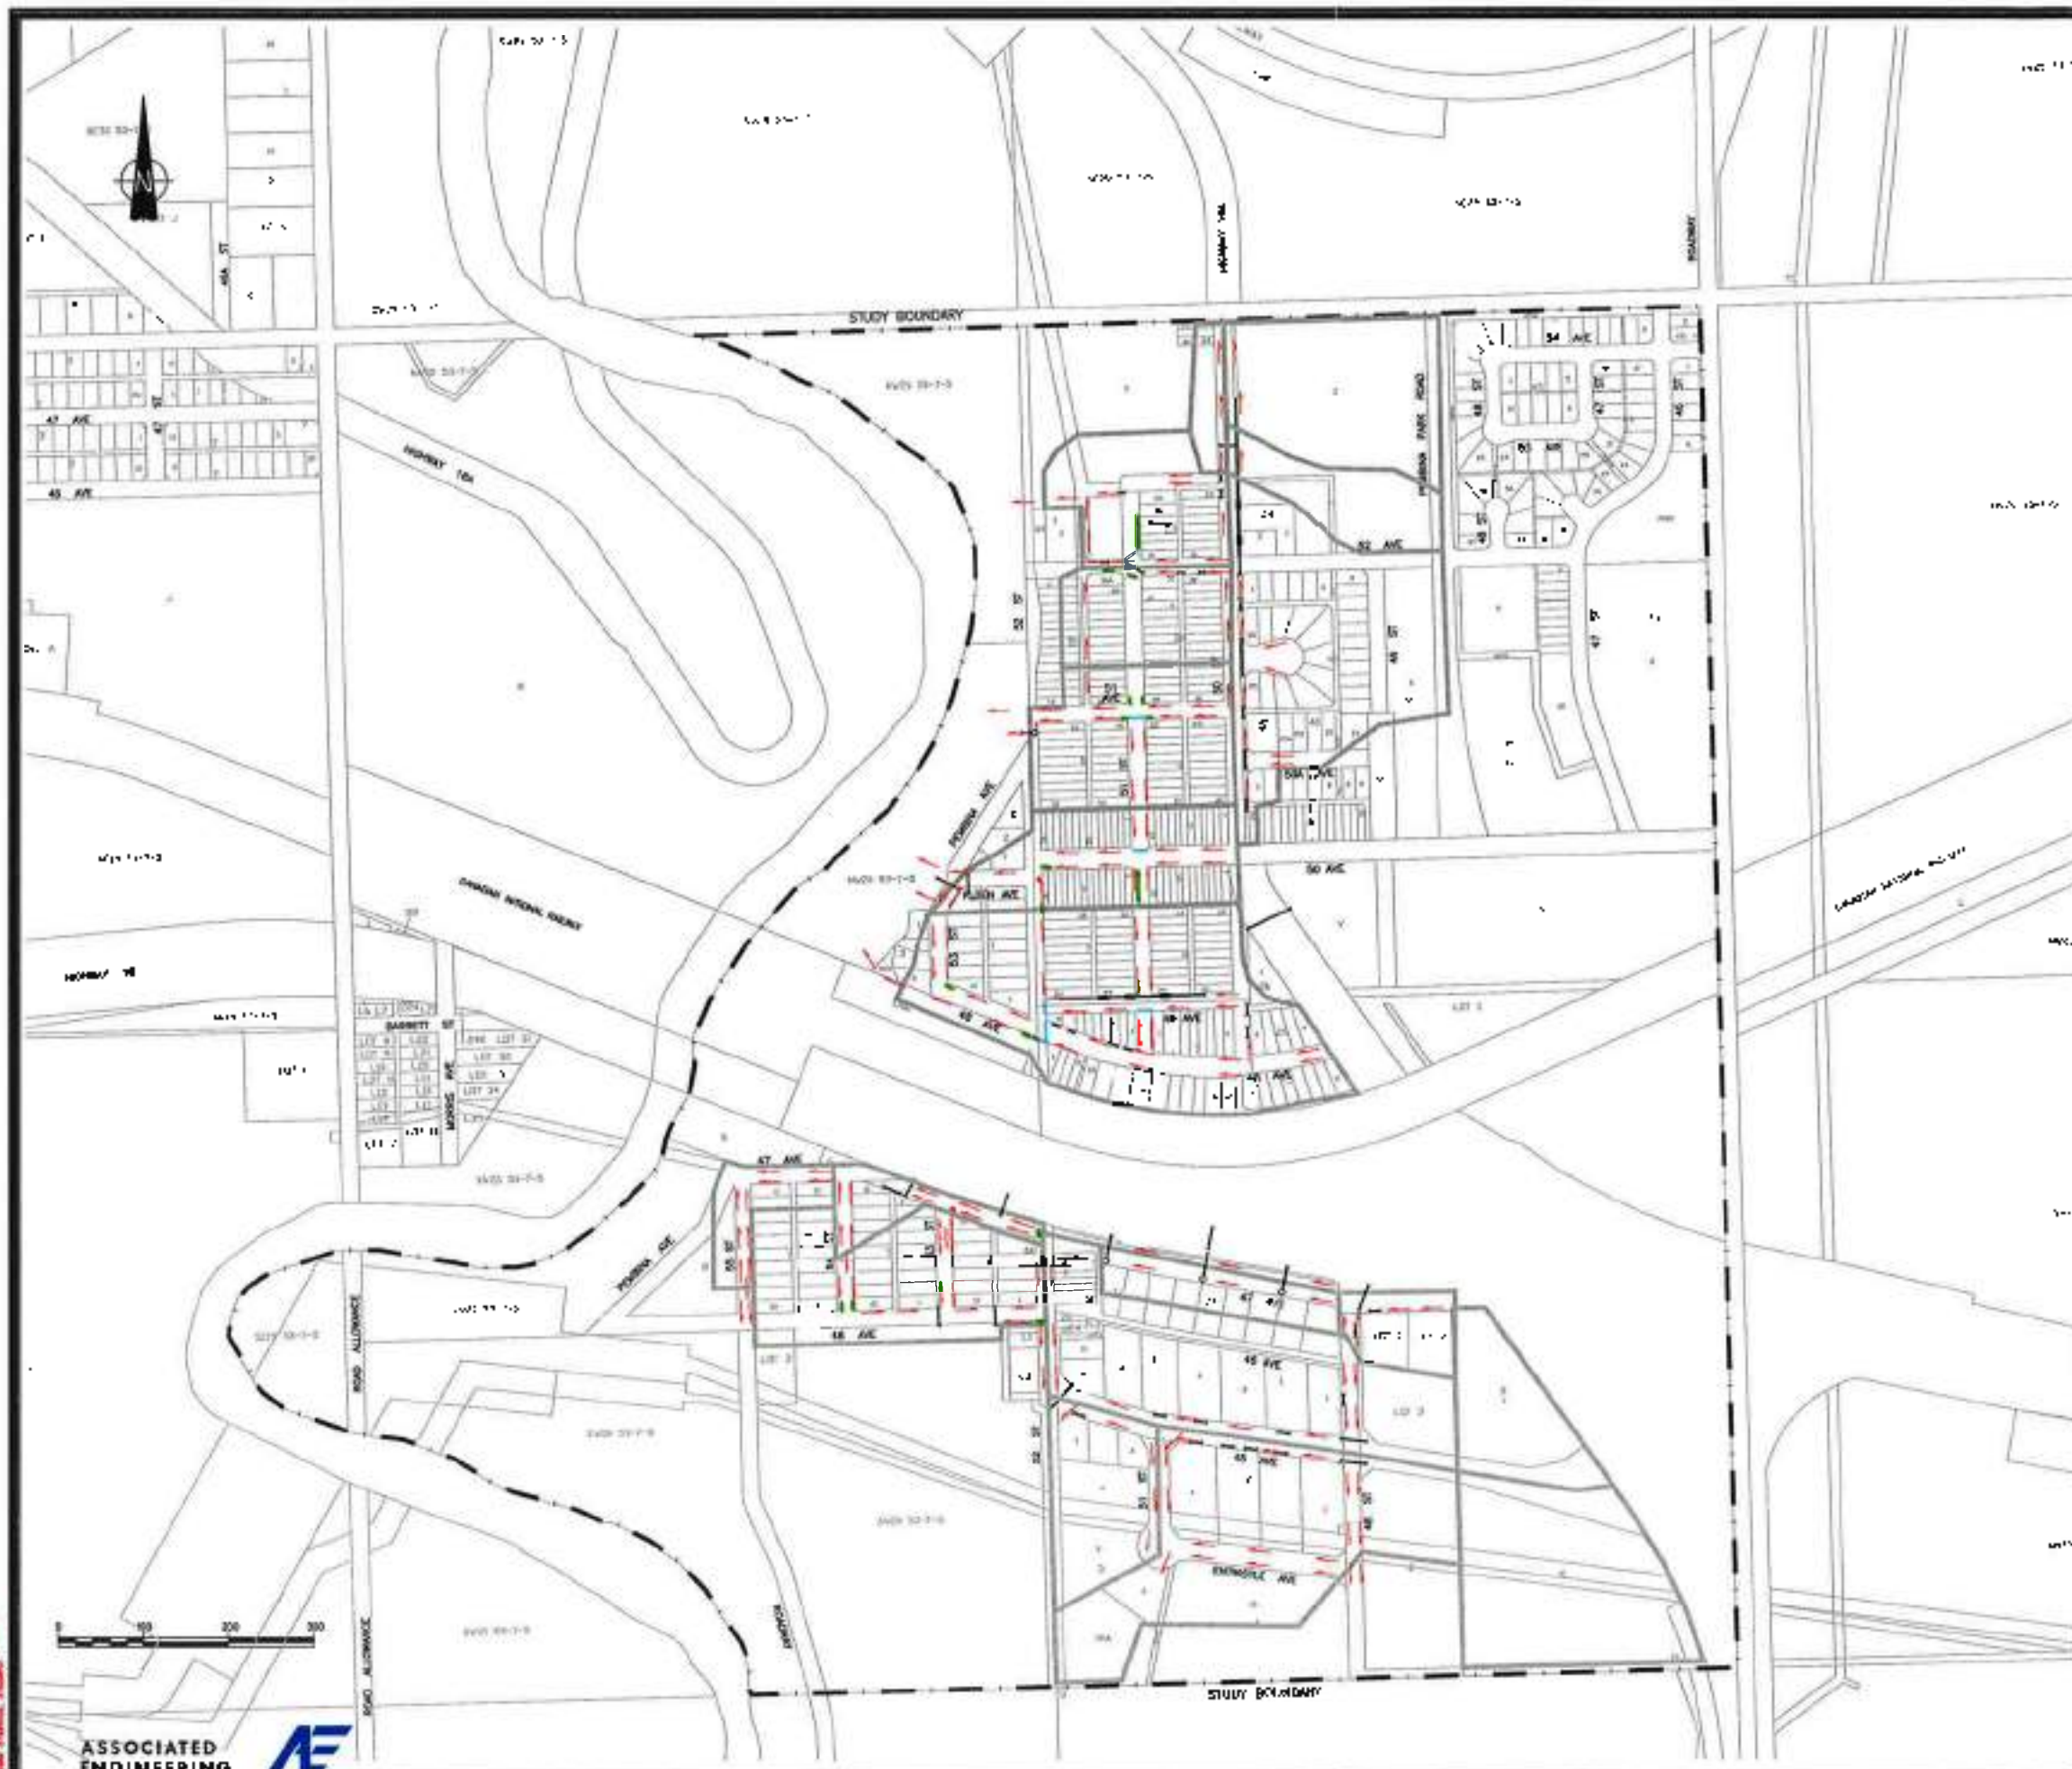
FIGURE 6.1

Five of these locations (48, 50 – two locations, 51, and 53 Avenues) are located north of Highway 16 in the defined Northwest Drainage Basin and one location (47 Avenue) is located south of Highway 16 in the Southwest Drainage Basin. These locations are illustrated on Figure 6.1 taken from the report, provided in Appendix B, as well as Drawing Nos. 18683-8A in Appendix A.

As mentioned, the Northwest Basin is the most developed of the four basins, corresponding to the most developed residential area of Entwistle. However, as observed in the report, despite the construction of some ditch and culvert infrastructure, the drainage is described as poor, resulting in numerous areas of ponding, typically at intersection corners, but some river discharge locations do provide some conveyance of flow.

For the Southwest Basin, the majority of the runoff flow follows the roadways and gutters intercepted by some ditches and culverts. With discharge moving to the south. Ponding is also observed in this area at intersections.

The report further provided recommendations for upgrading the storm drainage infrastructure recognizing that major regrading of the existing roadways was not feasible. The proposed upgrades were presented in Figure 6.2, provided in Appendix B. In the Northwest Basin, a network of storm sewers with defined discharge points on the bank of the river valley was proposed. In the Southwest Basin, it was recommended that catch basin and culvert upgrades be undertaken.

It is understood that the recommended storm sewer has not been installed, nor will it be installed as it is cost prohibitive. There have been some minor improvements to drainage in Entwistle since 2000, none of which have served to improve or reduce the effects of discharge over the bank of the river valley.

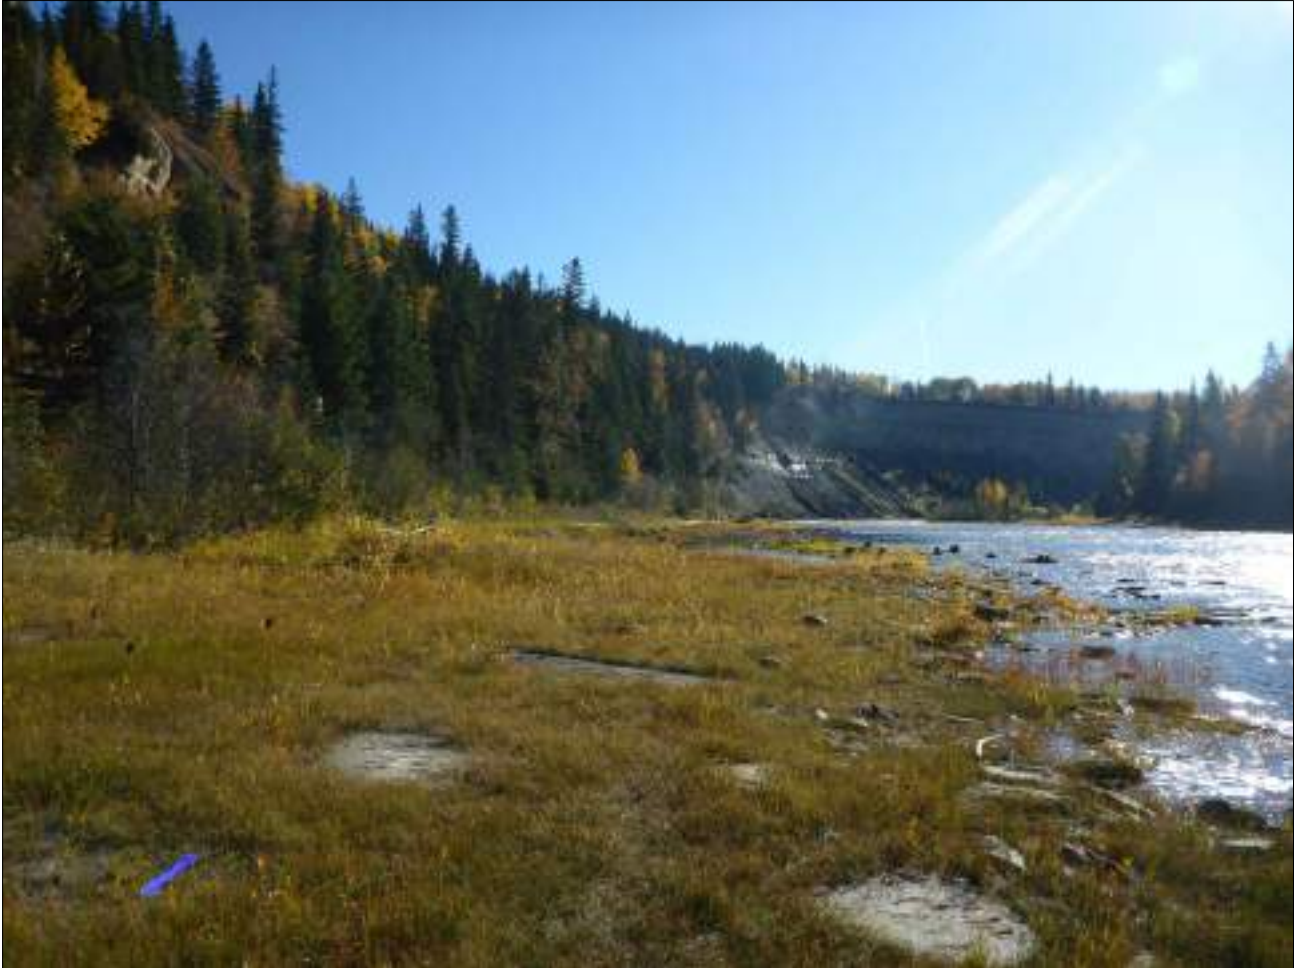
The available LiDAR survey indicates that slopes in this area are generally between 20 and 45 degrees, with some of the upper slopes where sloughing has occurred being over 45 degrees. In general, these steeper slopes are located towards the south of the identified site where the river is more concave in route (Photos 7 and 8, Appendix C). Along some of these southern slopes, near vertical walls have been exposed near the crest of the slopes with colluvial material collecting at the toe. The contact between overburden soils to bedrock is visually observable as a relatively horizontal line at approximately 10 m depth from the crest (Photos 9 and 10, Appendix C). Some midslope seepage was also observed along these slopes. These slides appear to be relatively historic in nature, as the colluvial slopes at the toe have some mature vegetation growing on them.

PHOTO 7 SITE 2 - OVERALL VALLEY SLOPE - SOUTH

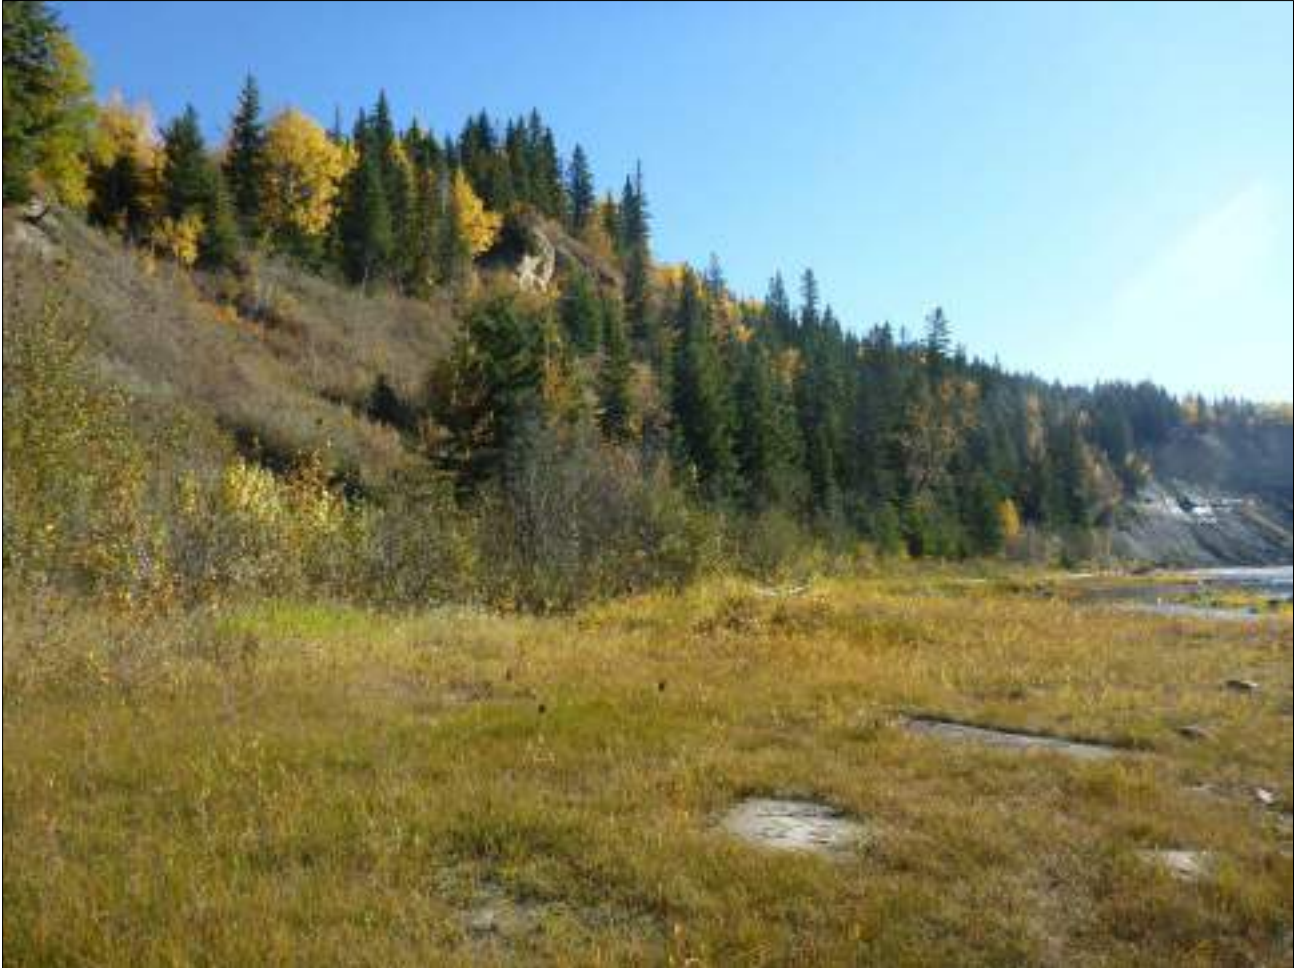
PHOTO 8 SITE 2 - OVERALL VALLEY SLOPE - SOUTH

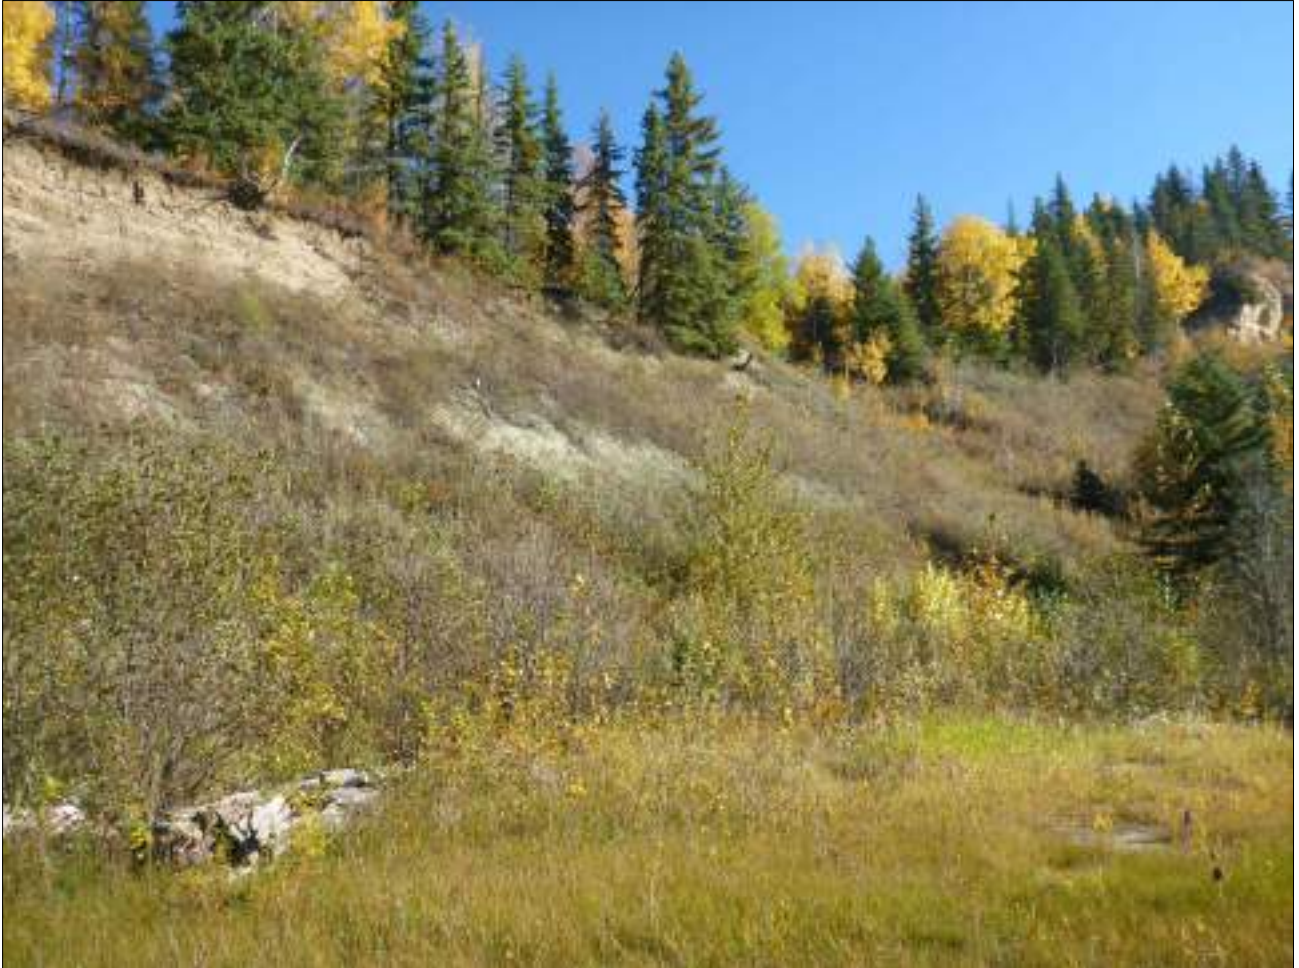
The valley slope along the north portion of this area is where the more recent slope movement was identified in the desktop study. These slopes show some exposed overburden and sandstone outcrops, but are much shorter in height compared to the northern portion, due to more gradual upper slopes in this area (Photos 11, 12, and 13, Appendix C). The colluvium in this area at the toe of the slope features more recently started vegetation. The failure in this area appears to be a retrogressive one that in time has moved back from the crest. However, the vegetation that is on the slopes is vertical, indicating that the movement has not occurred in the very recent past, confirming the result of the desktop study where it was suggested that these slope movements have occurred decades in the past.

PHOTO 11 SITE 2 - OVERALL VALLEY SLOPE - NORTH

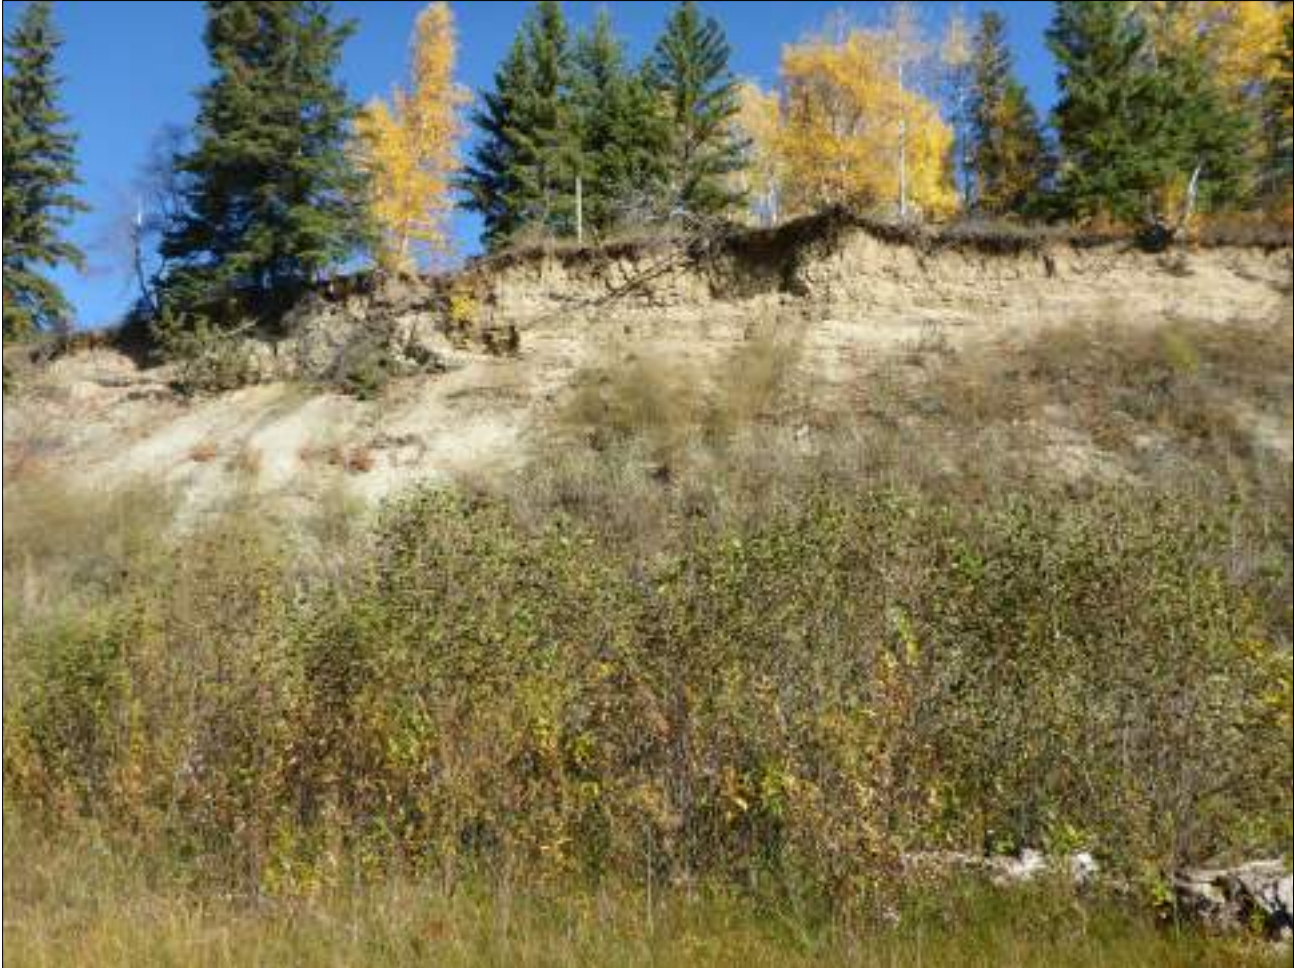
PHOTO 12 SITE 2 - OVERALL VALLEY SLOPE - NORTH

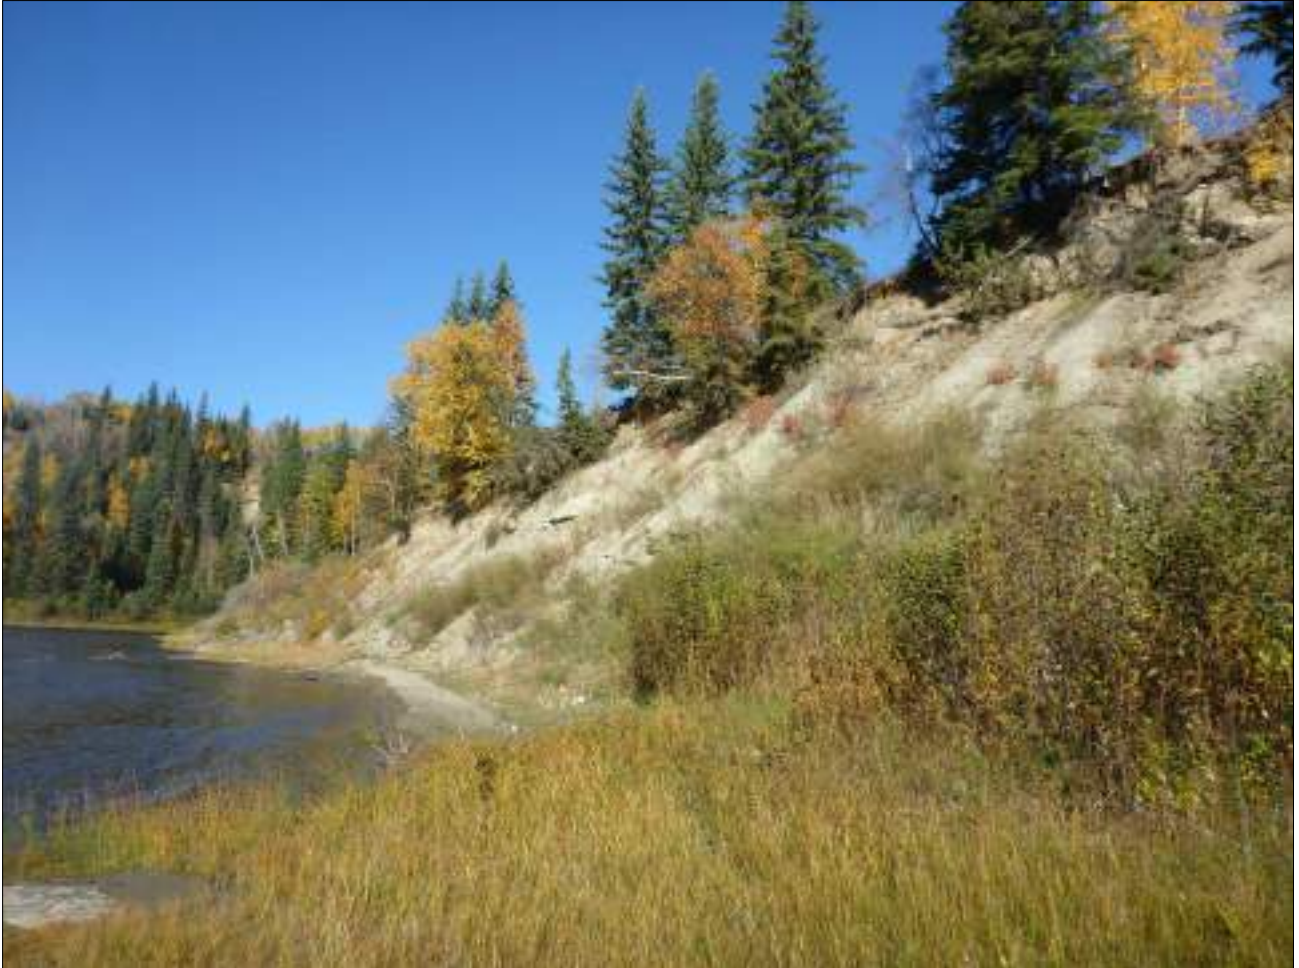
PHOTO 13 SITE 2 - OVERALL VALLEY SLOPE - NORTH

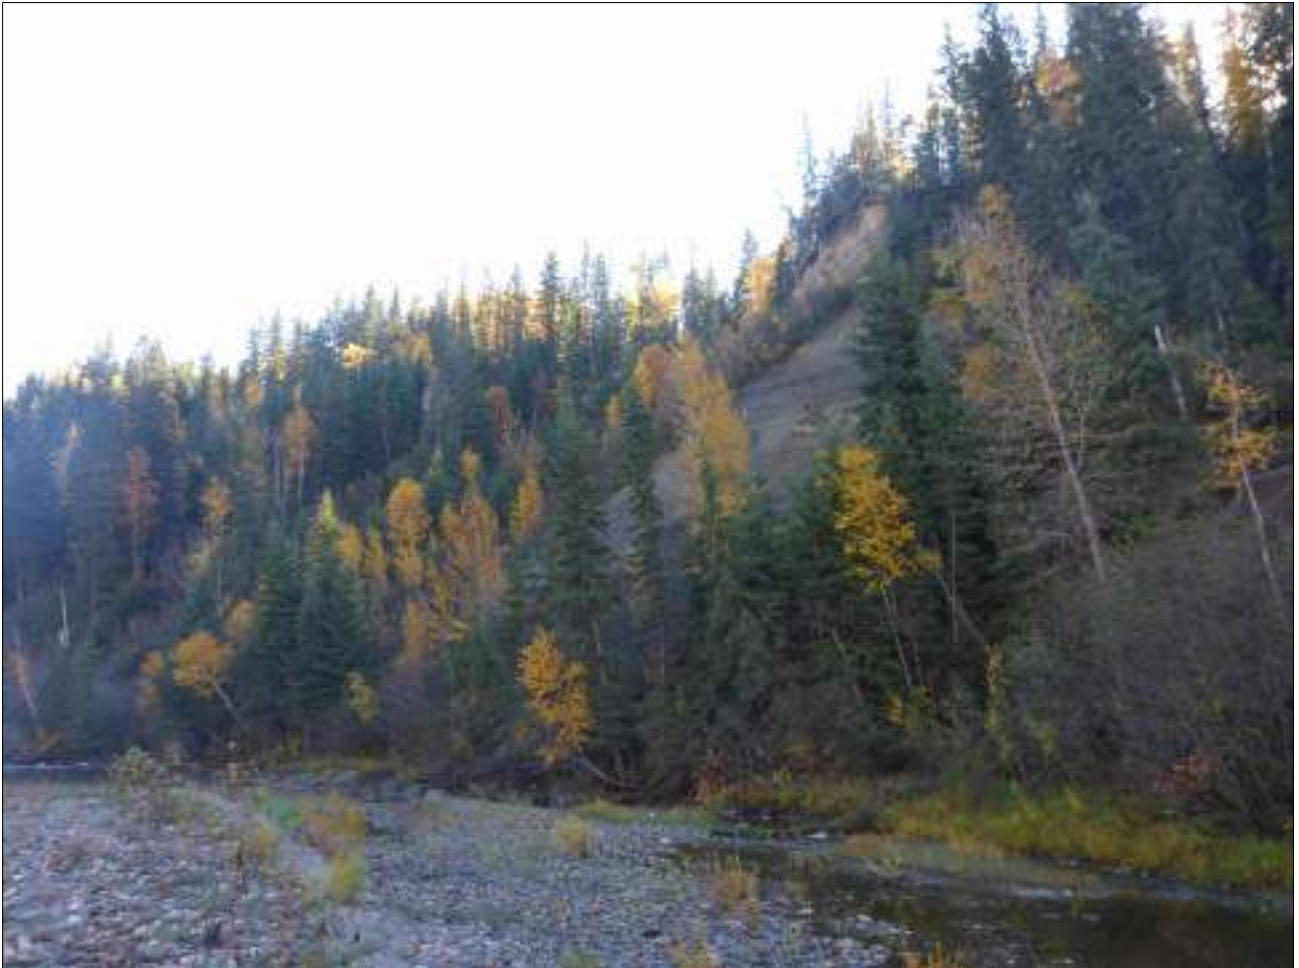
LiDAR data indicates that the majority of slopes in this area are in the range of 20 to 45 degrees with some of the upper slopes greater than 45 degrees. Towards the south end of the site, an exposed slope could be observed (Photo 14, Appendix C) where a possible landslide zone

PHOTO 14 SITE 3 - OVERALL VALLEY SLOPE - SOUTH

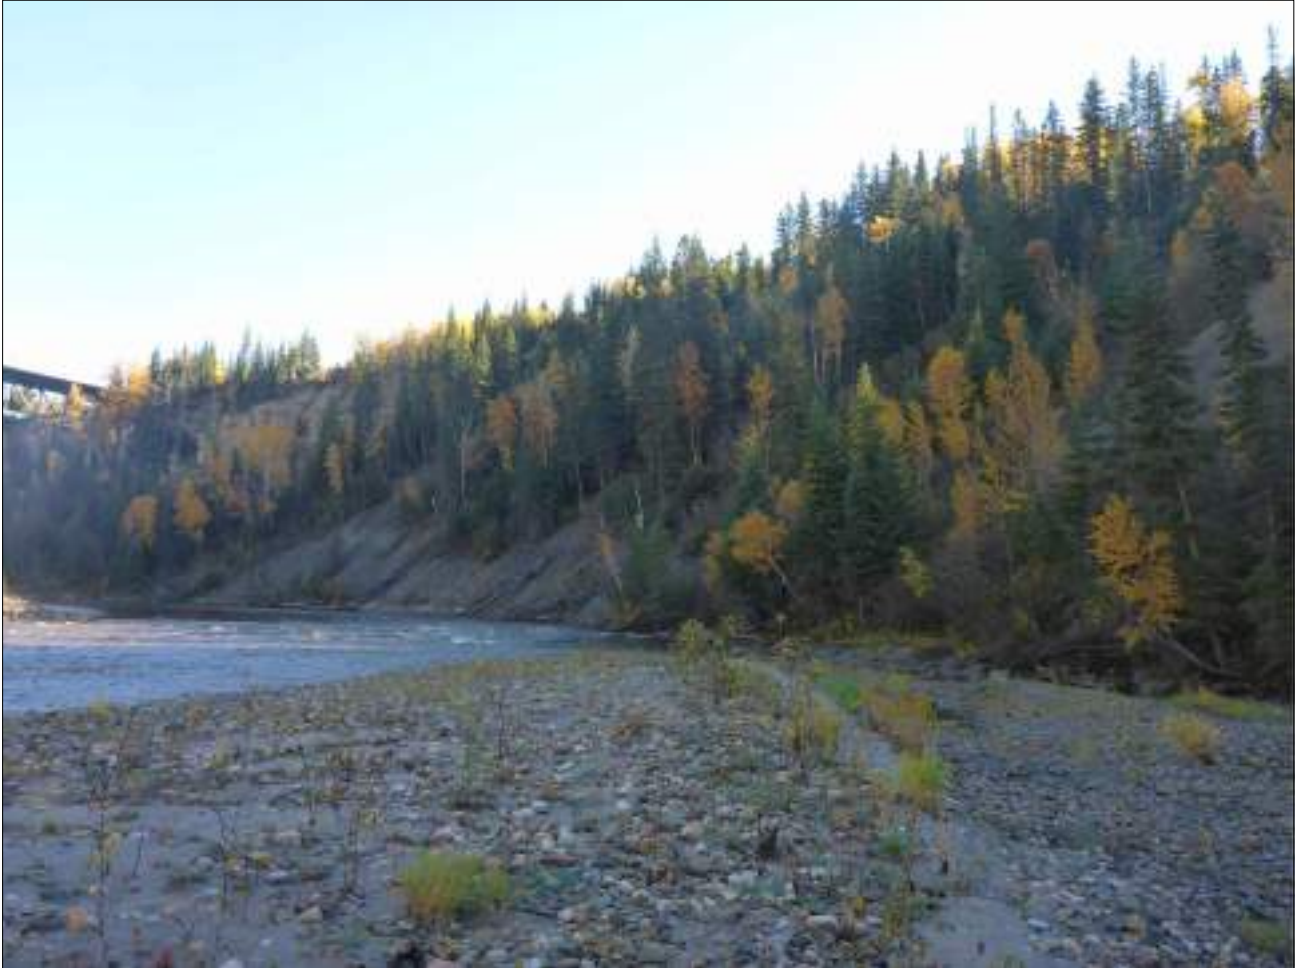
In the middle of the area the slopes appeared to be more stable with no visible outcrops and uniform mature vertical vegetation (Photo 15, Appendix C). This area also featured some colluvial slopes of previously mobilized material with mature vegetation growing on it (Photos 18 and 19, Appendix C). However, there is also a small amount of tree deadfall on these slopes that appears to indicate that some movement has occurred in the past and some trees have fallen as a result of it.

PHOTO 15 SITE 3 - OVERALL VALLEY SLOPE - MIDDLE

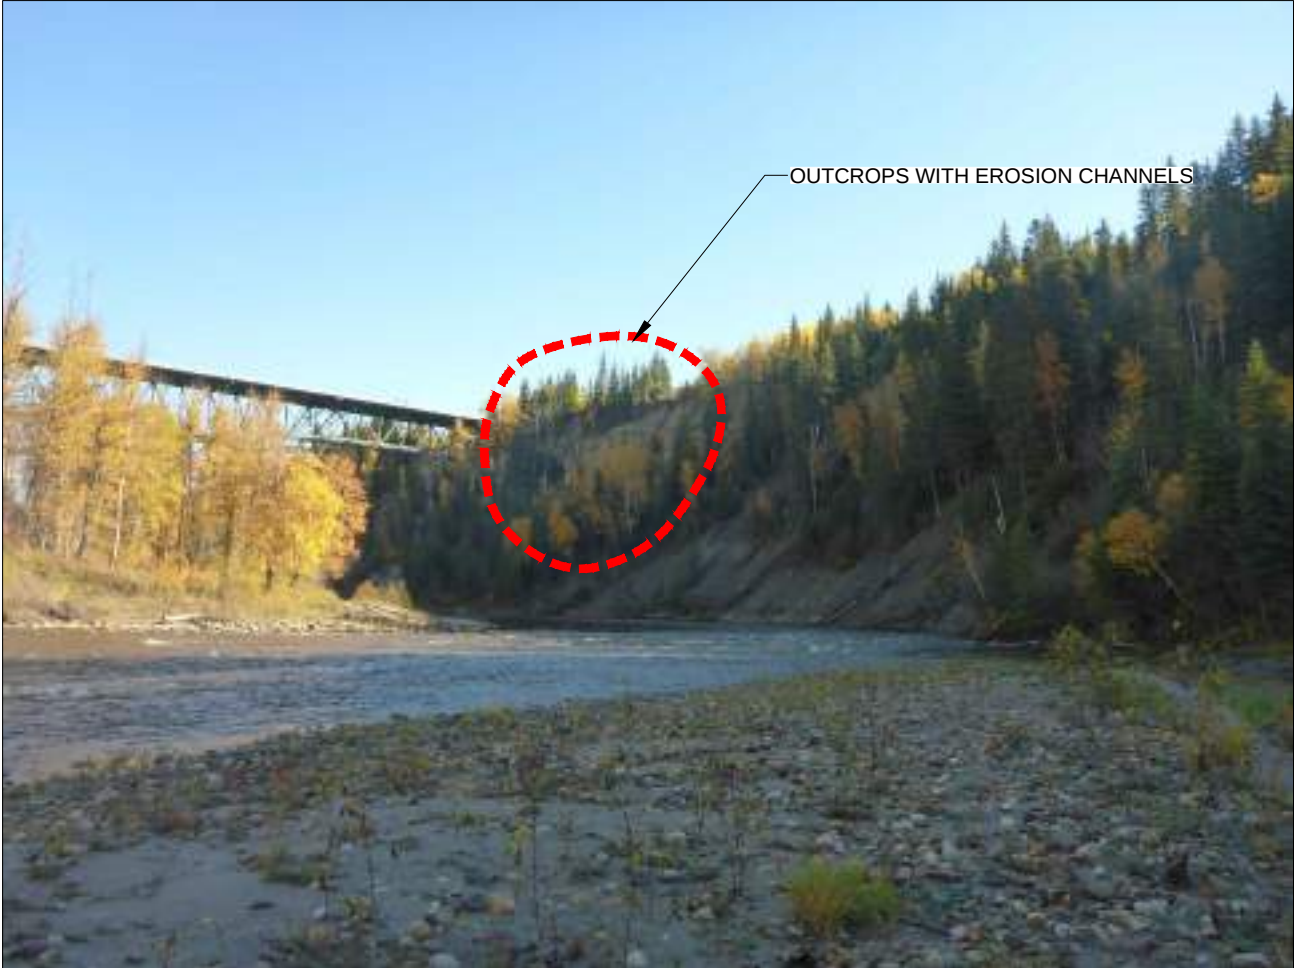
Towards the north end of Site 3, some exposed outcrops could be observed, with some visible erosion channels running through them (Photo 16, Appendix C). This is consistent with reports from Parkland County that the landowner in that area is concerned with the overland flow he can observe from the west side of his property.

PHOTO 16 SITE 3 - OVERALL VALLEY SLOPE - NORTH

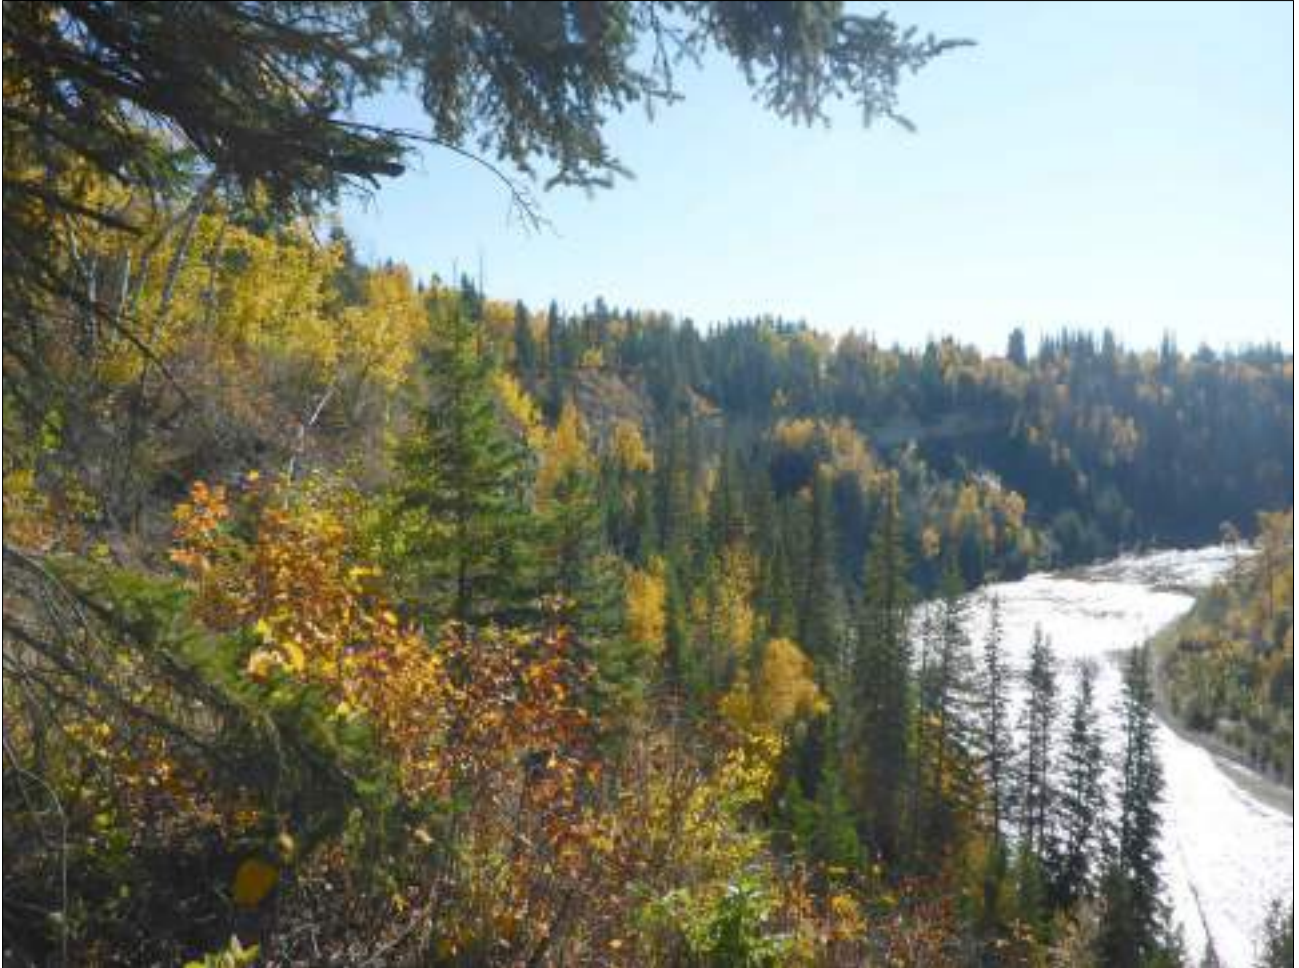
The valley slopes in the Site 4 area are located southwest of the end of Township Road 534 at the north end of the defined study area. This zone is located at the northern reaches of the developed residential area on Entwistle that is north of Highway 16. The area can be considered as heavily forested with mature vegetation as the townsite transitions to the lands within Pembina River Provincial Park. Most of this vegetation as viewed from the crest area appears to be vertical in growth pattern (Photos 20 and 21, Appendix C).

PHOTO 20 SITE 4 - TYPICAL SLOPE VEGETATION CONDITIONS

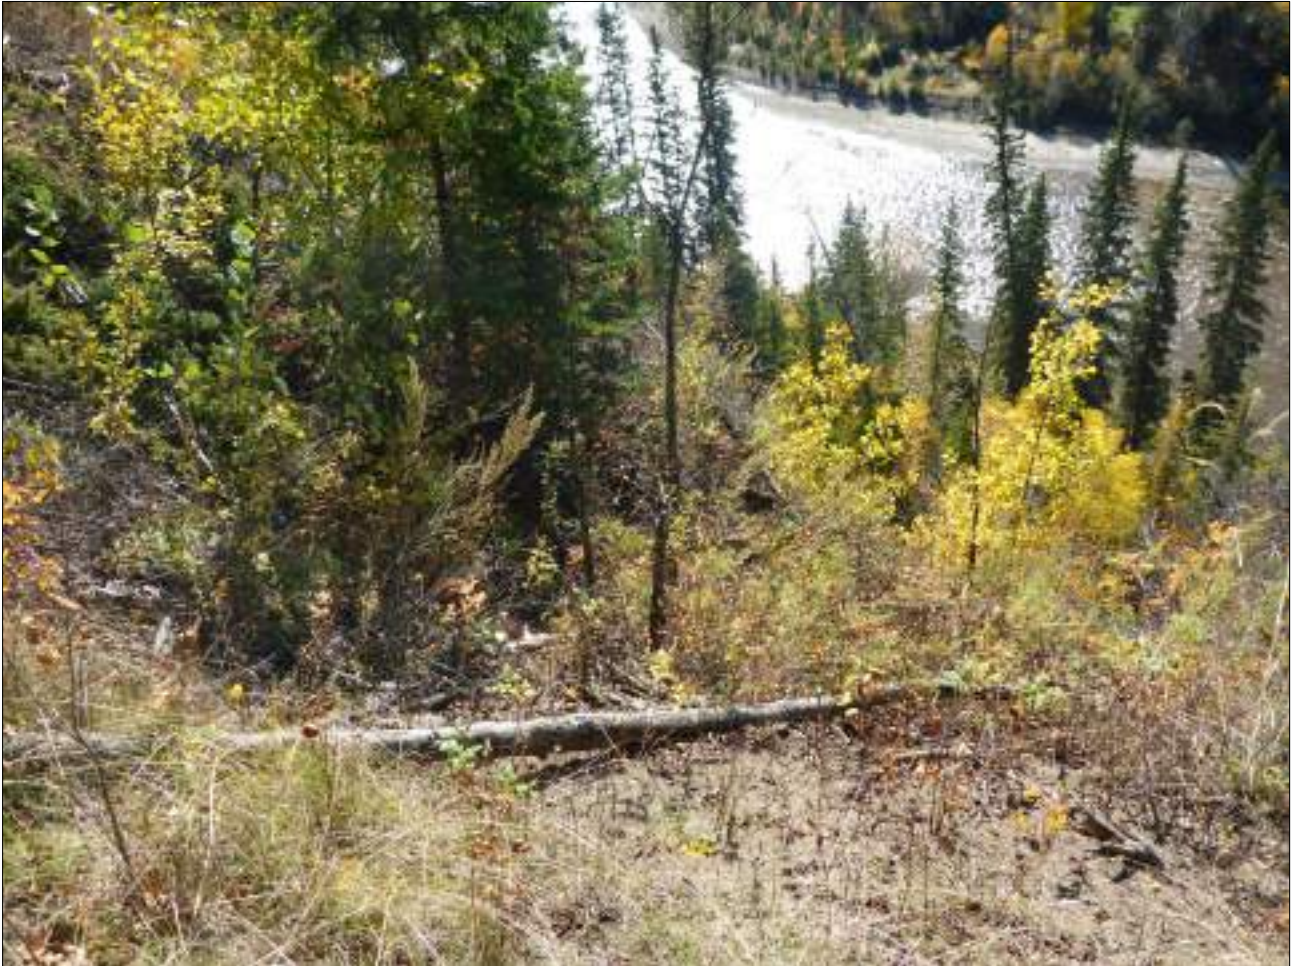
PHOTO 21 SITE 4 - TYPICAL SLOPE VEGETATION CONDITIONS

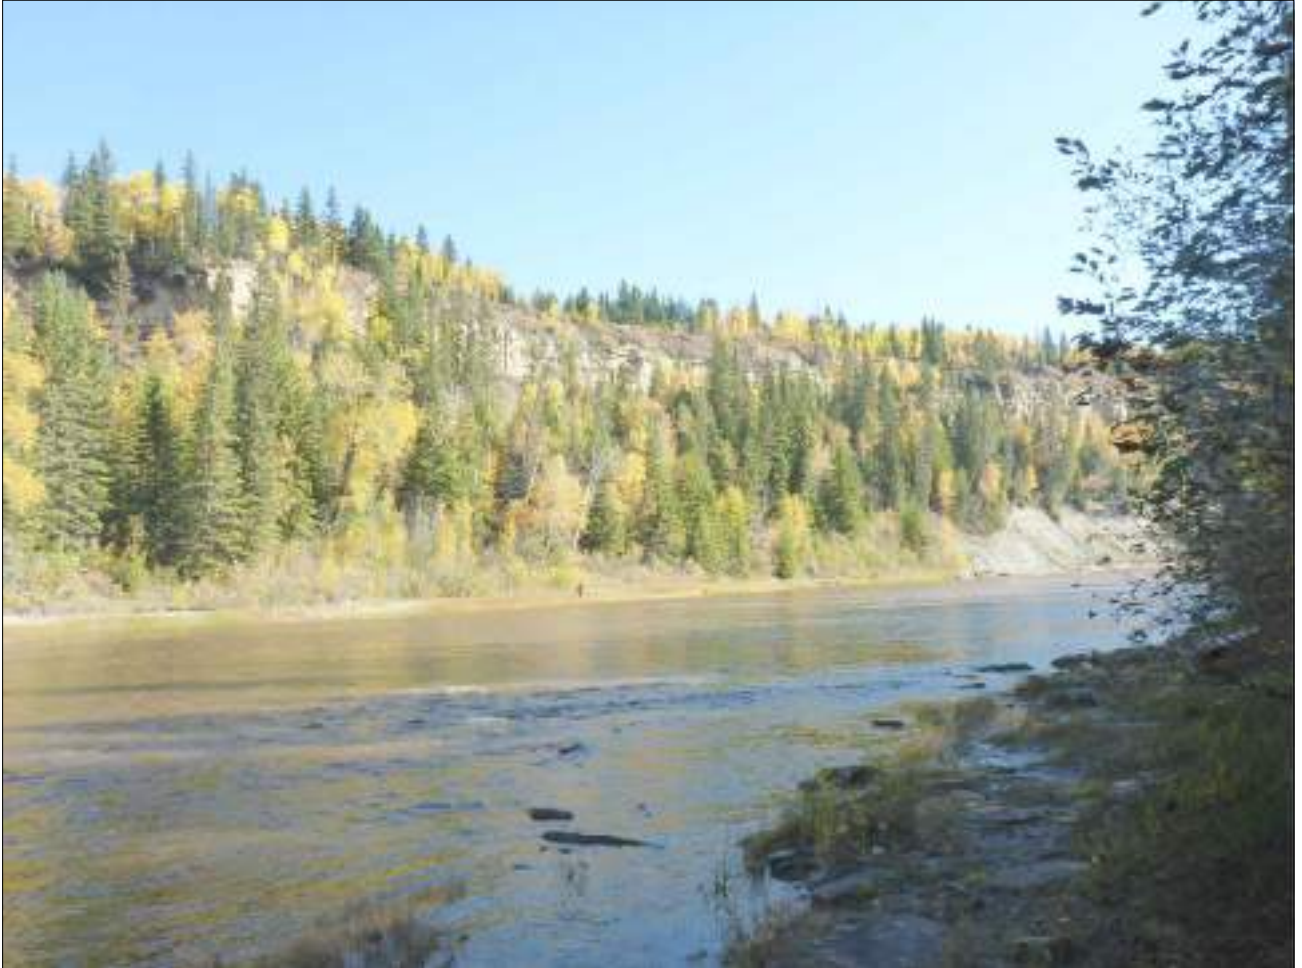
PHOTO 22 SITE 4 - OVERALL VALLEY SLOPE - SOUTH

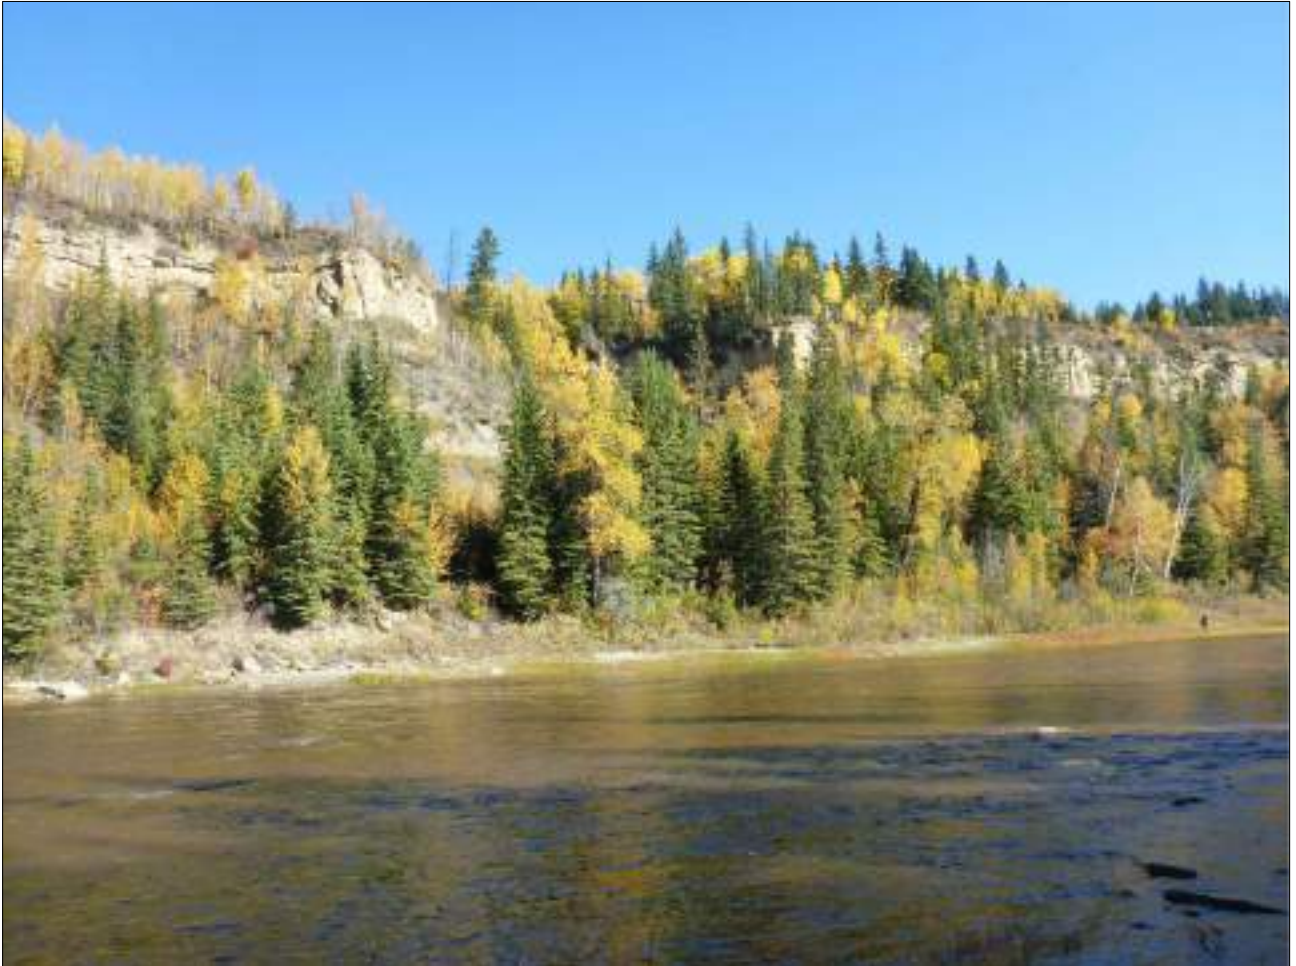
The exposed vertical walls indicated by the LiDAR survey are visually evident along the southern, middle, and northern portions of this site. Colluvial slopes of previously mobilized material is quite consistent across the entire length of the site (Photos 23, 24, 25, and 26, Appendix C). These colluvial slopes generally feature large mature tree vegetation that is relatively vertical in growth. These slopes appear to have moved in the past, possibly decades ago, and the exposed sandstone vertical faces appear to be stable and relatively shallow (approximately 5 m below the crest elevation).

PHOTO 23 SITE 4 - OVERALL VALLEY SLOPE - MIDDLE

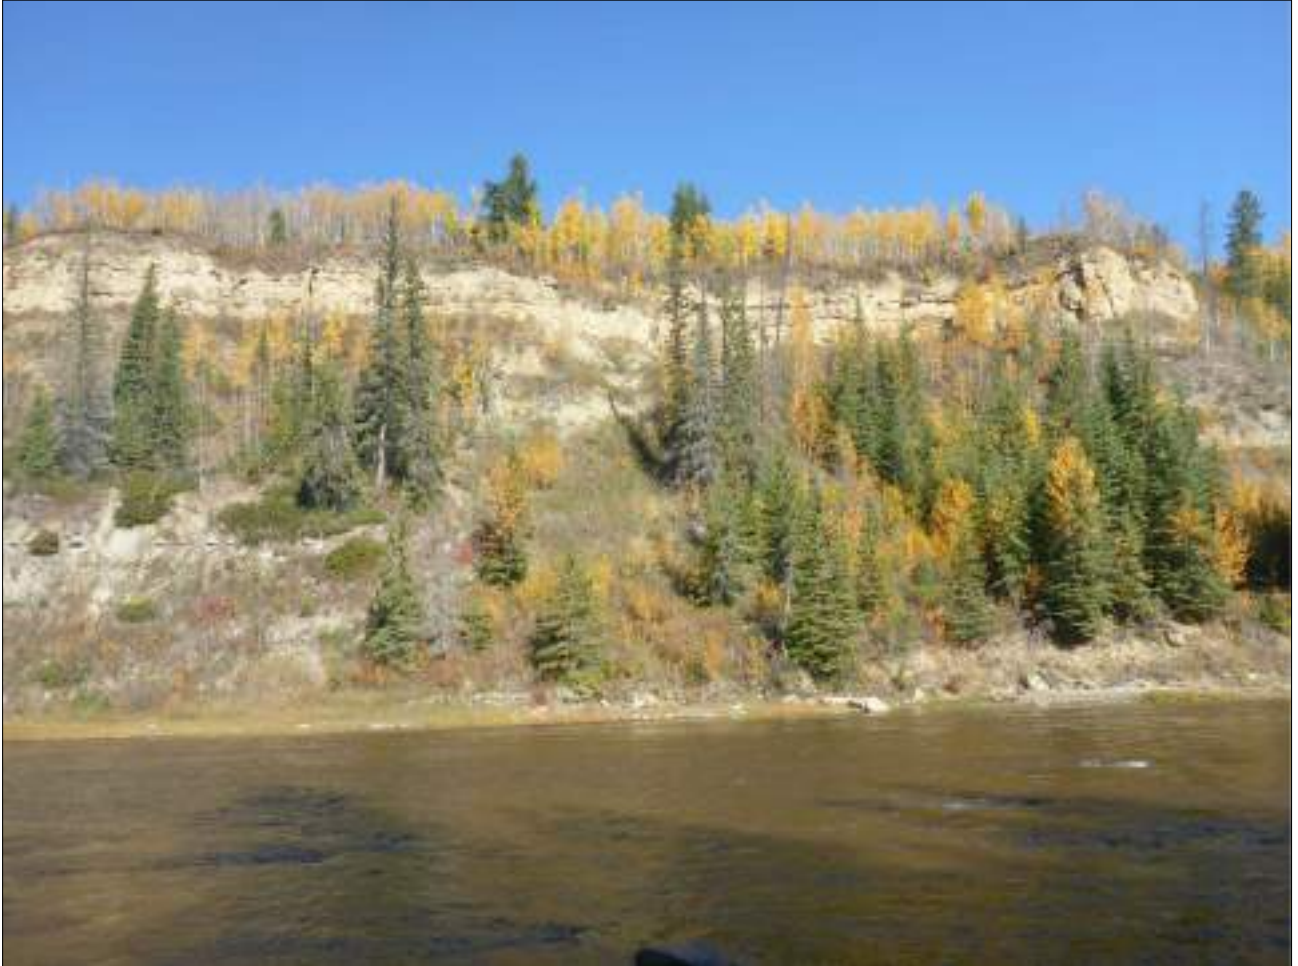
PHOTO 24 SITE 4 - OVERALL VALLEY SLOPE - MIDDLE
