**HIGH LEVEL BANK STABILITY REVIEW  
PEMBINA RIVER VALLEY  
ENTWISTLE, ALBERTA  
REVISION 1**

**Report  
to  
Parkland County**

Date: November 29, 2017  
File: 18683

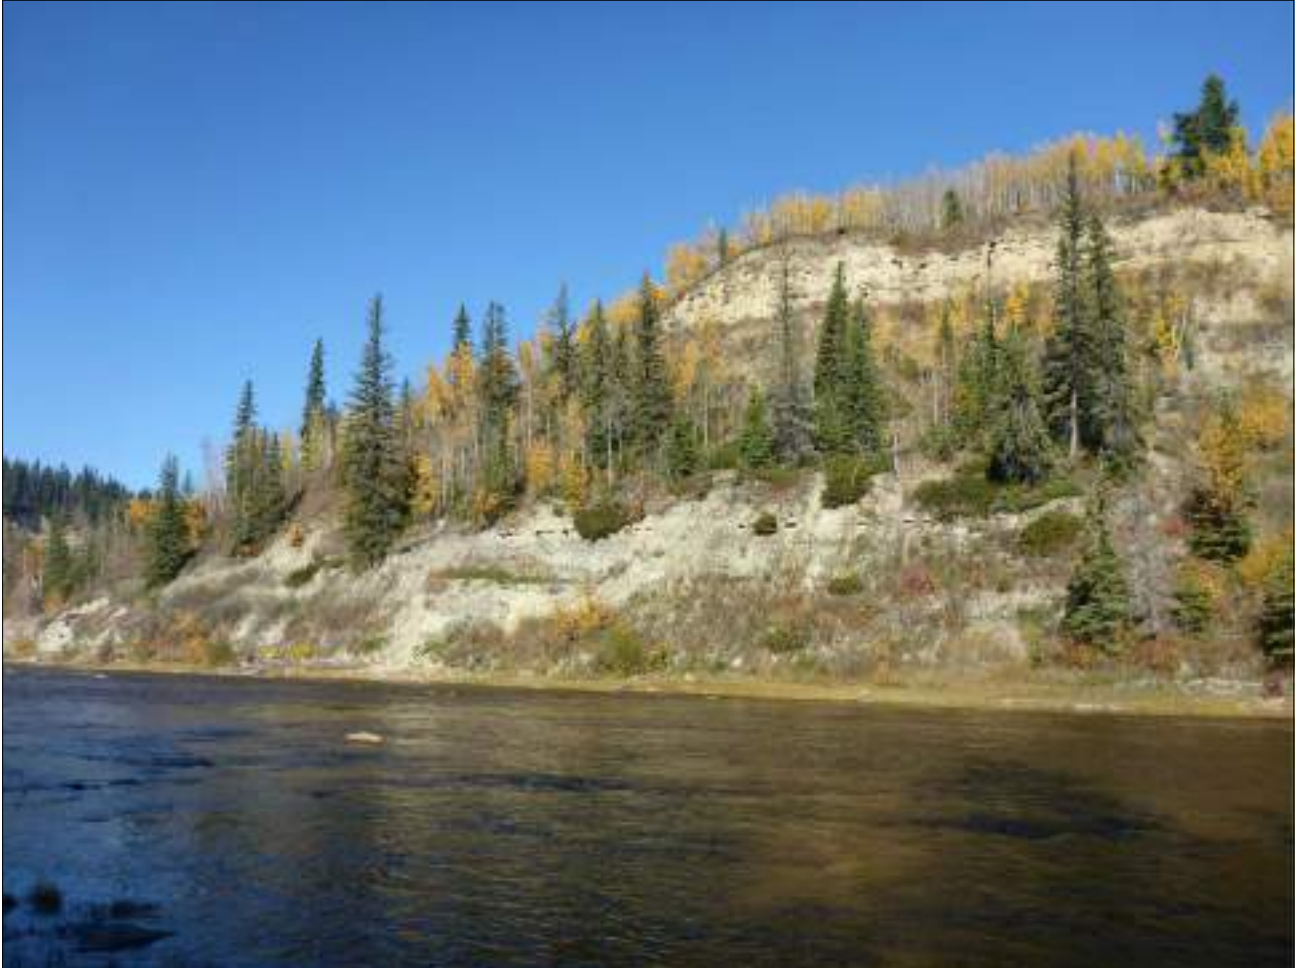
The exposed vertical walls indicated by the LiDAR survey are visually evident along the southern, middle, and northern portions of this site. Colluvial slopes of previously mobilized material is quite consistent across the entire length of the site (Photos 23, 24, 25, and 26, Appendix C). These colluvial slopes generally feature large mature tree vegetation that is relatively vertical in growth. These slopes appear to have moved in the past, possibly decades ago, and the exposed sandstone vertical faces appear to be stable and relatively shallow (approximately 5 m below the crest elevation).

PHOTO 25 SITE 4 - OVERALL VALLEY SLOPE - NORTH

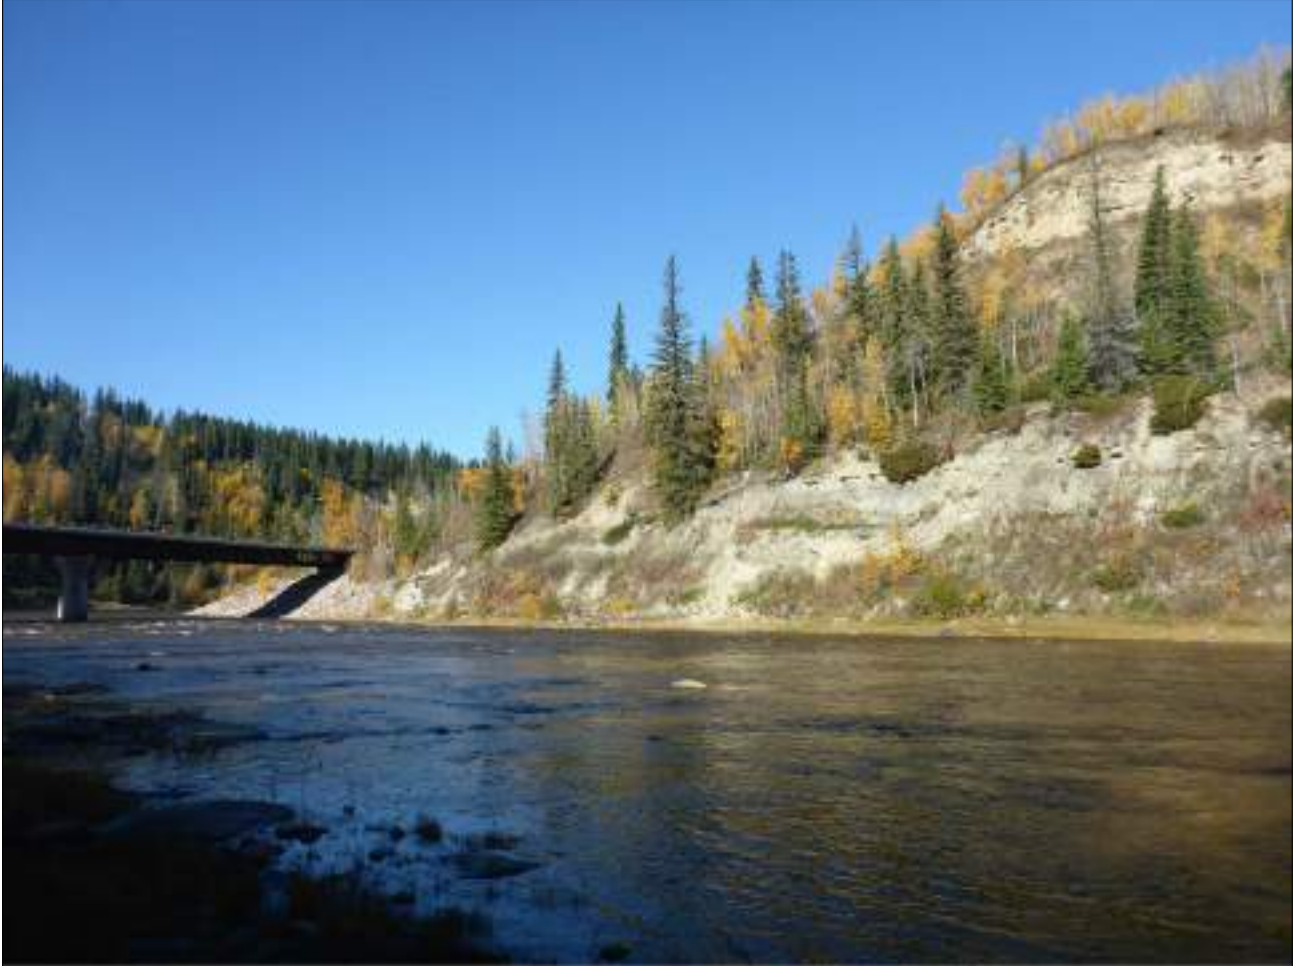
PHOTO 26 SITE 4 - OVERALL VALLEY SLOPE - NORTH

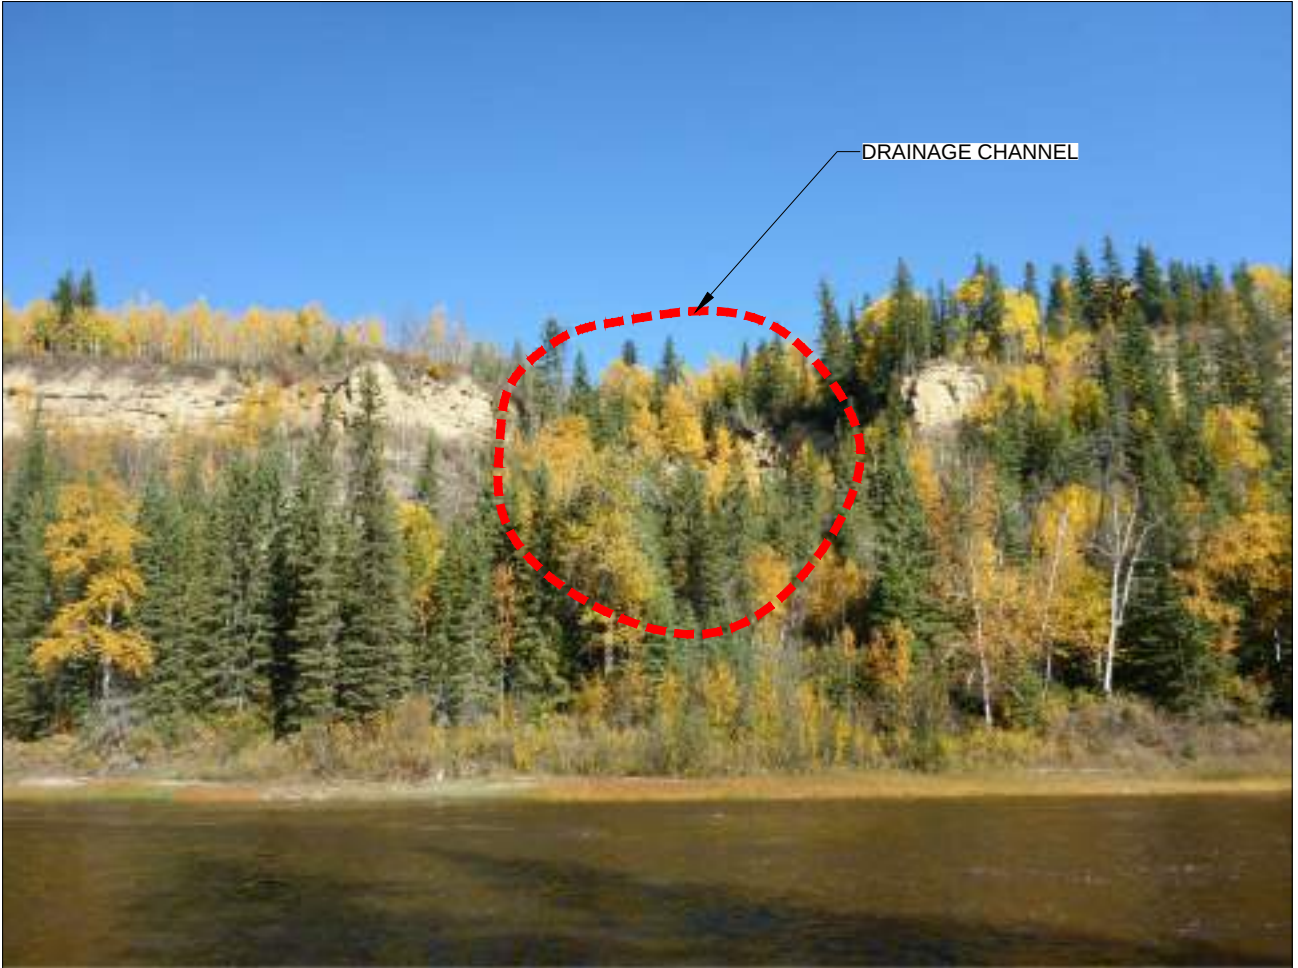
A drainage channel was also observed about in the middle of the site, and is also evident from topography and LiDAR data (Photo 27, Appendix C). From the toe of the valley slope it does not

PHOTO 27 SITE 4 - DRAINAGE CHANNEL
