# Appendix M – Detailed Bridge Condition Survey of Ellis Creek Bridge (Orbit Engineering)

Detailed Bridge Condition Survey of  
Site Number 3801, Maple Grove Road over Ellis Creek Bridge

OE18761AC

October 24, 2018

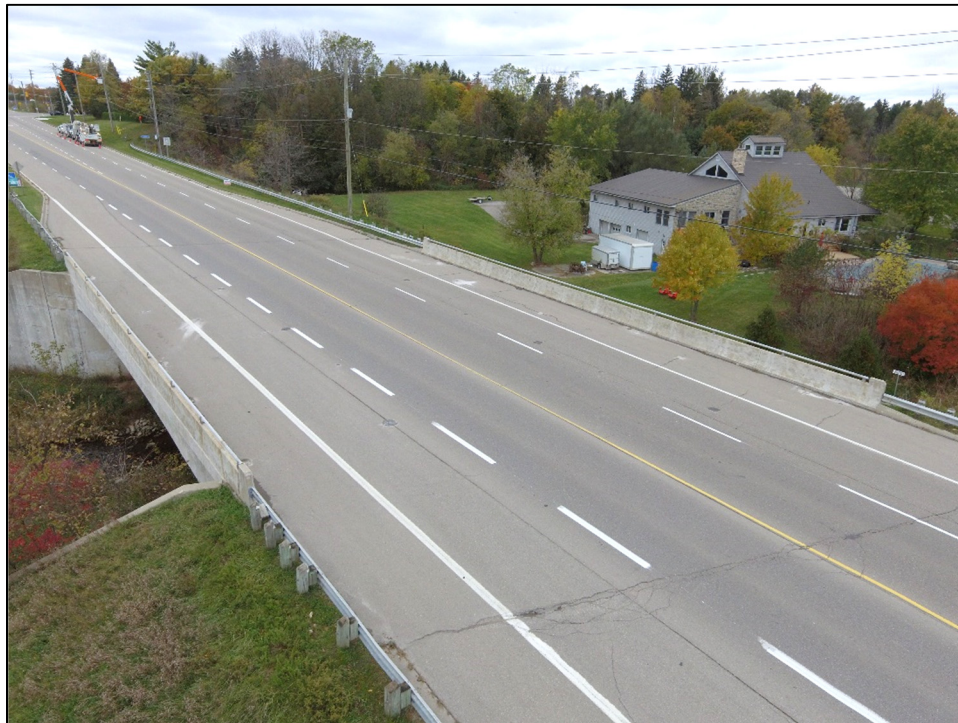
**Photo P1: General View of Structure ID: 3801 Maple Grove Road / Chiligo / Fisher Mills Creek Bridge**

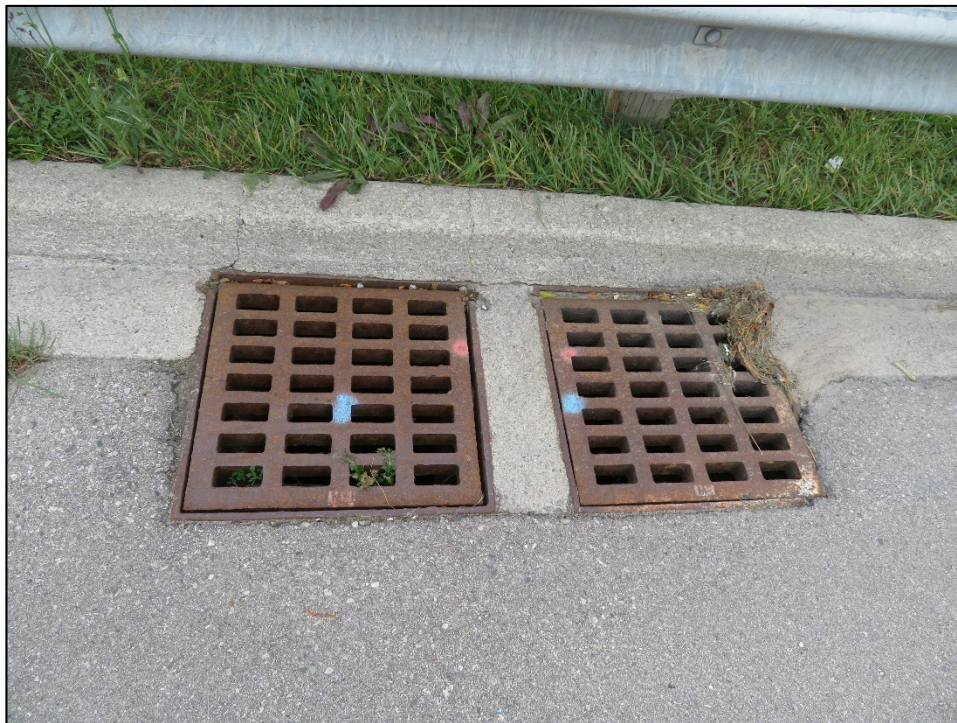
No evidence of deck drainage was found on this structure. However, catchbasins were located at the south-east, south-west and north-east quadrant, outside the structure limits, as shown in Photos P34 to P36.

**Typical Condition of Catchbasin @ South-West**

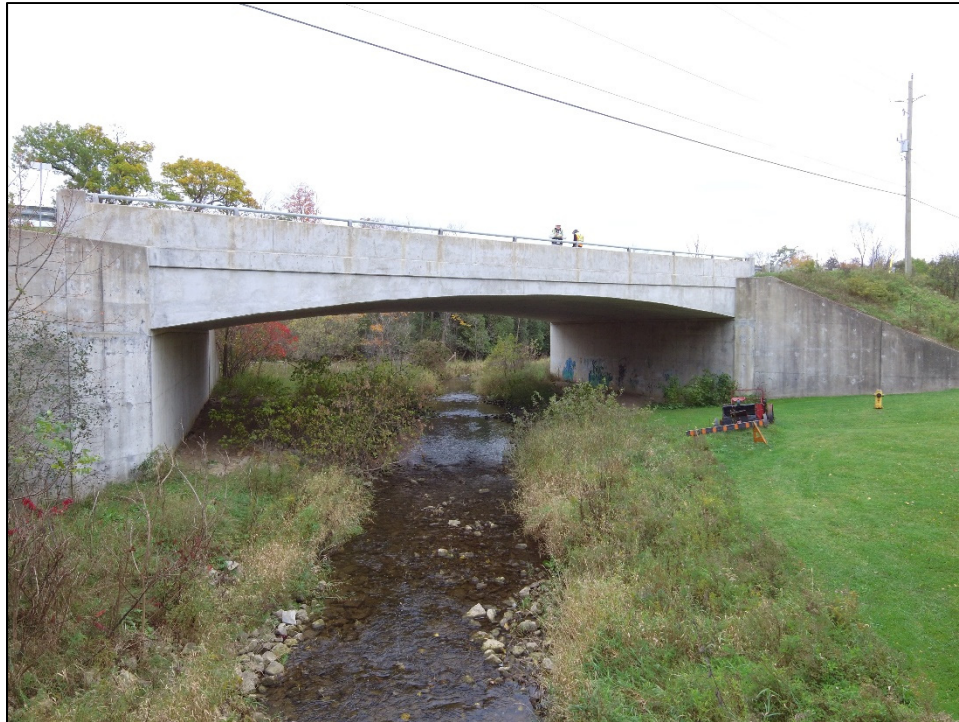
**Photo P1 – North Elevation**

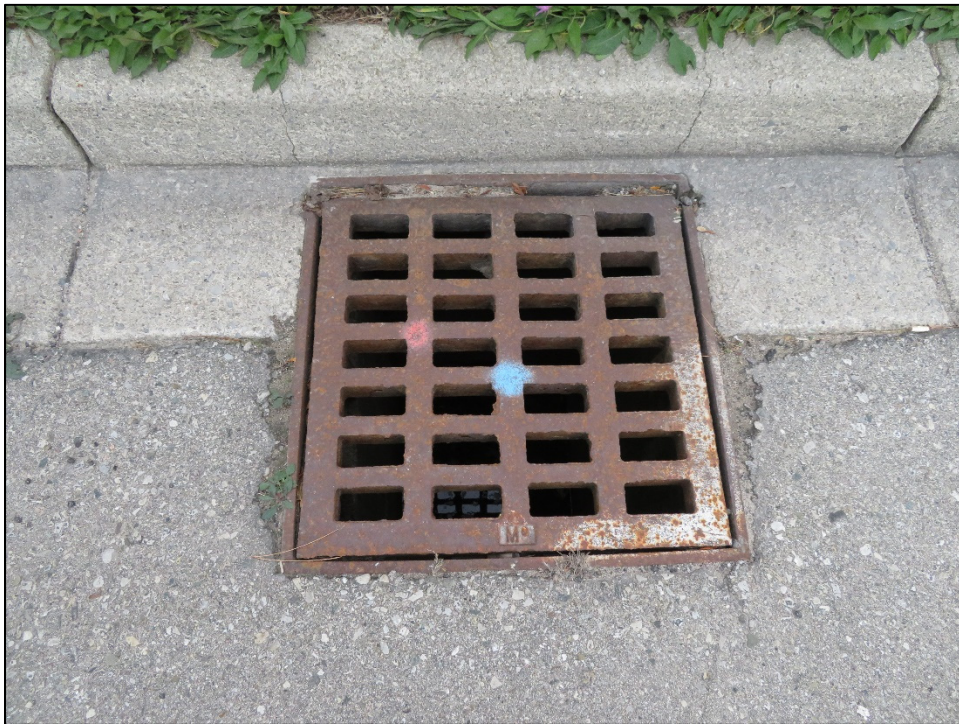
**Photo P34 – Typical Condition of South-East Catchbasin**

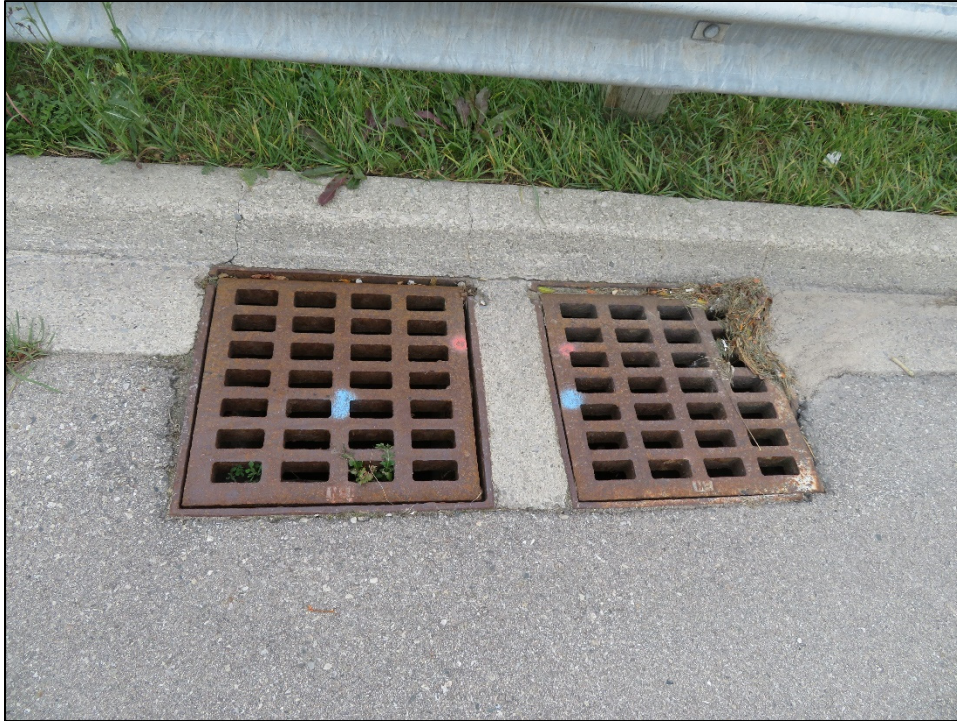
**Photo P35 – Typical Condition of South-West Catchbasin**

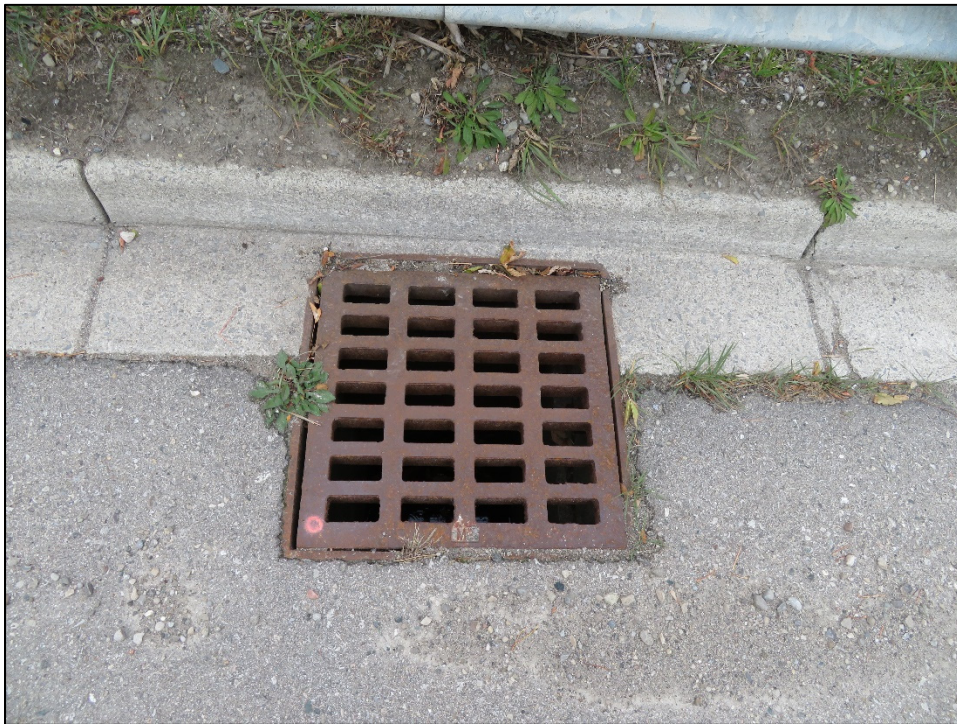
**Photo P36 – Typical Condition of North-East Catchbasin**

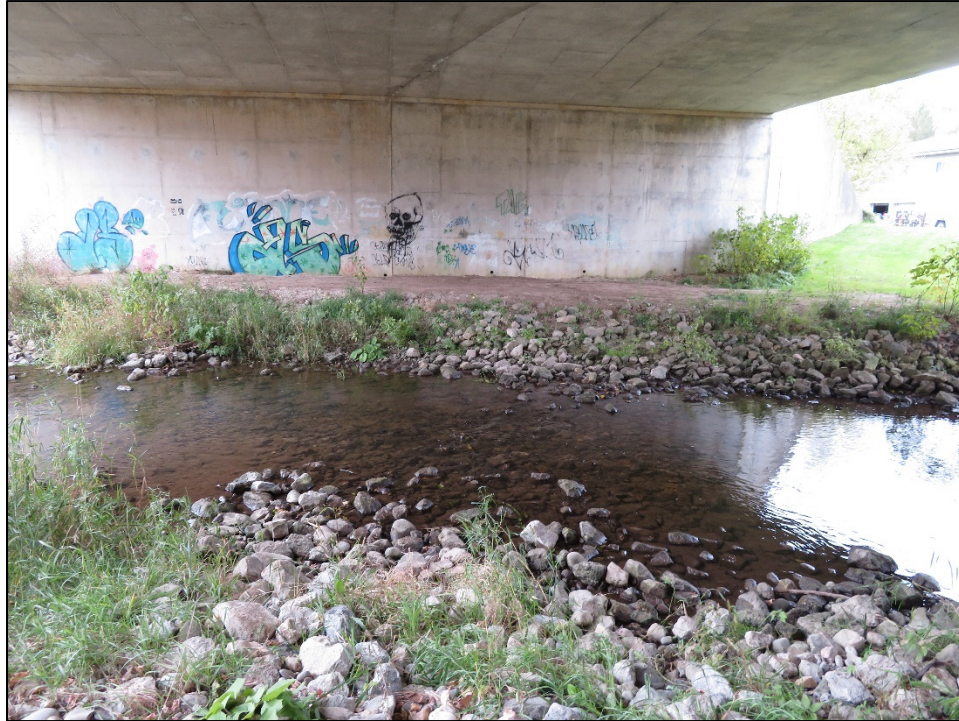
**Photo P37 – Typical Condition of West Slope**

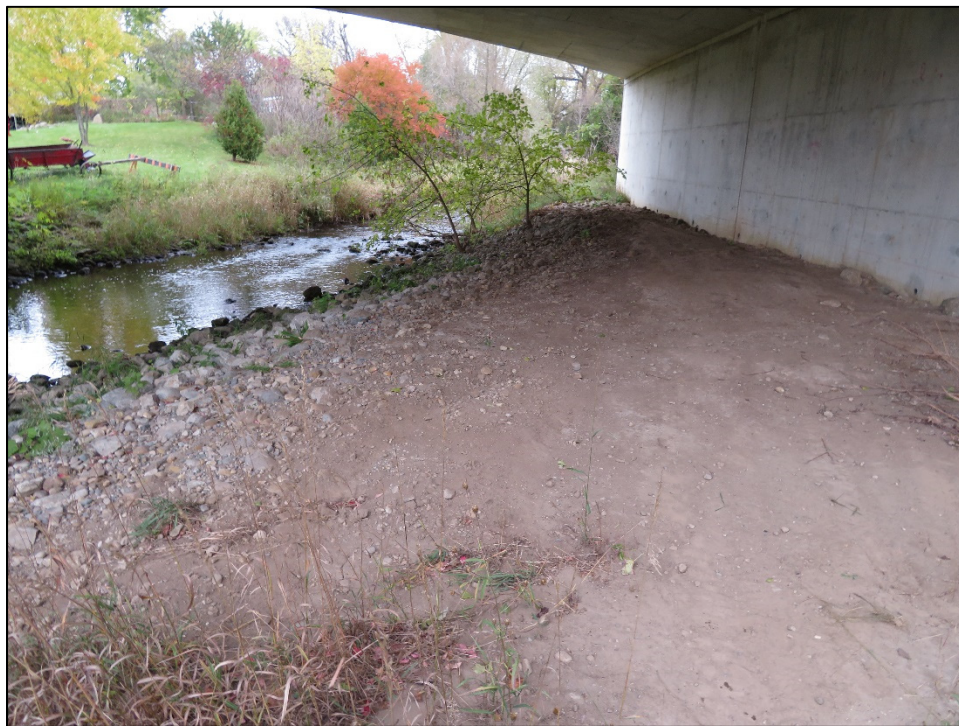
**Photo P38 – Typical Condition of East Slope**

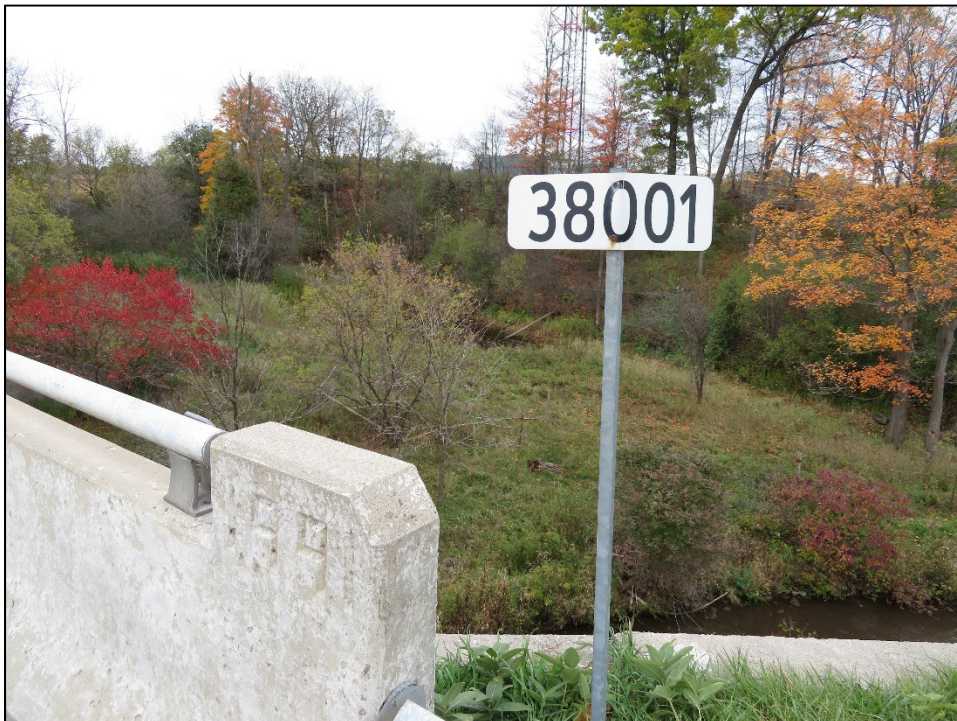
**Photo P44 – Bridge Date Stamp on South Barrier Wall and Site Number Sign**
