February 6, 2019

File: 11680

**THE SHORES PHASE 1 DEVELOPMENT, SECHELT, B.C.  
GEOTECHNICAL COMMENTS ON SINKHOLE RISK MANAGEMENT**

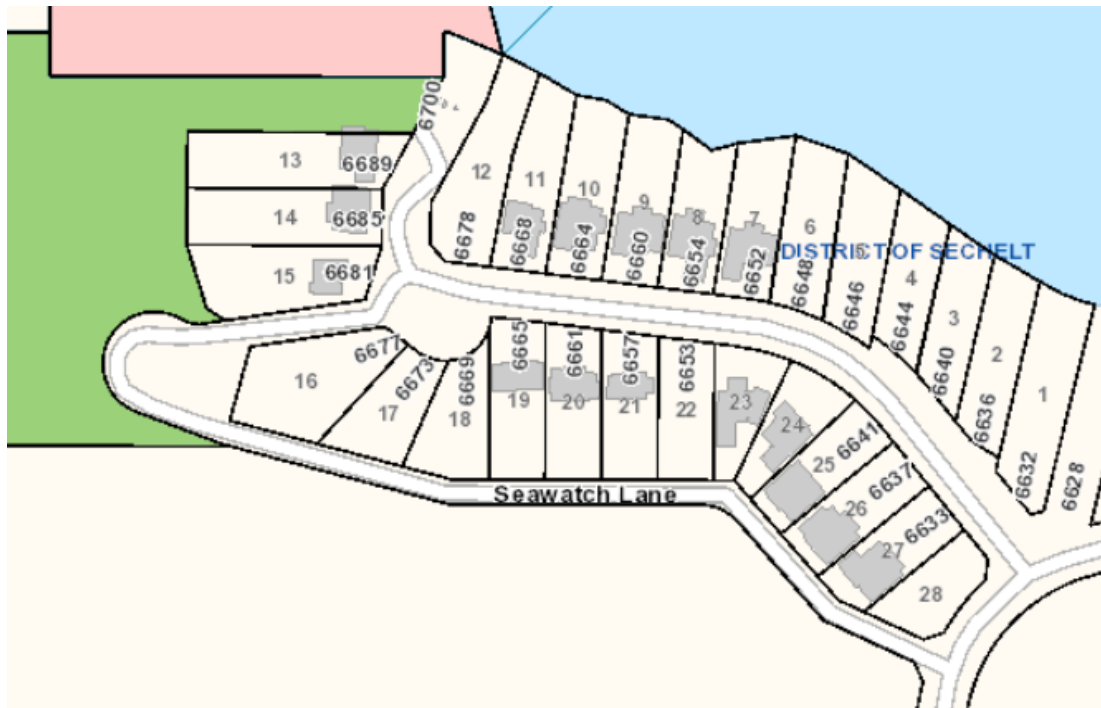
Figure 2. SCRD Map of Phase 1 Site

The Shores Phase 1 Development (the site) has a history of geotechnical issues including sinkholes and groundwater seepage erosion dating back to 2004. The locations of the recorded sinkholes and other site features are shown in Figure 1 (attached). The site includes 14 houses, 2 of which are currently unoccupied (Lot 9 and Lot 21). Partially completed foundations are present on Lot 11 and Lot 15. The SCR map of the site is shown in Figure 2 which shows the lot and street numbers and the locations of the houses.

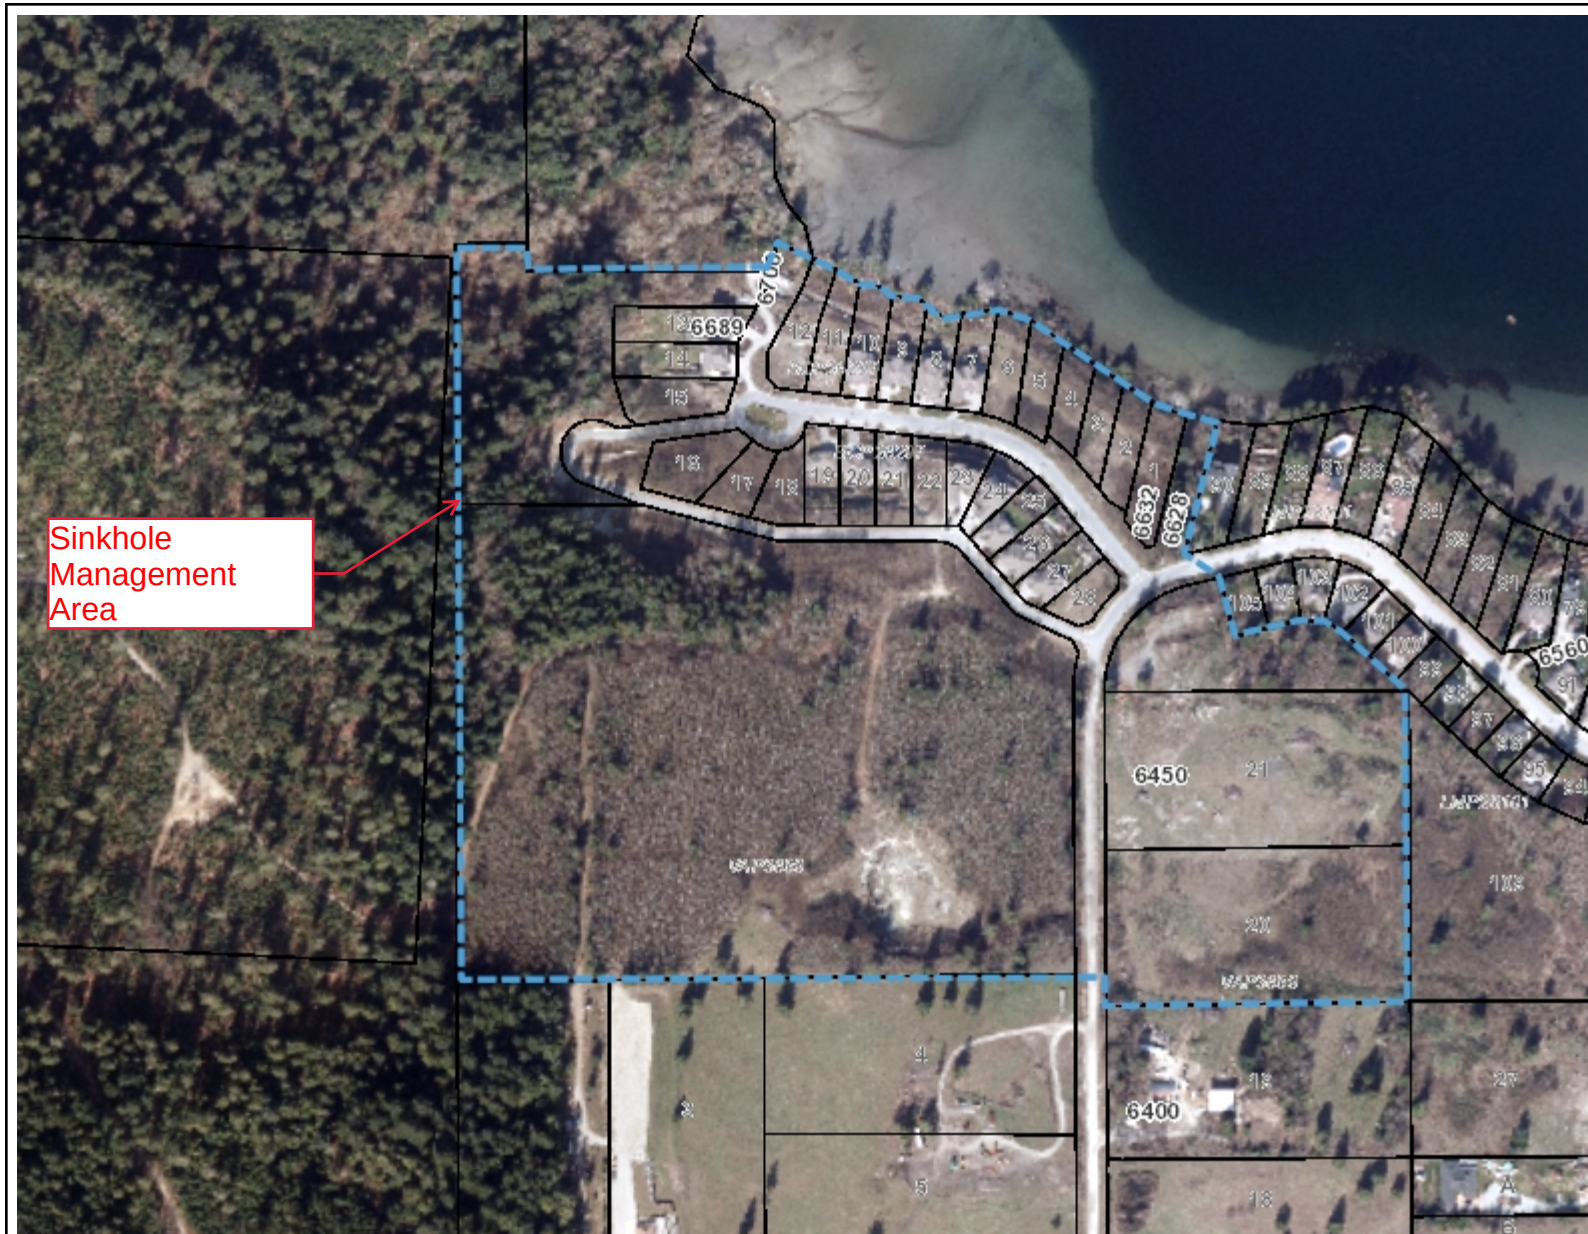
Figure 4. Sinkhole Management Area  
Thurber File: 11680

Figure 4 presents our recommendations for the boundary of the Sinkhole Management Area based on the currently available information and understanding of the sinkhole hazards. This boundary includes a precautionary geotechnical setback from known sinkhole areas because the extents of the subsurface erosion have not been confirmed on the neighbouring properties.
