**KERR WOOD LEIDAL**  
consulting engineers

# Lot 9/10 Stormwater Replacement

Final Report  
November 2018  
KWL Project No. 551.026-300

District of Sechelt

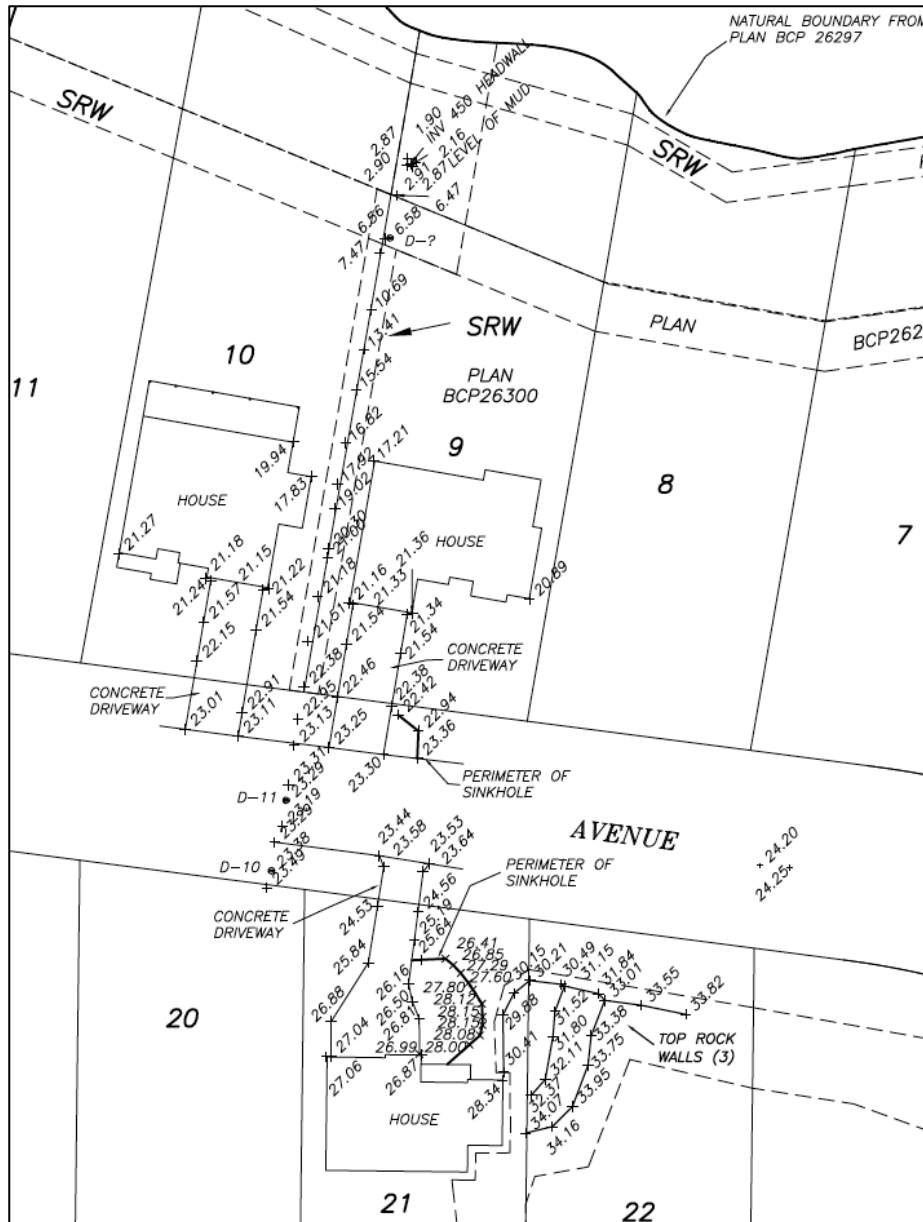
**Figure 3-3: Illustration of Storm Outfall Right-Of-Way Between Lots 9 And 10 (reproduced from Strait Land Surveying Inc.)**

The scope of the present work is to address the specific area of the Seawatch Development where a storm outfall pipe is located between lots 9 and 10, as shown in Figure 3-3.
