# BUILDING CONDITION ASSESSMENT REPORT

## JAMES WHYTE ARENA

70 FRONT STREET NORTH, THOROLD, ONTARIO

Our Project No.: 0T1-919309-CA

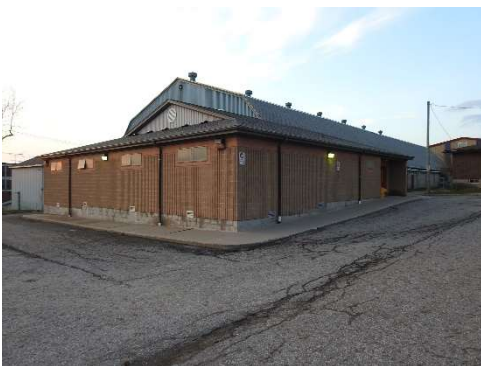
The building was constructed as a natural ice pad in 1936 through partnership with Abitibi Paper. Original architects are unknown. In 1950, a refrigerated ice pad was installed and four change rooms were added to the south end. The refrigeration plant was updated in 1960 and again in 1992, 1995, 1997, and 1998. The original 1936 wood framed roof structure was modified in 1976, 1991, and 1992. In 1983, dasherboards, glazing, pad, and apron were installed to increase the ice dimensions from 170' by 70' to 185' by 76'. The design was prepared by Williams Woodruff and Elmes Architects, St Catharines, Ontario. In 1999/2000 four change rooms were added to the northwest corner of the building. The arena design incorporates a single level building with an enclosed mezzanine sound/media room at the northeast corner. The main entrance is located on the northwest elevation, adjacent to the parking lot. Secondary entrances are located at the east and west elevations through the main foyer. The facility has a gross floor area of approximately 22,500 square feet (sf).

The exterior walls of the arena are constructed with 8 inch plain faced masonry block. The walls of the addition are constructed with 8 inch architectural block.
