# Appendix M – Detailed Bridge Condition Survey of Ellis Creek Bridge (Orbit Engineering)

Detailed Bridge Condition Survey of  
Site Number 3801, Maple Grove Road over Ellis Creek Bridge

OE18761AC

October 24, 2018

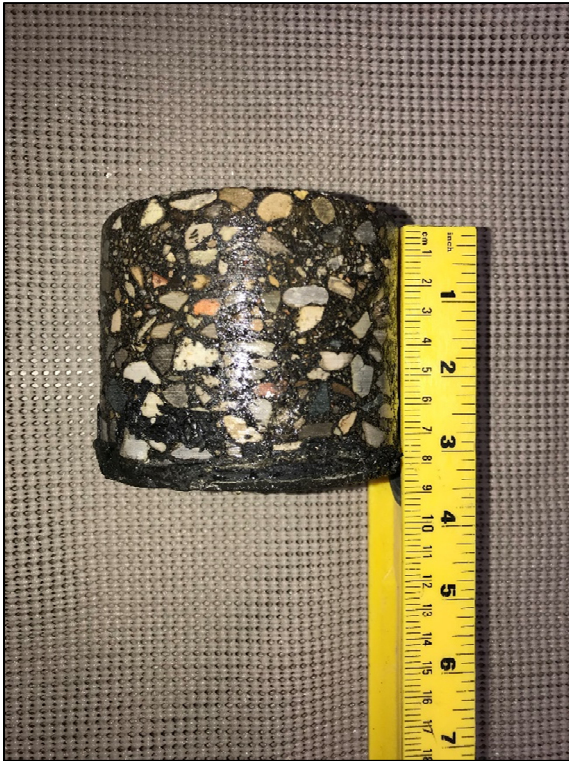
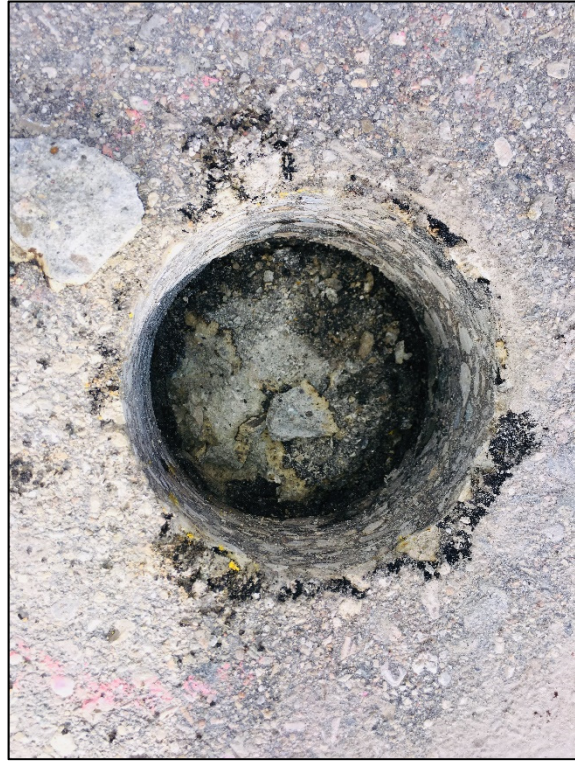
### CORE C1

The asphalt wearing surface of the approaches were typically in fair condition, exhibiting evidence of cracking, as shown in Photos P11 (east) and P12 (west). Core C1 confirmed the existence of concrete approach slabs below the asphalt.

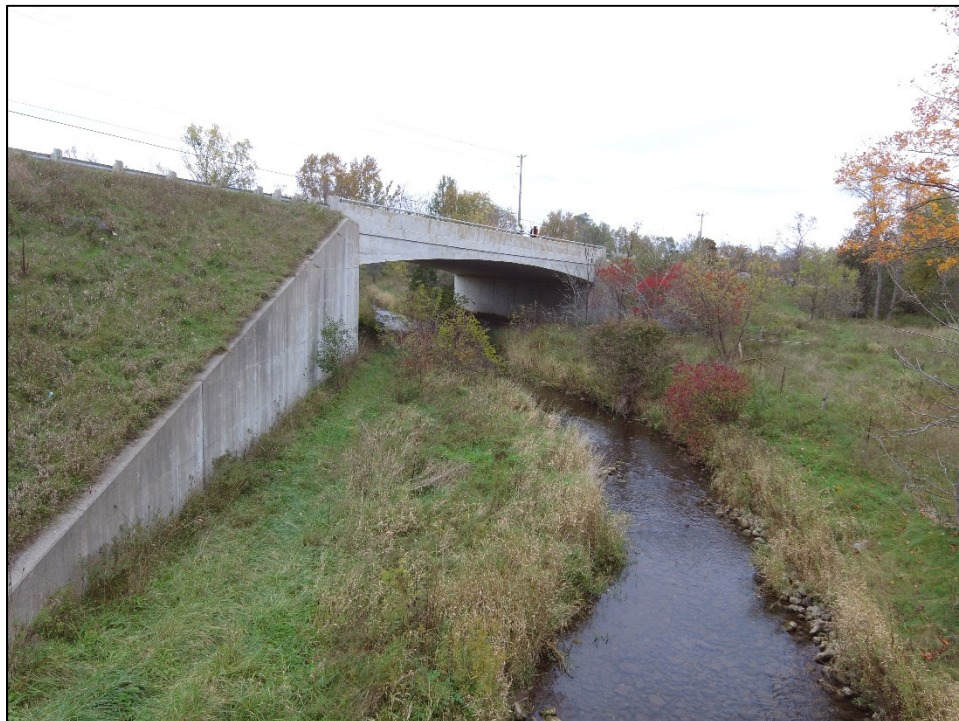
**Photo P2 – South Elevation**
